# Final Environmental Assessment for Phase II Air Cargo Facility Development

Lakeland Linder International Airport  
Polk County, Florida

# **Phase II Air Cargo Facility Development at Lakeland Linder International Airport (LAL)**

## **Phase IB Cultural Resources Assessment Survey**

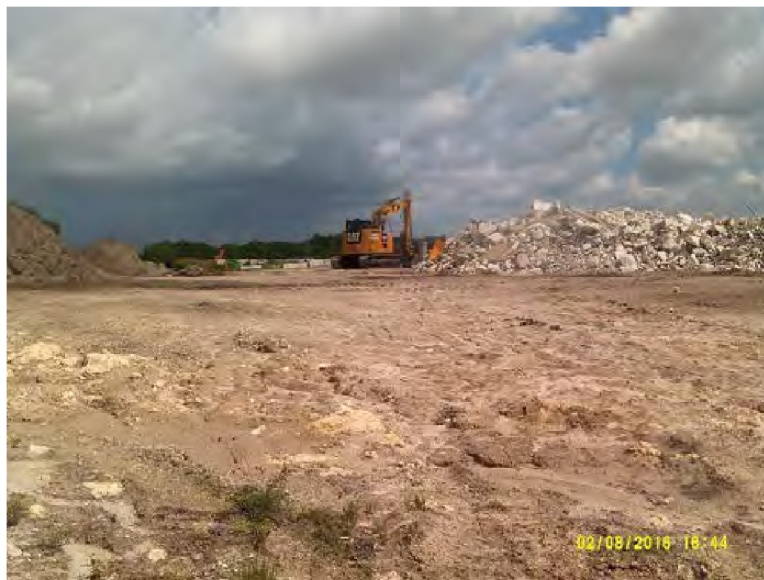
**Photo 5-1:** Construction activities south of Drane Field Road, facing east.

Large portions of the Direct Effects APE were subjected to a visual reconnaissance survey where significant disturbances were observed (**Photo 5-1**). There were large piles of construction rubble and material from grading present across the site. Subsurface testing was conducted in most areas to confirm the observable damage to the ground surface with the exception of inaccessible or newly paved areas. A total of 12 STPs were excavated in the Direct Effects APE (**Figure 5-1**). The only areas with relatively undisturbed soils are the wetlands (although construction materials were present in the A horizon in the wetland areas as well), and the majority of the shovel testing was attempted along the wetland edges. The following is a discussion of the western and eastern parcels.

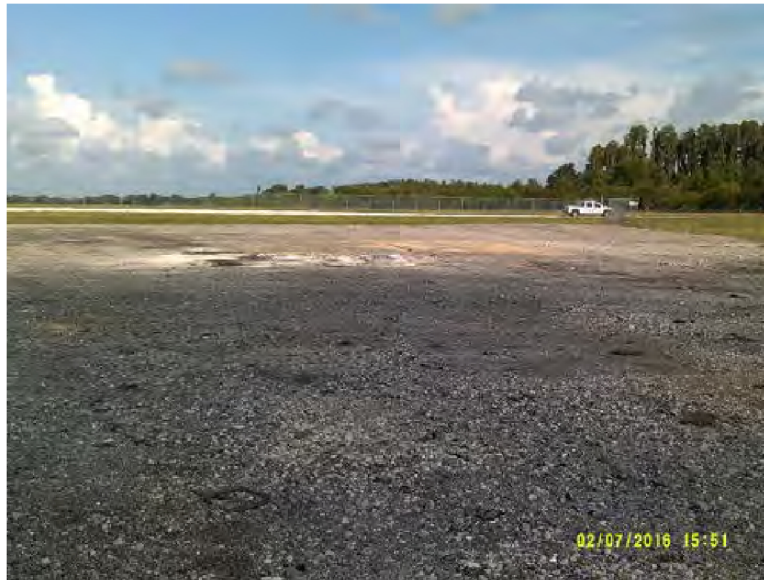
Shovel tests were planned but not excavated south of the wetland on the southern portion of the property on either side of Kelvin Howard Road. This area was paved to the east of Kelvin Howard Road and there was standing water on the western side of the road (**Photo 5-2**).

**Photo 5-2:** Paved area east of Kelvin Howard Road, facing west.

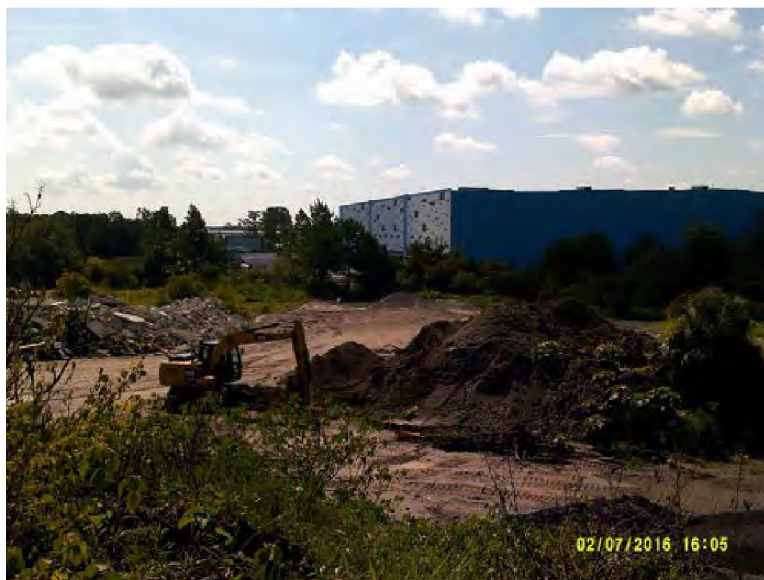
**Photo 5-3:** Construction activities in the western parcel, Air Cargo warehouse visible in background, facing southeast.

The northern portion of the APE closest to Drane Field Road was recently used as a staging area for the Phase I construction of the air cargo facility. Grading and mixing of gravel and clay had occurred over much of the prepared surfaces and there were large debris piles present (Photo 5-3).

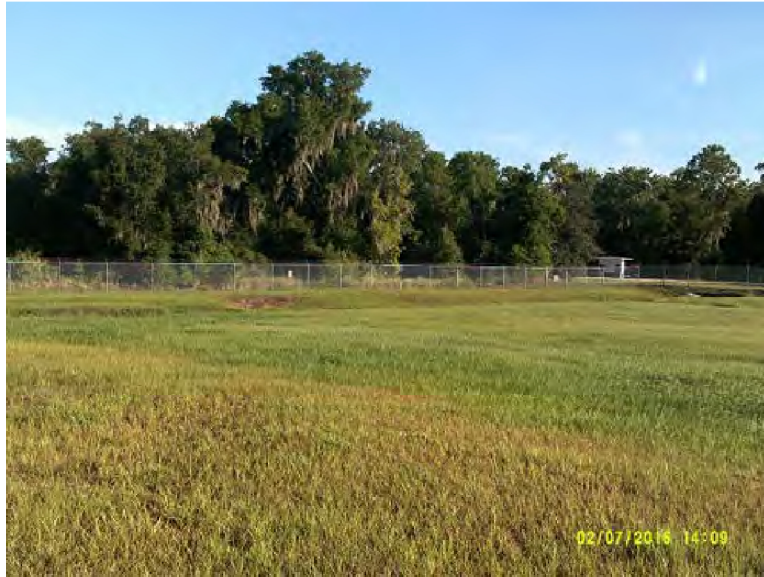
The eastern parcel measures approximately 2.8 acres (1.1 hectares). The parcel is paralleled on the north side by Aero Place, the eastern and southern sides by unnamed airport access roads, and on the western side by dense hardwood wetlands. This parcel is bisected by two drainage ditches, one north-to-south and one east-to-west. The western edge of the property (west of the ditch) was comprised of rip-rap and was not testable. The primary vegetation in this area was manicured lawn (**Photo 5-4**).

**Photo 5-4:** Eastern Parcel setting, facing northwest

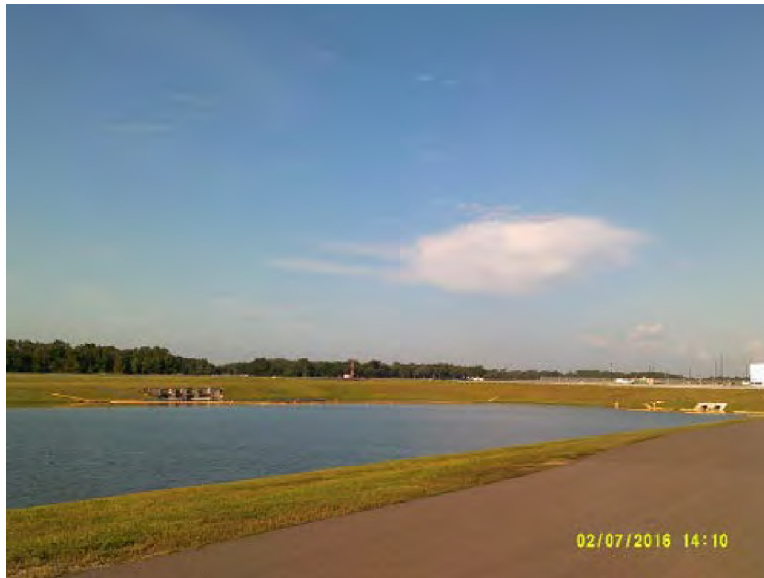
A total of four shovel tests were excavated in this location. All tests encountered disturbed soils, likely from the construction of the adjacent ditches, access roads, and the large man-made pond to the south (**Photo 5-5**). STP E2 is representative of the disturbed stratigraphy in this area (**Figure 5-2, Photo 5-6**). Stratum I consists of dark, reddish-brown (2.5YR 3/1) sand fill with limestone and metal from 0-16 cm bgs. Stratum II is characterized by reddish-black (2.5YR 2/1) sand fill with limestone from 16-44 cm bgs. Stratum III displayed reddish-brown (2.5YR 4/3) sand fill with limestone from 44-62 cm bgs. Stratum IV consists of light reddish brown (2.5YR 6/3) sand fill from 62-80 cm bgs. Stratum V contained white (2.5YR 8/1) sand from 80-90 cm bgs.

**Photo 5-5:** Retention pond south of Eastern Parcel, facing southwest

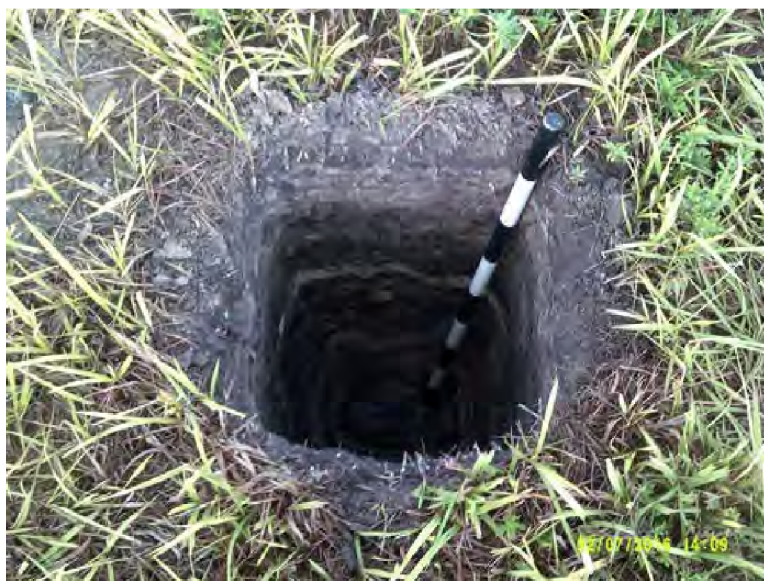
**Photo 5-6:** STP E2 Profile, facing north.

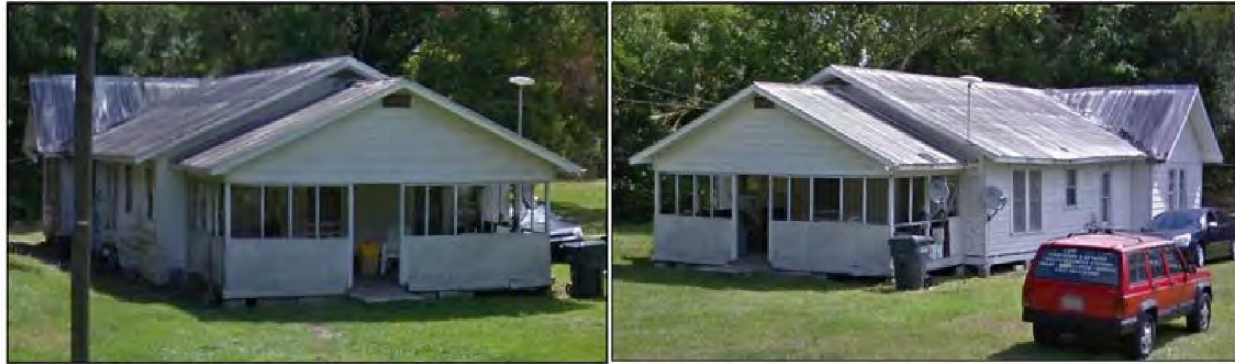
In 2011, according to Google Maps photos taken that year, the house had a frame, one-story, gable-front, central block (**Photos 5-7 through 5-12**). This was crossed at the front (west) by a partially enclosed gable-roofed porch and at the rear (east) by a perpendicular, gable-end, frame block. The house had double-hung sash windows, a seam-metal roof, and aluminum siding. Since 2011, the porch has been removed and replaced by an open porch; bays have been covered or shifted and windows and doors have been replaced; new artificial siding has been added; and a gable-front rather than gable-end roof has been placed atop the rear ell. The house continues to stand on concrete blocks. The house's many significant alterations suggest that after the 2011 photographs were taken, it was essentially stripped down to its studs and rebuilt, resulting in its current appearance. Bing Maps photographs from 2014 depict the house as it is at present, dating its alterations to between 2011 and 2014.

**Photo 5-7** (left): Robberson House in 2011, north side and west front elevations (source: <https://www.google.com/maps/>); **Photo 5-8** (right): Robberson House in 2011, west front and south side elevations (source: <https://www.google.com/maps/>).

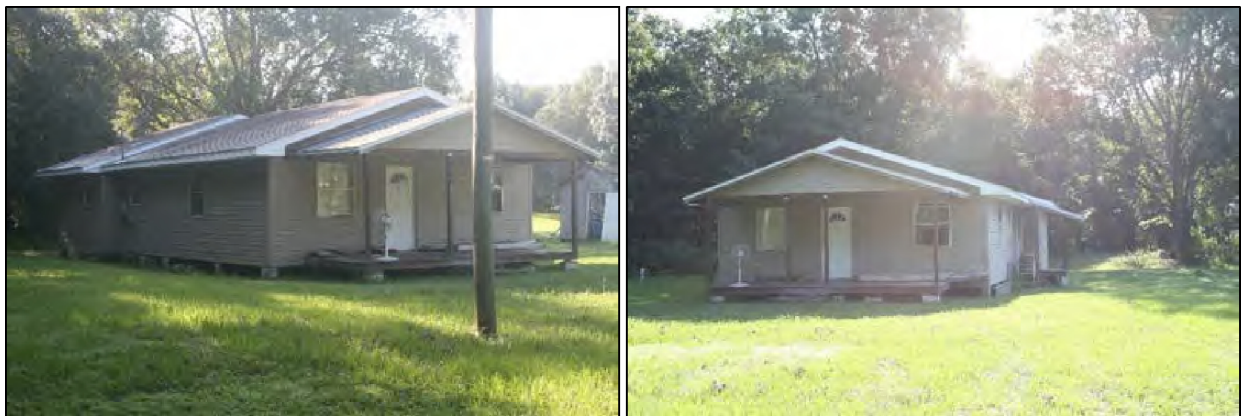
**Photo 5-9** (left): Robberson House in 2020, north side and west front elevations; **Photo 5-10** (right): Robberson House in 2020, west front and south side elevations.

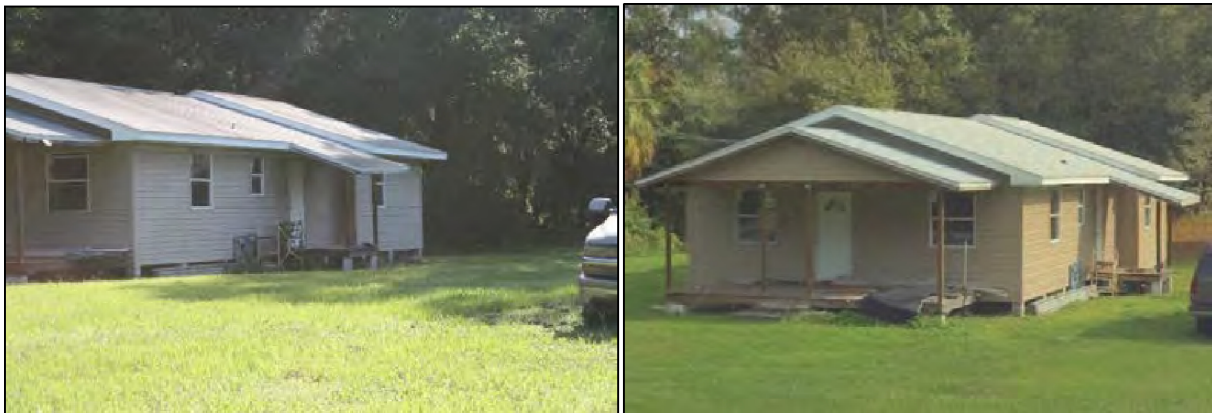
**Photo 5-11** (left): Robberson House in 2020, west front and south side elevations (source: <https://www.bing.com/maps/>); **Photo 5-12** (right): same elevations in 2014 (source: <https://www.bing.com/maps/>).

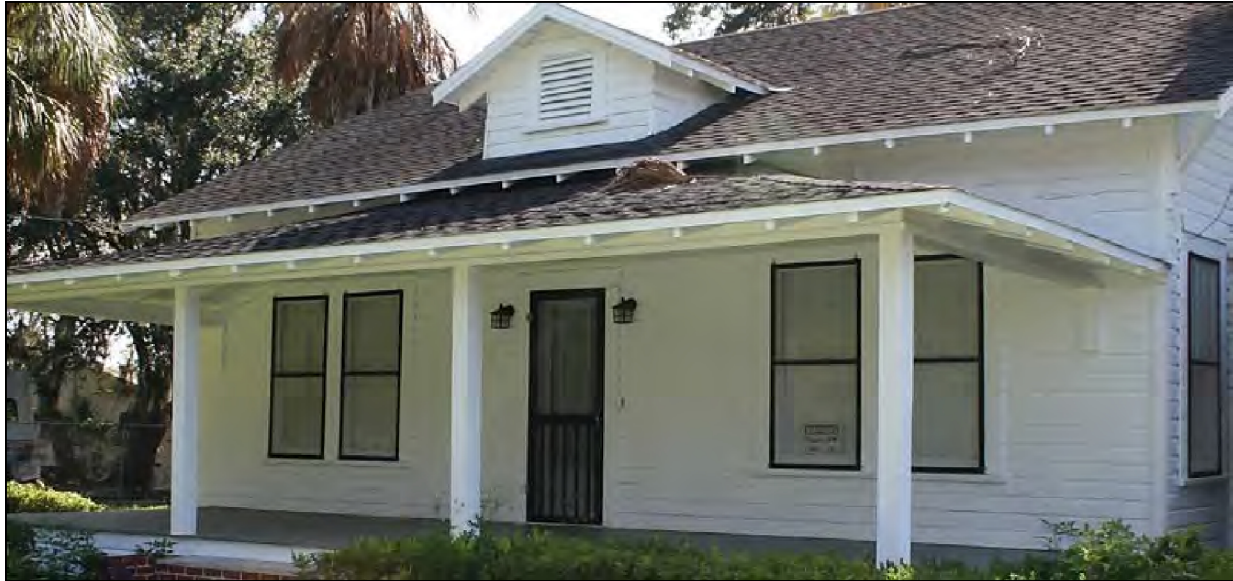
The marital status and ages of the Morgans and the farmhouse’s form and Craftsman-style features suggest that it was erected around 1924, the date tax records assign it (**Photos 5-13 through 5-17**). The frame house is one-story tall. Its west-facing front block has an asphalt-shingled gable-end roof and rests on brick piers. A door is centered at the front elevation, flanked by paired, double-hung, sash windows. The Craftsman-style four-vertical-light-over-one-light sash suggests the windows are original. The Craftsman-style glass-paned front door also appears to be original. Plain surrounds frame the door and windows. A hipped-roof porch supported by plain wooden posts and underpinned by exposed rafter tails – yet another Craftsman feature – extends across the facade’s full length. Exposed rafter tails also mark the wide overhanging eaves of the block’s roof and those of its small ventilated dormer, which is centered over the entry. A brick exterior-end chimney extends through the wide overhang on the block’s south side elevation. The block is clad in original German siding that terminates at plain corner boards.

**Photo 5-15** Aaron E. and Maude Morgan House, west front and south side elevations showing German siding and Craftsman-style windows, door, and exposed rafter tails, 2020.

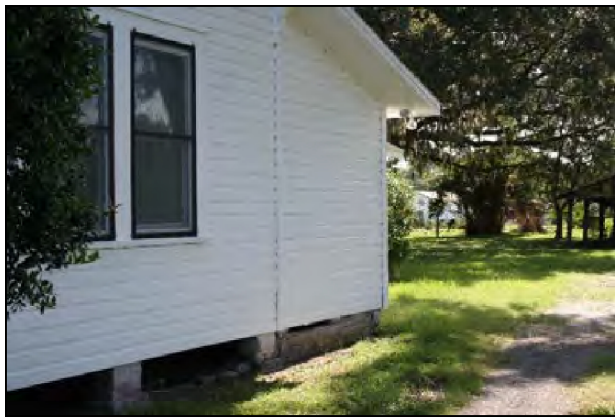
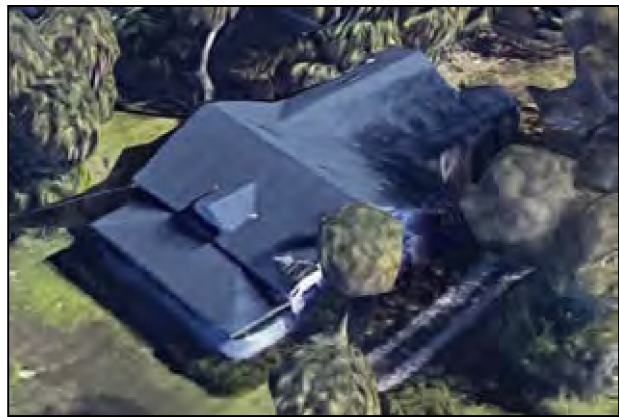
**Photo 5-16** (left): Aaron E. and Maude Morgan House, south side elevation at rear (north end) of house with front (west) elevation of barn at far right, 2020; **Photo 5-17** (right): Aaron E. and Maude Morgan House aerial depicting west front and south side elevations and roof lines, no date (source: <https://www.google.com/maps>).

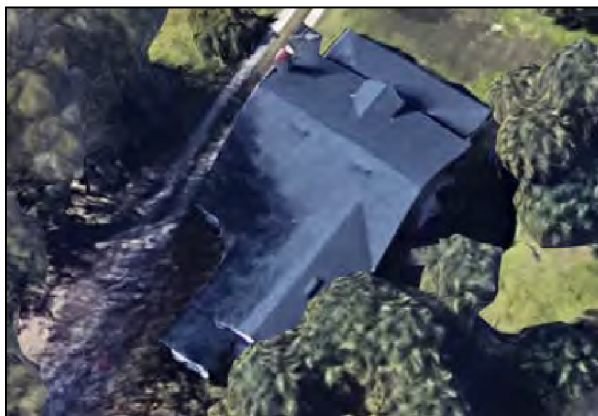
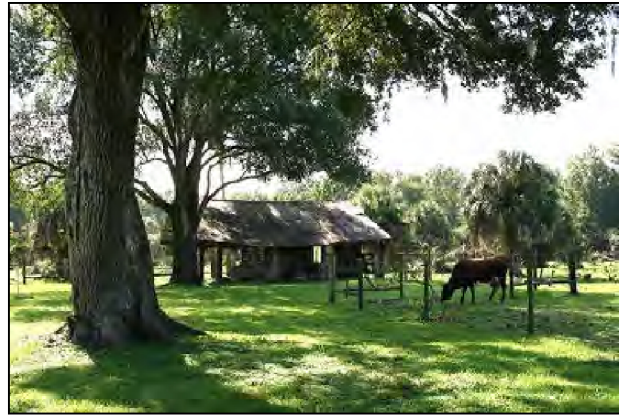
To the house’s rear (east), thick round poles support the gabled sheet-metal roof of an open pole barn that is less than 50 years old (**Photos 5-18 through 5-22**). Shaded by the roof is an earlier building that appears to be largely built of slender, round, saddle-notched, unchinked logs. (Note: due to COVID-19 concerns and no-trespassing signs, access to the property and its resources was limited.) Log buildings were erected in Polk and other northern and central Florida counties into the late nineteenth century (Florida Association of the American Institute of Architecture 2017: 4, 23, 108). The extant English Family Log Cabin, now located in Homeland Heritage Park, was moved to Homeland from elsewhere in Polk County. Constructed of round saddle-notched logs, it dates from about 1890 (Hacking, Forbes, and Jones 2006). Whether this building was erected in the late nineteenth century could not be determined.)

**Photo 5-18** (left): Aaron E. and Maude Morgan House, aerial depicting east rear and north side elevations, no date (source: <https://www.google.com/maps>); **Photo 5-19** (right): Aaron E. and Maude Morgan House, west front and south side elevations of barn to rear of house, 2020.

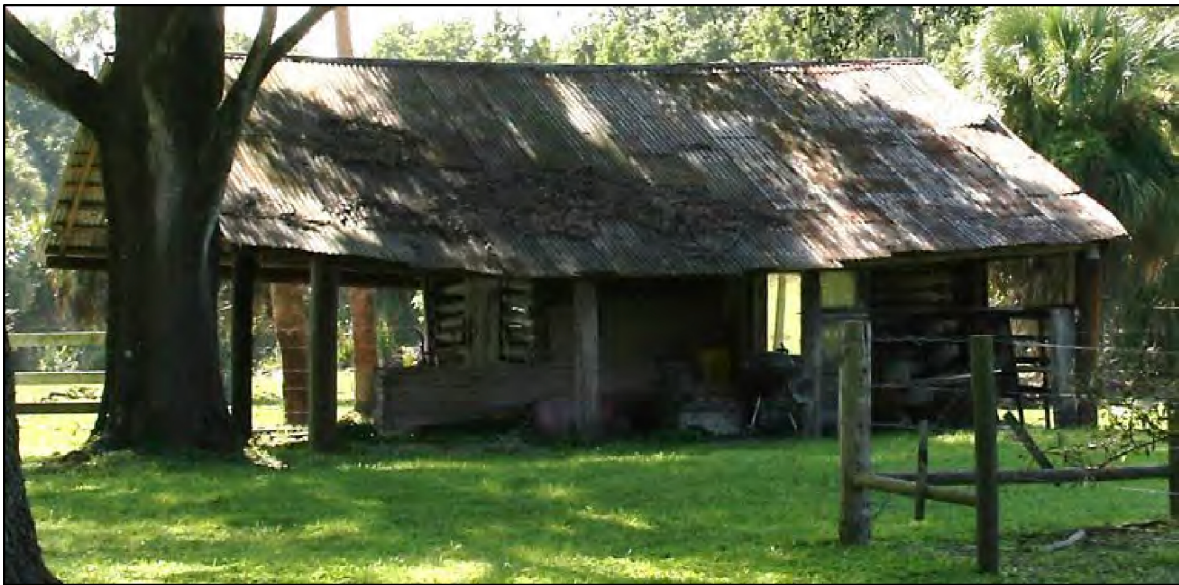
**Photo 5-20:** Aaron E. and Maude Morgan House, west front and south side elevations of pole barn and log building within it, 2020.

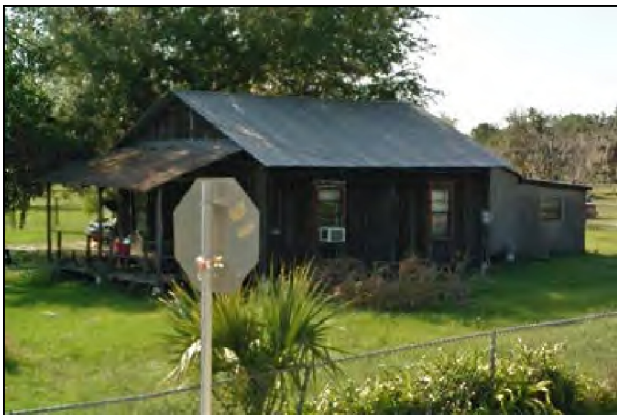
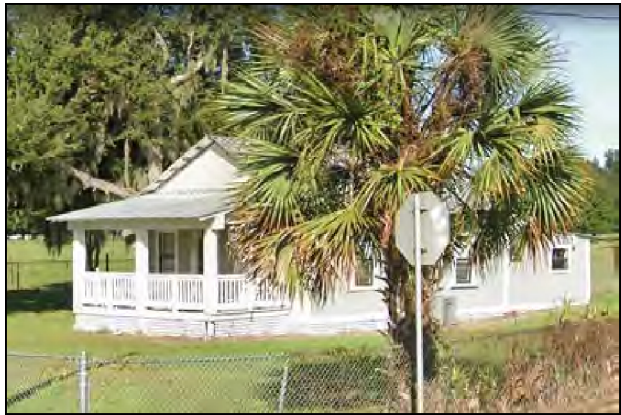
Photographs taken in 2011, before the house underwent a major renovation, depict a dwelling that may indeed have been built around 1920, the assigned tax date (**Photos 5-23 through 5-29**). In 2011 the small, gable-front, frame house – about 16 feet across and 24 feet deep according to tax records – was sided in heavily weathered vertical boards without battens and topped by a metal roof. Its two-bay-wide south-facing front facade was shaded by a plainly finished porch covered by a metal shed porch. To its rear (north) extended an ell faced with T111-type siding that had a double-pitched shed roof. Tax records identify much of the ell as a formerly open porch. Between 2011 and 2019, the old front porch was replaced by one with square posts and a balustrade. The front door was also replaced. A new metal roof was set atop the house and it received new artificial siding. Its two-over-two, double-hung, sash windows were cleaned or replaced in kind; the plain window surrounds were cleaned and painted. The rear ell was also re-sided.

**Photo 5-25** (left): Morgan Family House 1 south front and east side elevations in 2011 (source: <https://www.google.com/maps/>); **Photo 5-26** (right): Morgan Family House 1 in 2019 (source: <https://www.google.com/maps/>).

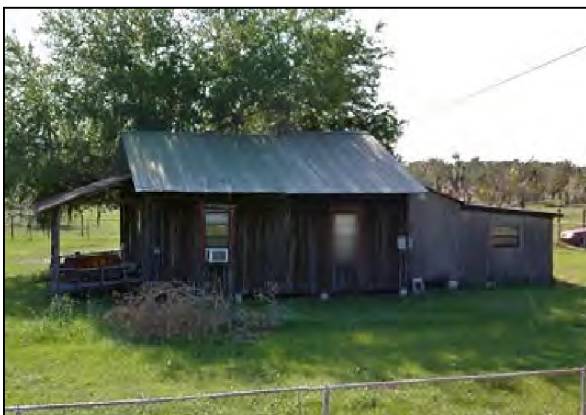
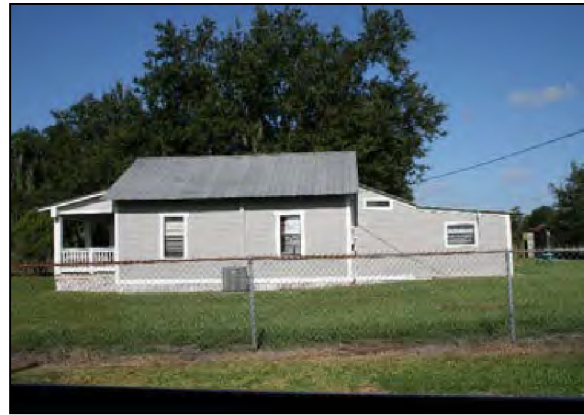
**Photo 5-27** (left): Morgan Family House 1 east side elevation in 2011 (source: <https://www.google.com/maps/>); **Photo 5-28** (right): Morgan Family House 1 east side elevation in 2020 (source: <https://www.google.com/maps/>).

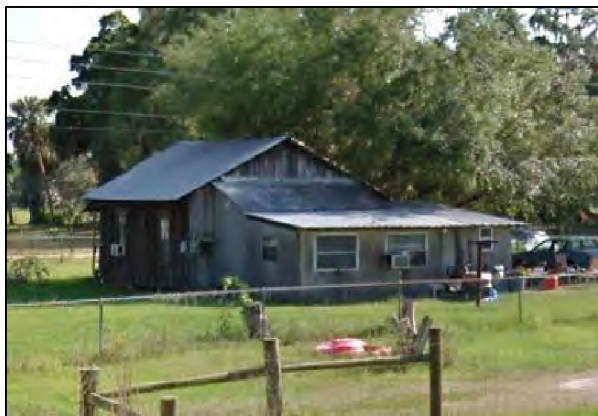
**Photo 5-29:** Morgan Family House 1: east side and north rear elevations, 2011 (source: <https://www.google.com/maps>).

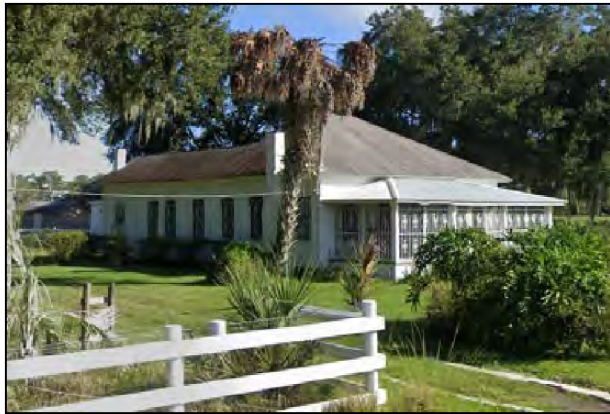
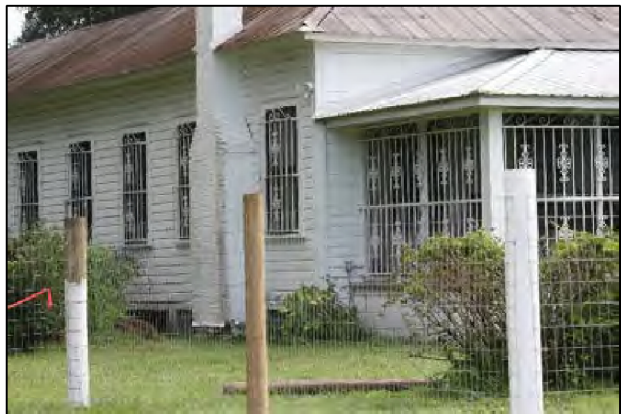
**Photo 5-32** (left): Morgan Family House 2, west side and south front elevations in 2019 (source: <https://www.google.com/maps>); **Photo 5-33** (right): same elevations in 2020.

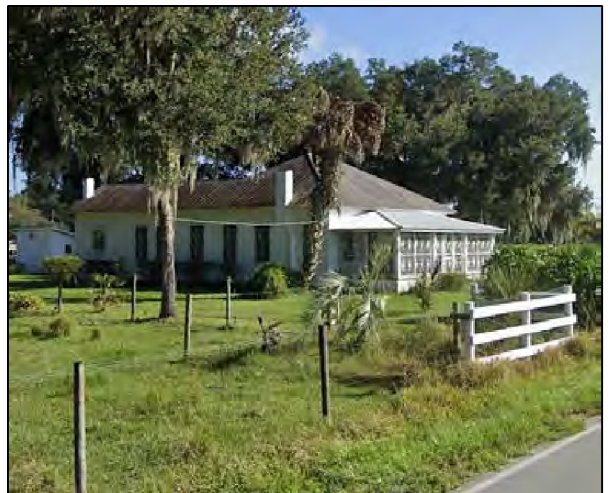
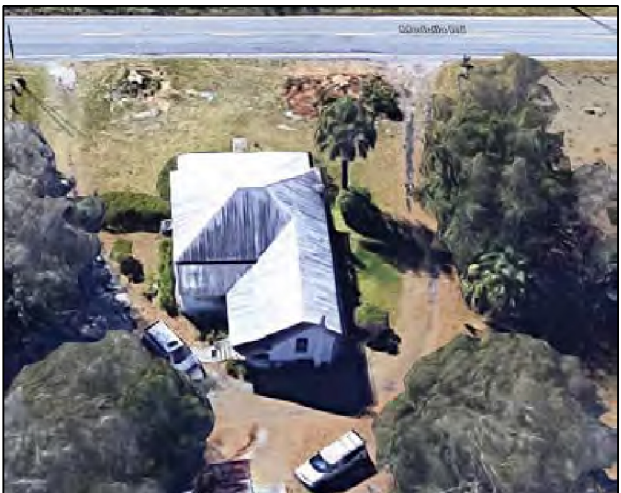
**Photo 5-34** (left): Morgan Family House 2, west side and south front elevations, 2019 (source: <https://www.google.com/maps>); **Photo 5-35** (right): Morgan Family House 2, aerial view of north rear elevation and roofs, 2018 (source: <https://www.google.com/maps>).

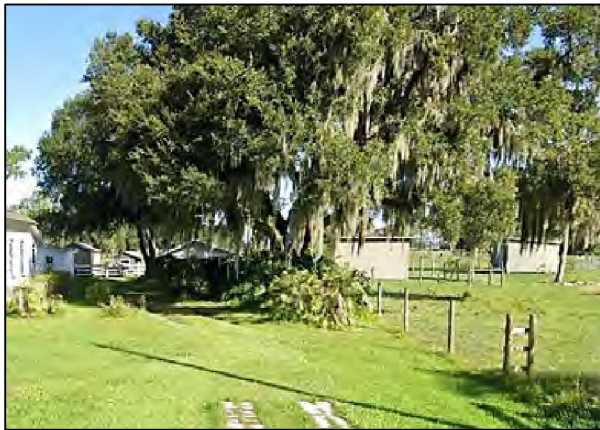
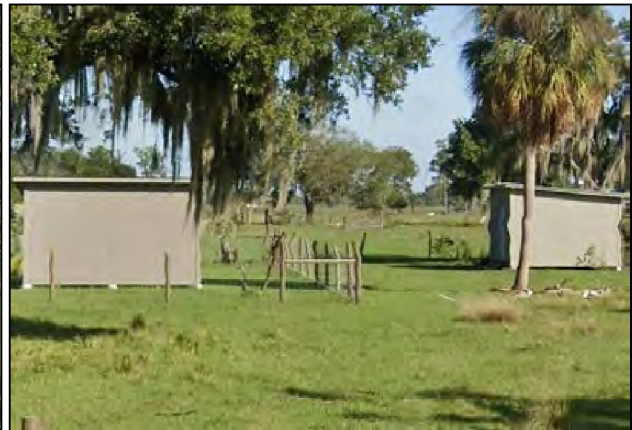
**Photo 5-36** (left): Morgan Family House 2, looking north (with house at left) and two shed-roofed sheds at right (east), garage at center left, and two gable-roofed sheds at left distance, 2019 (source: <https://www.google.com/maps>), **Photo 5-37** (right): Morgan Family House 2, view of eastern shed-roofed sheds, 2019 (source: <https://www.google.com/maps>).

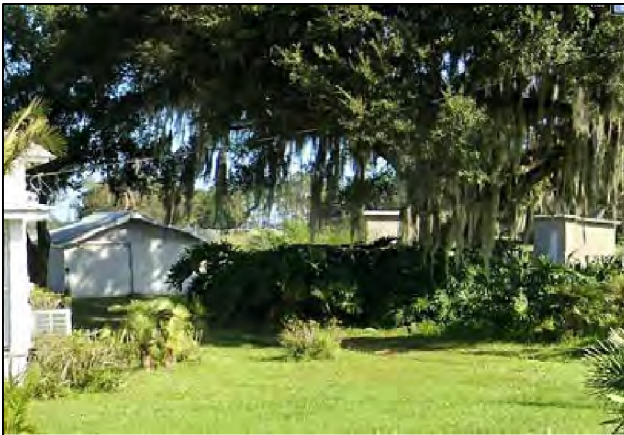
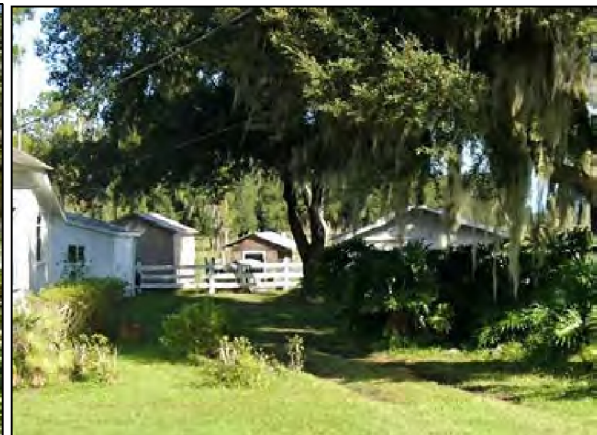
**Photo 5-38** (left): Morgan Family House 2, looking northeast (house at left) at garage at left and eastern sheds at right, 2019 (source: <https://www.google.com/maps>); **Photo 5-39** (right): Morgan Family House 2, looking northwest (house at left) at white shed-roofed shed and gabled sheds at left and garage at right, 2019 (source: <https://www.google.com/maps>).

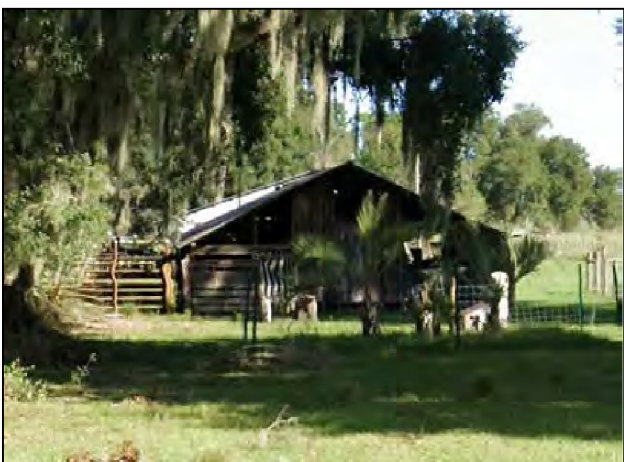
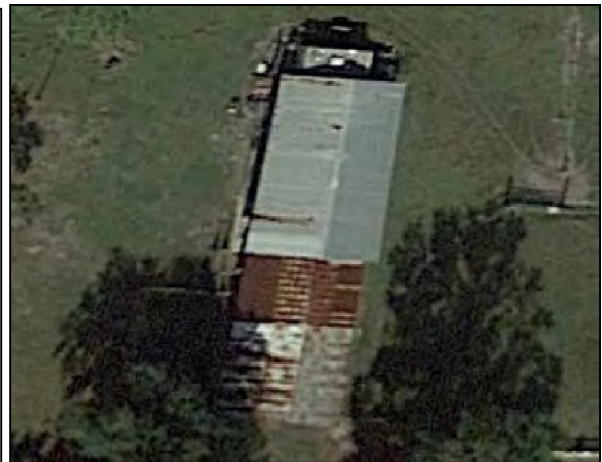
**Photo 5-40** (left): Morgan Family House 2, south front elevation of barn, 2019 (source: <https://www.google.com/maps>); **Photo 5-41** (right): Morgan Family House 2, aerial view of barn with south elevation at bottom, 2018 (source: <https://www.google.com/maps>).

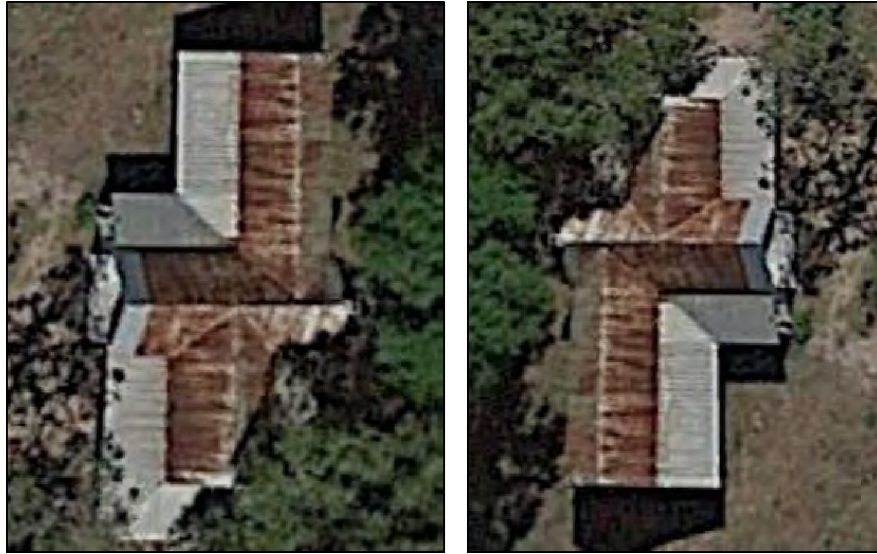
**Photo 5-42** (left): English Family House, 2018 aerial with south at bottom of image (source: <https://www.google.com/maps>); **Photo 5-43** (right): English Family House, 2018 aerial with north at bottom of right image; T-shaped roofs of main block and linearly extended ell are topped by rusted roofs; porches and west gable end of main block are apparent from shiny appearance of reclud roofs (source: <https://www.google.com/maps>).

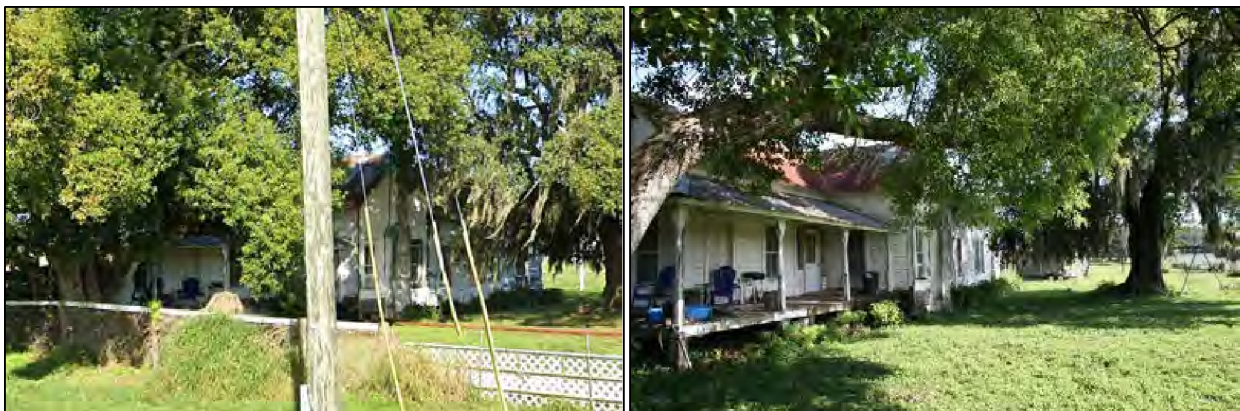
**Photo 5-46** (left): English Family House, east side elevation in 2019 (source: <https://www.google.com/maps>); **Photo 5-47** (right): English Family House, east side elevation in 2020.

The English Family House 2 is recommended as eligible for NR listing under Criterion C for its architecture. It remains a good intact representative of an early-twentieth-century Polk County farmhouse. It retains its original T-shaped form, German siding, crossetted surrounds, two-over-two sash windows, corner boards, and front porch with turned posts and decorative brackets. Its only notable alteration appear to be the enclosure of the rear porch. The house appears to stand on its original site and is therefore believed to retain its integrity of location, design, materials, workmanship and, by extension, feeling and association. The removal of outbuildings and construction of modern ones, along with the removal of its citrus grove and the one that abutted its parcel to the east, have negatively affected its setting. The proposed NR boundaries for the house are not recommended to encompass all of its approximately 20-acre historic parcel (Polk County parcel 232906000000024010), which is now a horse farm with modern outbuildings. Rather, they are recommended as the approximately ½-acre portion at the parcel's southeastern corner that includes the house and its associated trees and intact setting (**Photo 5-61**). The proposed boundaries extend south to a fence near the right-of-way of Medulla Road and east and west to fence lines. On the north they terminate 25 feet north of the ell, before the modern metal and frame pole barns are reached. Lacking any known association with historic events or persons, and unlikely to yield important historical information not available from other sources, the house is not recommended as NR eligible under Criteria A, B, or D.

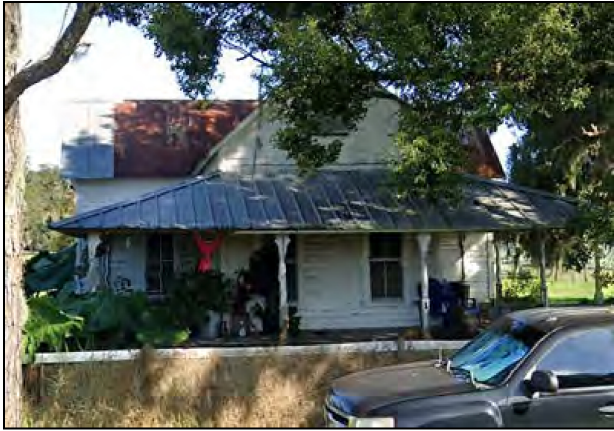
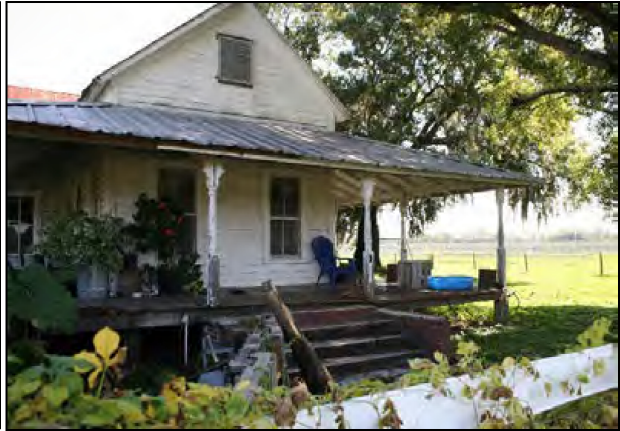
**Photo 5-48** (left): English Family House, south front and west side elevation in 2019 (source: <https://www.google.com/maps>); **Photo 5-49** (right): English Family House, south front and west side elevation in 2020.

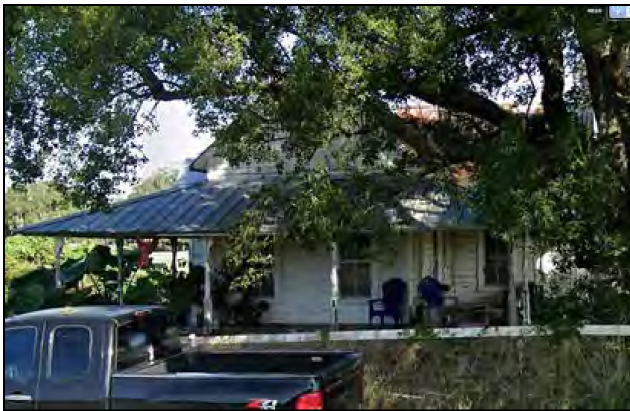
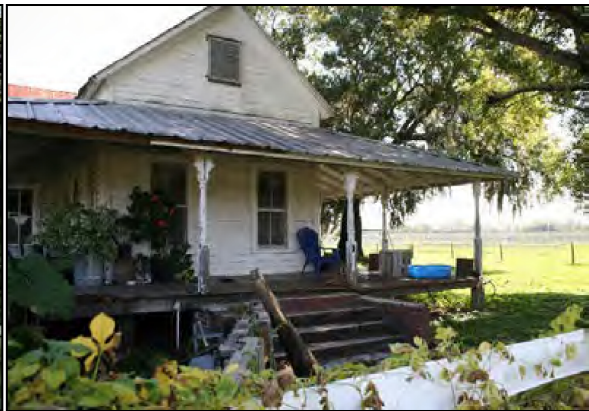
**Photo 5-50** (left): English Family House, south front elevation in 2019 (source: <https://www.google.com/maps>); **Photo 5-51** (right): English Family House, south front elevation in 2020.

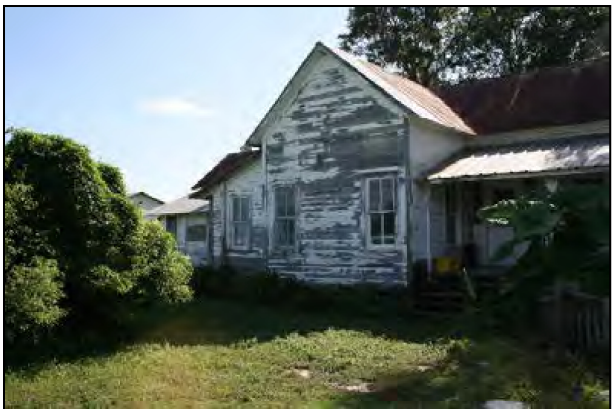
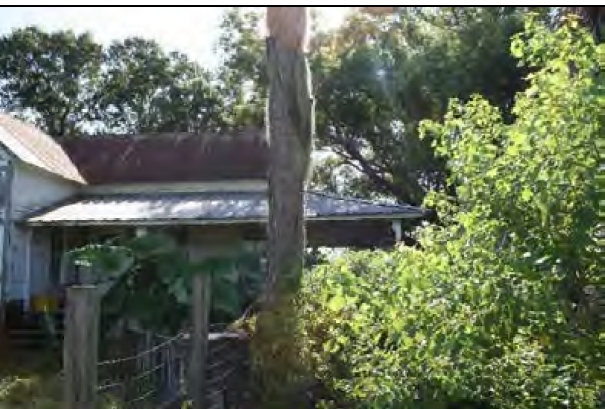
**Photo 5-52** (left): English Family House, west side elevation in 2020; **Photo 5-53** (right): English Family House, west side elevation in 2020.

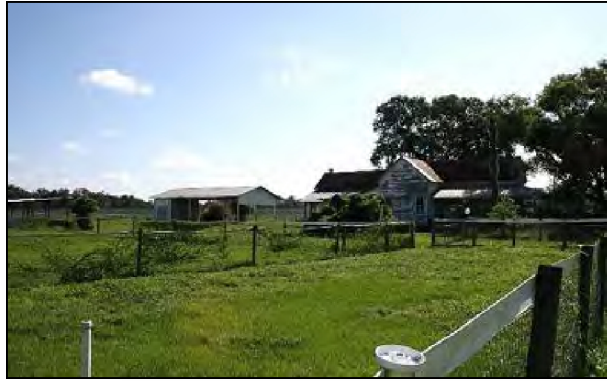
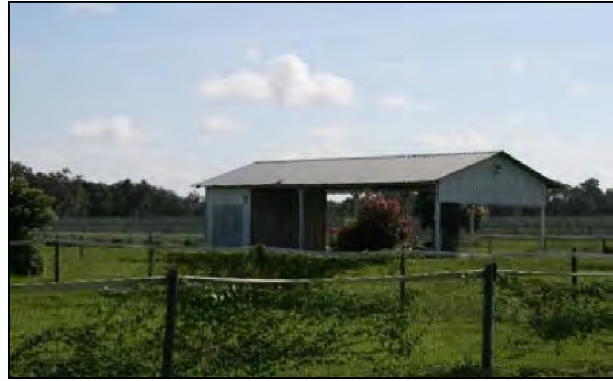
**Photo 5-54** (left): English Family House, looking northeast at west side of house at right, metal pole barn at center, and wooden pole barn at far left, 2020; **Photo 5-55** (right): English Family House, metal pole barn in 2020.

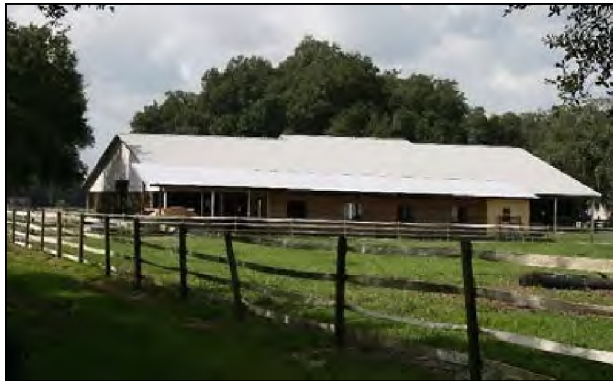
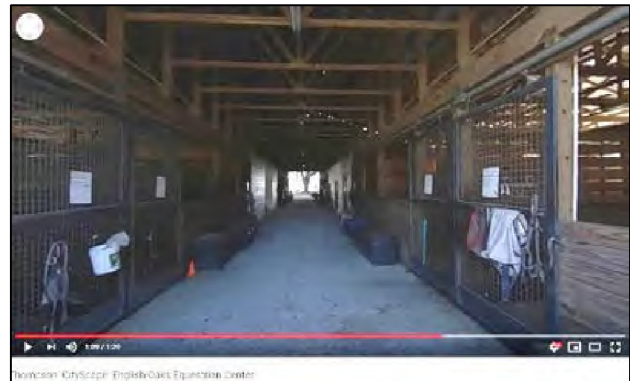
**Photo 5-56** (left): English Family House, west side and south rear elevation of modern stable in 2020; **Photo 5-57** (right): English Family House, interior of stable in 2019 (source: <https://www.youtube.com/watch?v=CyRZU8S4zkU>).

After the English family sold the parcel to the Morrells, they quickly converted the property into its current use as the English Oaks Equestrian Center (**Photos 5-56 through 5-60**). (Its patrons include the Florida Southern University equestrian team, which Shannon Morrell coaches (*Lakeland Ledger* 2017b).) In 2007 they removed the citrus grove that extended to the north and west of the house and filled the southeastern third of the parcel. They also removed early outbuildings near the house, built a frame and a metal pole barn to the house's north, and added a large stable near the northern end of the property in 2013 accessed by a long new road. In 2017 the owners of the parcel abutting the east side of the English Family House parcel replaced a citrus grove with a solar farm, further altering the house's historic setting.

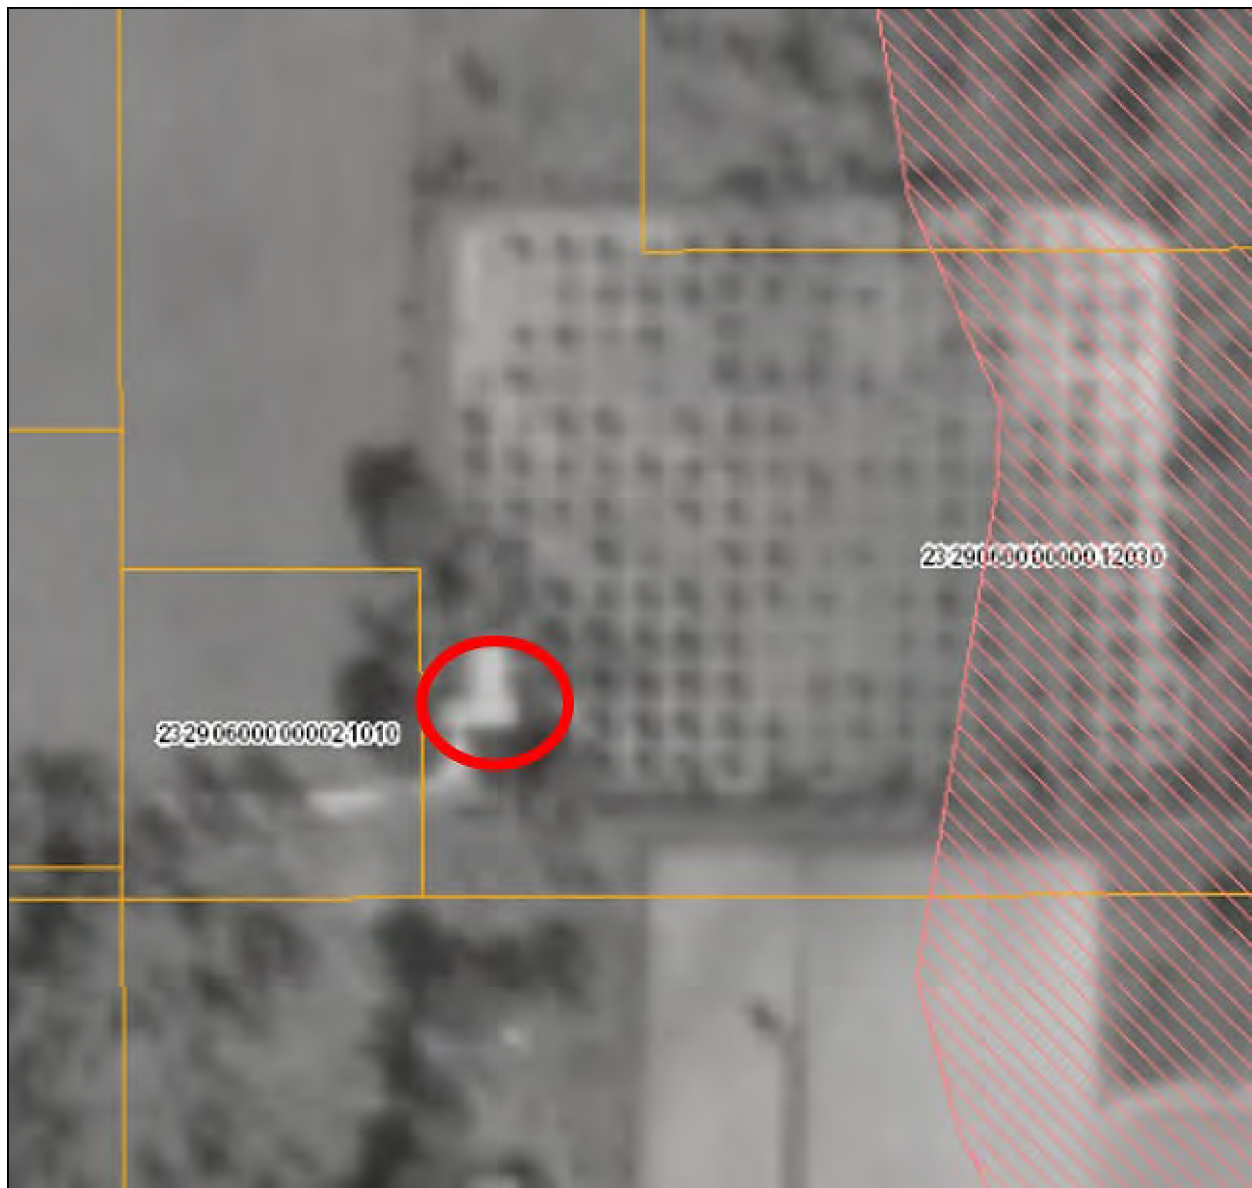
**Figure 5-6 House at 4404 Hamilton Road, 1964 Aerial**

House at 4404 Hamilton Road with parcel boundaries mislocated to the left (west) (source: <http://gisapps.polk-county.net/gisviewer>).

Hamilton Road. In a 1968 aerial, the house, one outbuilding to its (north) rear, and the grove are clearly visible (**Figures 5-5** through **5-8**). The former grove is now wooded and the house's diminished one-acre tract is abutted on its west and south by large expanses of solar panels. The property is gated off and the house could barely be viewed through the heavy growth of trees that largely surround it. It appeared to have its windows boarded up, but no further inspection could be made.

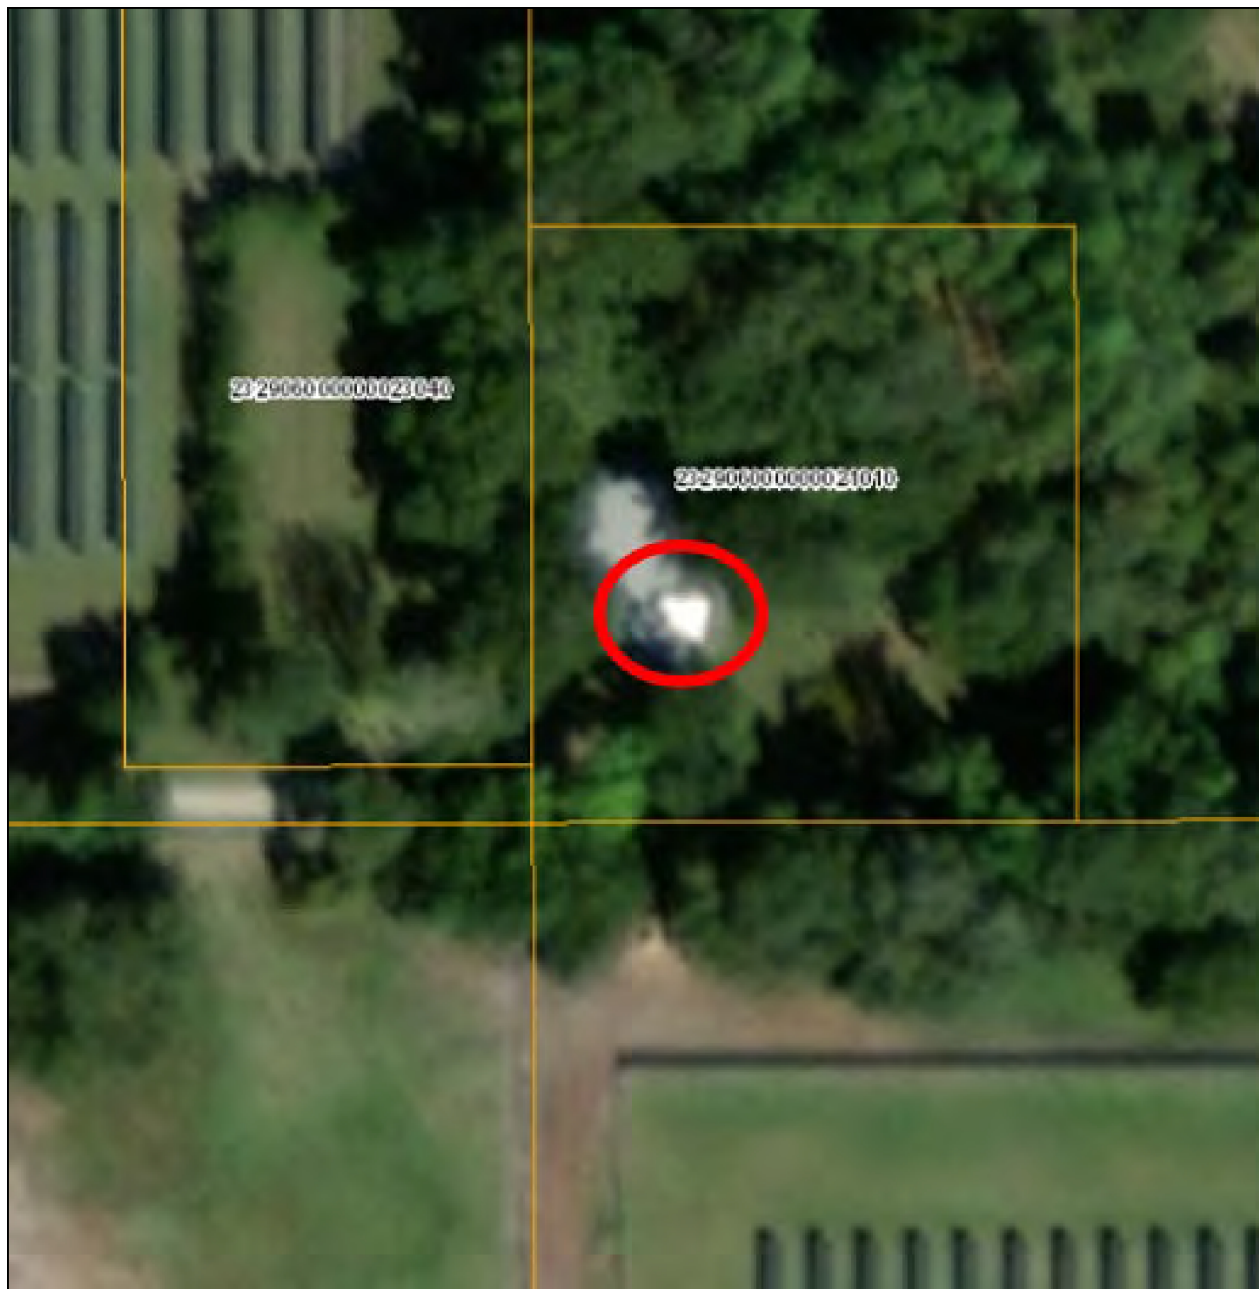
**Figure 5-8 House at 4404 Hamilton Road, 2010 Aerial**

Former grove largely filled with trees and edged by solar farms (source of both. <http://gisapps.polk-county.net/gisviewer>).

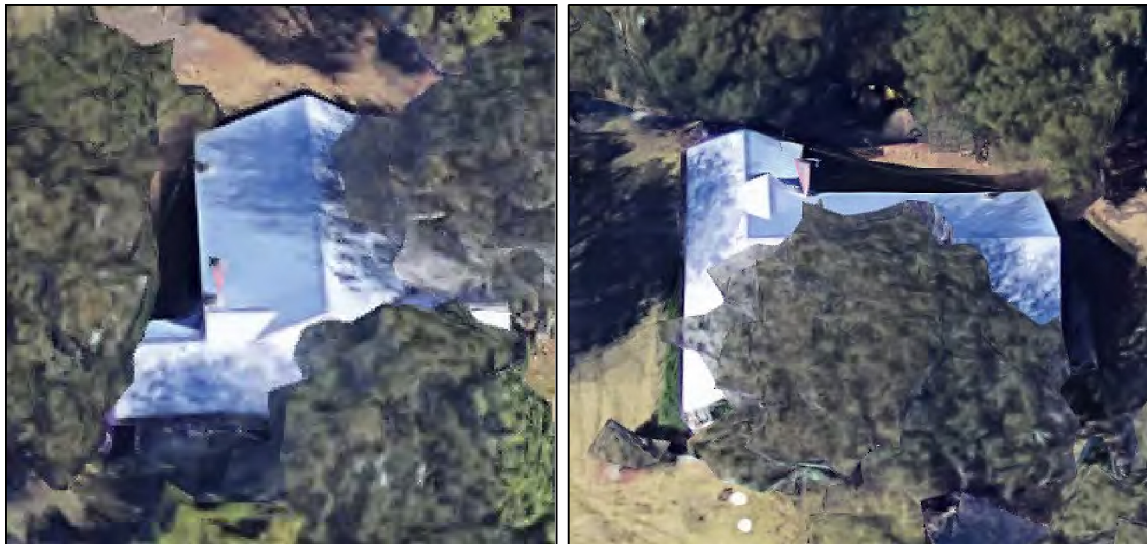
**Photo 5-62** (left): House at 4404 Hamilton Road, 2018 bird's-eye aerial view with south front of house at bottom (source: <https://www.google.com/maps>); **Photo 5-63** (right): House at 4404 Hamilton Road, 2018 bird's-eye aerial view with south front of house at left (source: <https://www.google.com/maps>).

Tax records and aerial photographs indicate that the house has a one-story main block with a south-facing, metal, gable-front roof (**Photos 5-62** through **5-65**). It is built of frame with frame cladding. An unfinished open porch crosses most its front elevation. To its east is an additional section of unfinished porch that wraps partly around the east side elevation. A small gable peak in the roof above the side of this porch suggests that the porch shields a side entrance. To the west of the front porch another extended porch partly wraps the west elevation. It is enclosed but unfinished. The body of the house behind the porches is one-story tall. Rectangular, it encompasses just under 1,150 square feet. The outbuilding depicted on the aerials behind the house is now gone or hidden by overgrowth. From the edge of the parcel, the house and its grounds appear to be long abandoned and unmaintained. Bird-eye aerials from 2018 depict heavy overgrowth at the house's south front and east side elevation, further suggesting heavy deterioration.
