# Final Environmental Assessment for Phase II Air Cargo Facility Development

Lakeland Linder International Airport  
Polk County, Florida

# **Phase II Air Cargo Facility Development at Lakeland Linder International Airport (LAL)**

## **Phase IB Cultural Resources Assessment Survey**

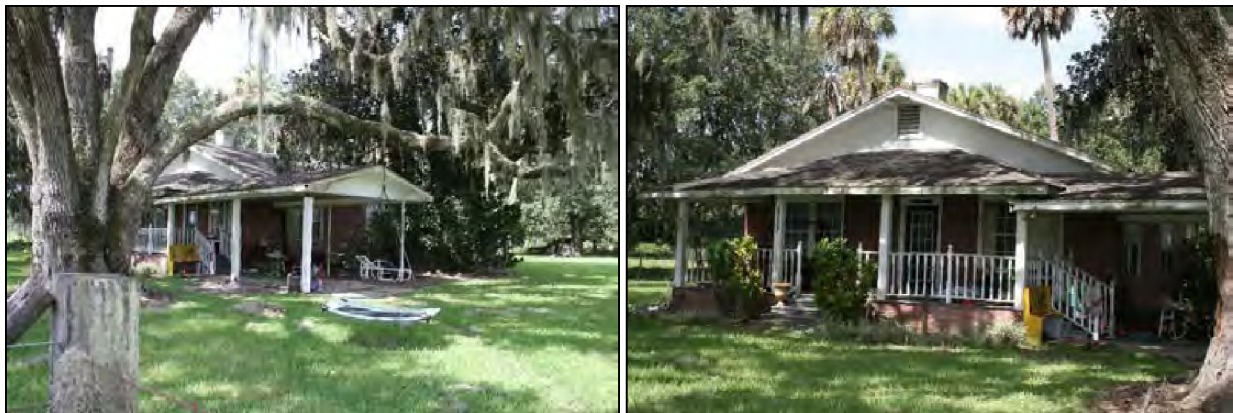
**Photo 5-67** (left): House at 4333 Hamilton Road, south side in 2020; **Photo 5-68** (right): House at 4333 Hamilton Road, east front elevations in 2020.

The house is built of frame with an overlay of brick veneer (**Photos 5-66 through 5-68**). It is one-story tall and has a gable-front roof pierced by a central brick chimney stack. Three bays cross its front (east) elevation, a central door flanked by paired windows with clip-in muntins. Windows with clip-in muntins mark the side elevations as well. A full-facade porch crosses its front elevation. A carport extends to the porch's north. An artificial-sided gable-front shed stands to the carport's north. The house's veneer, porch, and windows suggest a construction date within the past 30 or 40 years. If it was built in 1920, it is so heavily altered that this is not discernable.

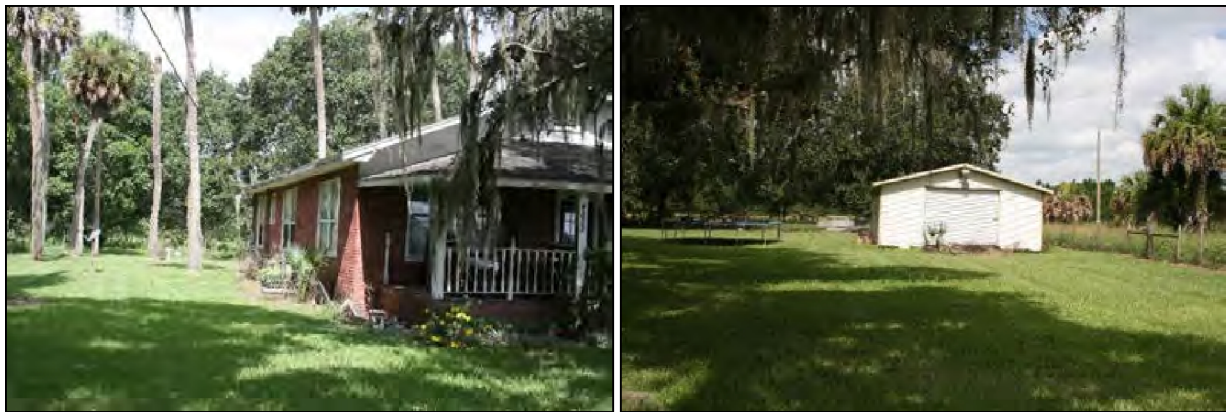
**Photo 5-69** (left). House at 4333 Hamilton Road, north side and east front elevations in 2020; **Photo 5-70** (right). House at 4333 Hamilton Road, modern shed in 2020.

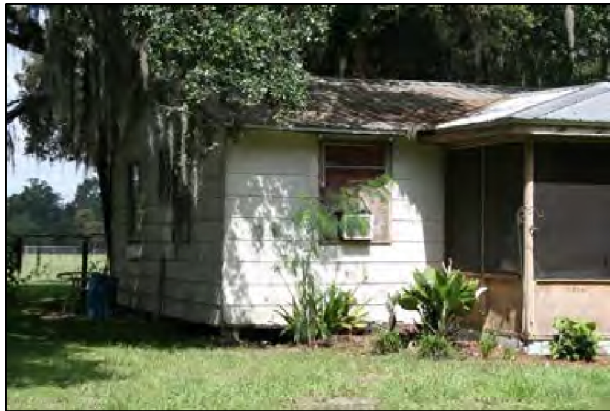
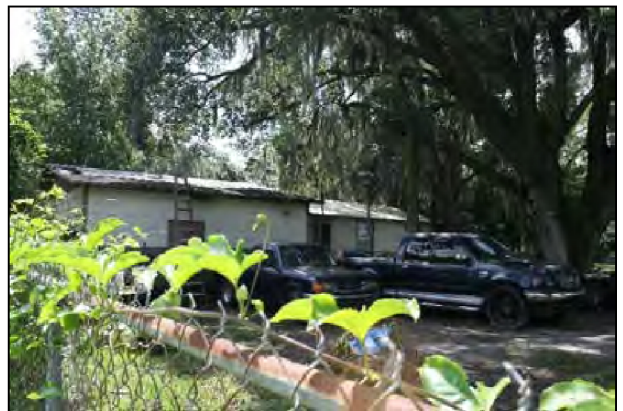
**Photo 5-73** (left): Futch-Dawson House, south side and east front elevations; **Photo 5-74** (right): Futch-Dawson House, north side and west rear elevations.

The house has two blocks that are nearly equal in size (**Photos 5-71** through **5-75**). The gable-end block on the south is the principal one. Its east-facing front elevation is four bays wide. A door and a window are shaded by a hip-roofed screened front porch; a window is also placed to either side of the porch. These as the house's other windows are double-hung with two-horizontal-light-over-two-horizontal-light sash. The later-added north block holds a two-bay garage. Like the main block, it is topped by a gable-end roof and sided with asbestos shingles. It is flush with the main block at the front but extends a few feet farther back at the house's west-facing rear elevation. The window sash, their placement immediately under the eaves, the proportions of the main block, the asbestos shingles – all suggest a construction date within the past 50 years.

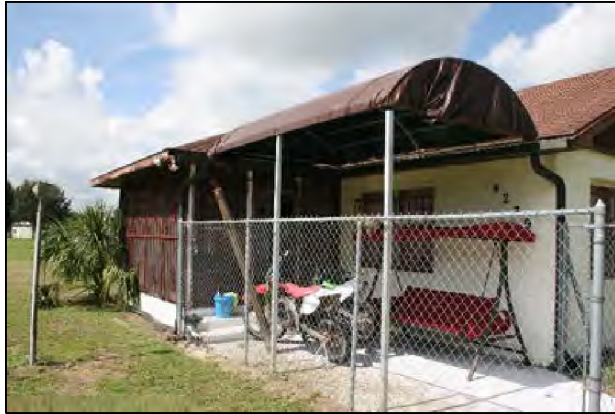
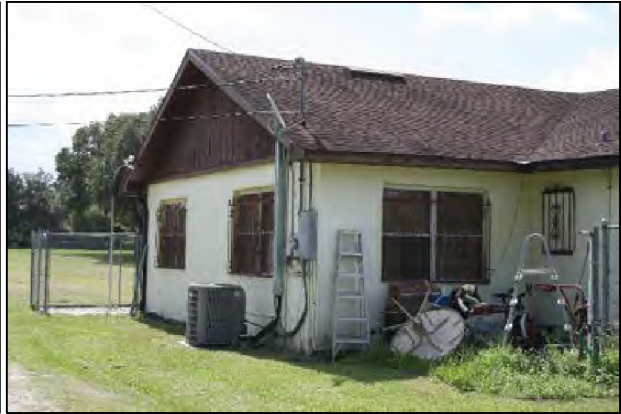
**Photo 5-78** (left): Futch-Dawson House, east front and north side elevations; **Photo 5-79** (right): Futch-Dawson House, north side and west rear elevations.

The house occupies a zig-zag-shaped parcel on the west side of Hamilton Road and is located down a lane about 300 yards from the road (**Photos 5-76 through 5-81**). Its distance from the road and the shape of its parcel indicate that its 5.54-acre parcel was cut out of a larger agricultural tract. The house is almost square with a notch out of the back of the northwestern corner of its rear (west) elevation. One-story tall, it encompasses approximately 1,600 square feet. The house is of stuccoed masonry construction. Its gable-end roof is asphalt-shingled. At its front (east) elevation it has a tripled one-over-one window grouping at the left, an entry shaded by a screened hip-roofed porch at the center, and paired one-over-windows at the right. The house's other windows are also one-over-one. A gabled roof extends to the house's rear. It is abutted by a fenced patio shaded by a modern metal-pole-supported roof. A modern outbuilding stands to the house's south. The window sash, the house's proportions and relatively large footprint, and its masonry construction suggest a construction date within the past 50 years.

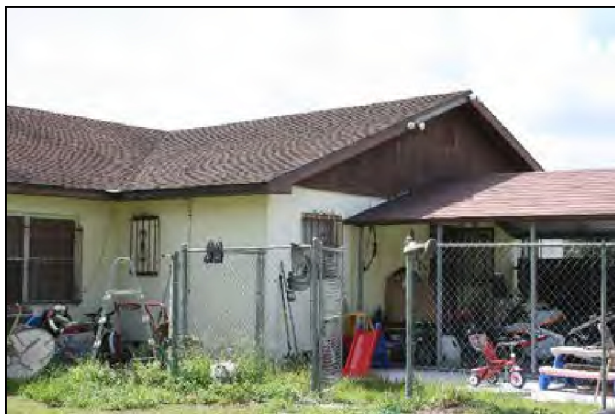
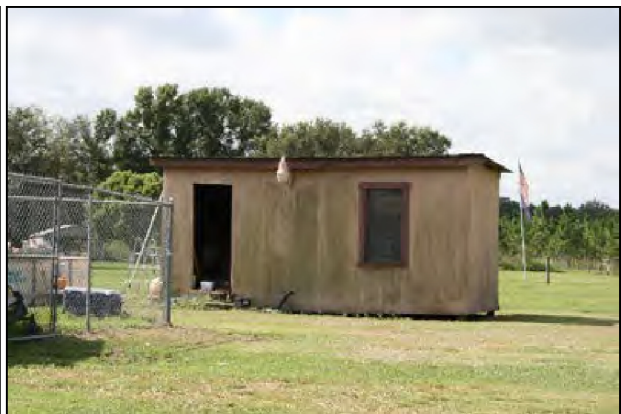
**Photo 5-80** (left): Futch-Dawson House, west rear elevation; **Photo 5-81** (right): Futch-Dawson House, modern shed to house's south.

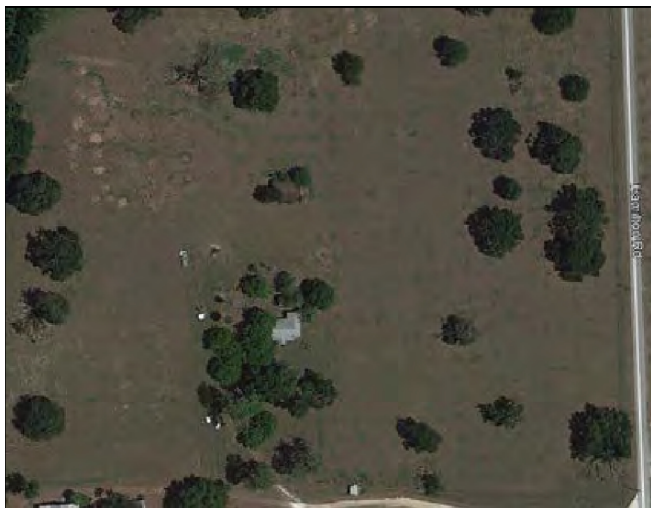
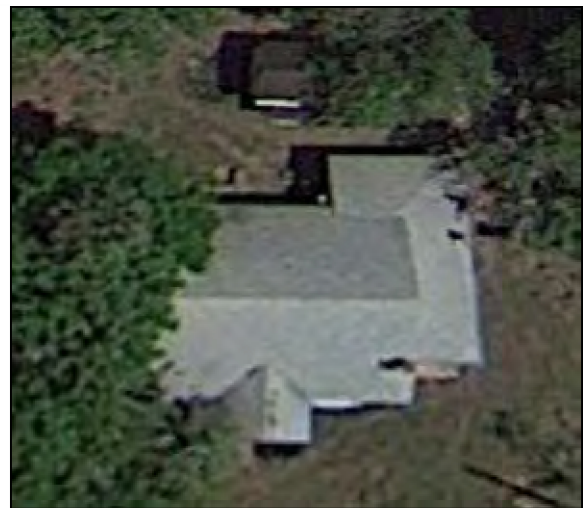
**Photo 5-82** (left): Opal and Oliver Phillips House, 2012 aerial with north at top showing ghost marks of a former grove (source: <https://www.google.com/maps>); **Photo 5-83** (right): Opal and Oliver Phillips House, 2012 aerial zoomed in

showing south front elevation of house with porch at bottom and garage at top (north) (source: <https://www.google.com/maps>).

The house's main block is one-story tall and two rooms deep (**Photos 5-82 through 5-89**). It is built of frame and topped by an asphalt-shingled gable-roof. A one-bay gable-front porch supported by square posts extends over its central front (south-facing) entry. The windows to either side of the facade are shaded by later-added metal hoods. An exterior-end brick chimney rises from the block's east gable. A hipped-roof wing wraps around much of the east side elevation of the house and part of the north rear elevation. The house has been vacant for a number of years and its windows are boarded over. It appears to be maintained, though, and its artificial siding is in good condition. When the house was artificially sided in recent years its original exposed rafter tails were boxed in. A frame two-car garage standing to the house's north rear appears to have been its contemporary, likely dating from the 1930s. A largely collapsed frame barn is overgrown by trees farther to the north. Its construction date is not known.

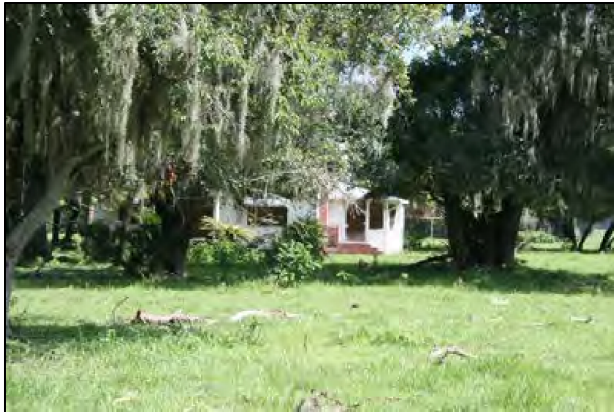
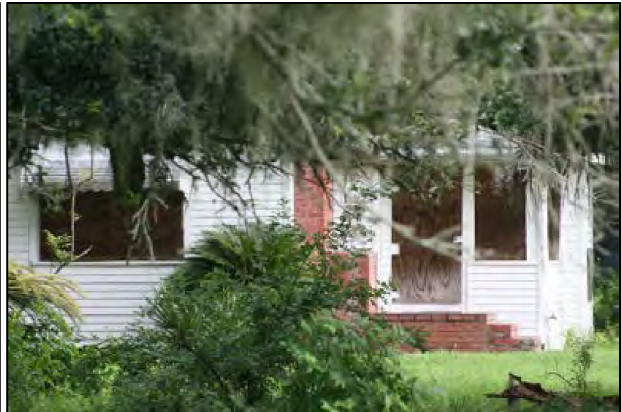
**Photo 5-84** (left): Opal and Oliver Phillips House, south front elevation with porch at bottom and garage at top (north), 2020; **Photo 5-85** (right): Opal and Oliver Phillips House, detail of south elevation, 2020.

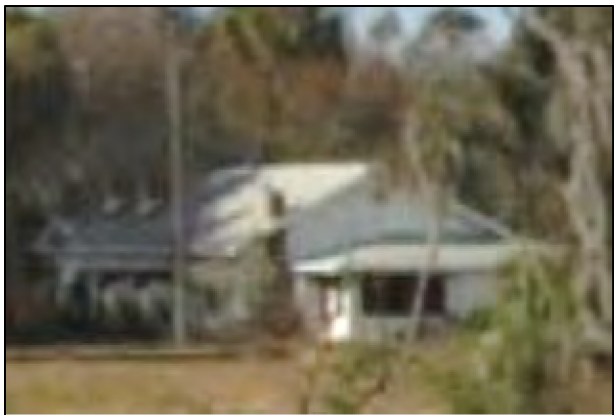
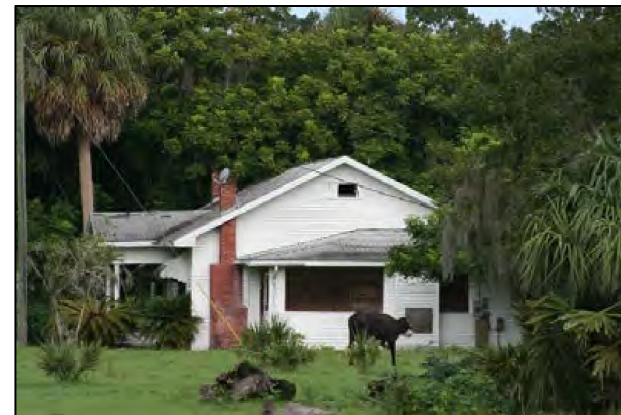
**Photo 5-86** (left): Opal and Oliver Phillips House, south front and east elevations with porch at left in 2014 (source: <https://www.bing.com/maps/>); **Photo 5-87** (right): Opal and Oliver Phillips House, south front and east elevations with porch at left in 2020.

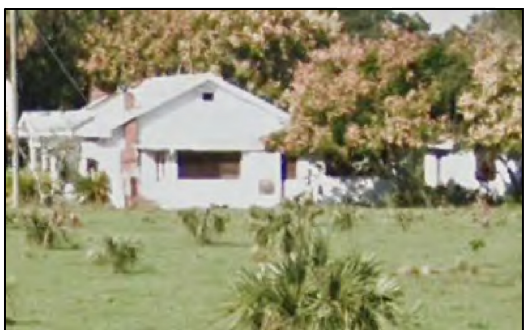
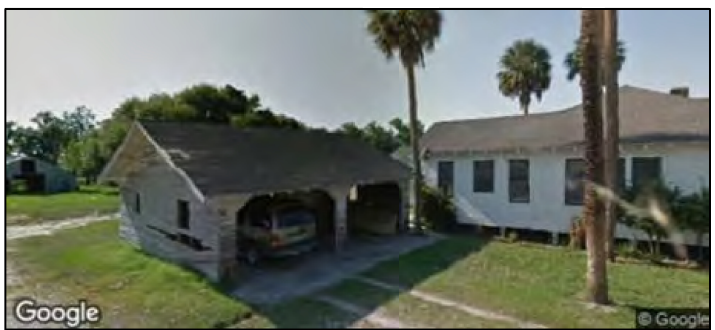
**Photo 5-88** (left): Opal and Oliver Phillips House, south front and east side elevations with garage at far right, 2019 (source: <https://www.google.com/maps>); **Photo 5-89** (right): Opal and Oliver Phillips House, north rear of house with garage at left center and now collapsed barn at far left, no date (source: Connected Investors website).

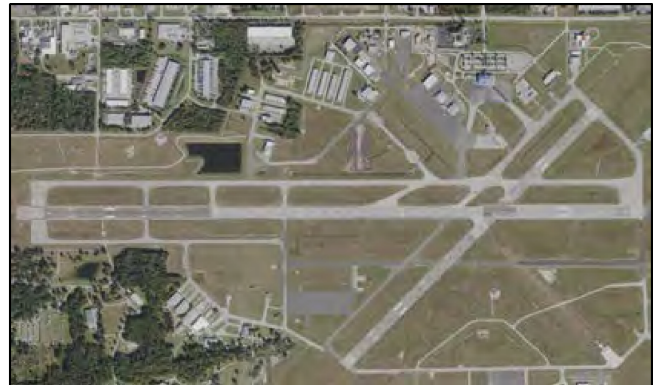
**Photo 5-90** (left): Lakeland Army Air Field with Drane Field Road at north top, 1953 (source: <https://web.archive.org/web/20120608222530/http://www.airfieldsdatabase.com/WW2/WW2%20R27b%20CO-HA.htm>; **Photo 5-91** (right): modern Google Maps aerial.

Only the ghost of the original runway pattern of the former Lakeland Army Air Base is visible at the current Lakeland Linder International Airport (Map #11a) (**Photos 5-90 and 5-91**). Since the late 1980s, it has been transformed by the construction of extensions and new runways and the sodding over of old runways and pads (*Tampa Tribune* 1967b, 1968, 1997, 2000, and 2002). The runway and the airport grounds, therefore, are believed to have lost their integrity of design, setting, materials, workmanship and, thereby, feeling, and association. The airfield is accordingly not recommended as eligible for NR listing due to a loss of integrity. (The airfield does remain at its original location.)

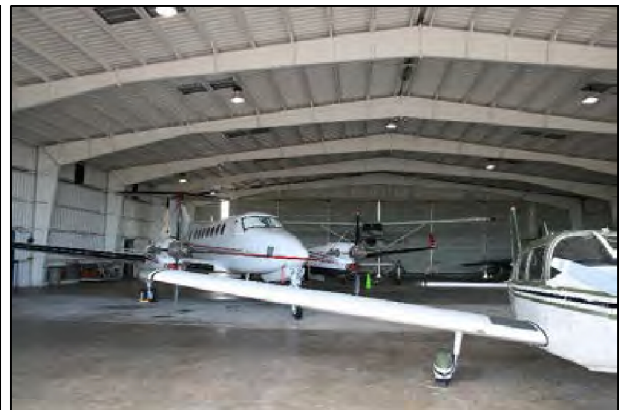
**Photo 5-94** (left): Sheltair Aviation maintenance hangar (Map ID #11b), interior views. **Photo 5-95** (right): Sheltair Aviation maintenance hangar (Map ID #11b), interior views.

As noted at the historic context of this report, none of the Airport's scores of WWII-era buildings survived. Tax records and historic aerals, however, indicate that four of the its standing resources were erected between about 1959 and 1971. Three of these are hangars standing on the southwest side of Airfield Drive West about 400 feet southeast of the modern airport terminal. Matching steel hangars erected c.1960 (*Tampa Tribune* 1959a) now house the aircraft maintenance facilities of Sheltair Aviation (Map ID #11b) (**Photos 5-92 through 5-95**) and Aeromech Aviation (Map ID #11c) (**Photos 5-96 through 5-99**). These were joined by a nearly identical hangar (**Photos 5-100 through 5-103**) to their northwest – now home to the maintenance facilities of Double M Aviation (Map ID #11d) – between the taking of aerial photographs of the Airport in 1964 and 1968. (The 1964 aerial appears to show ground preparation for the hangar.) A second building was added to this hangar by 1971. (A series of historic aerals of the Airport and Polk County are available at the Polk County GIS Map Viewer site.) The three earliest hangars are essentially square, about 120 feet on each side. They are conventional hangar types with steel primary load-bearing trusses and framing and steel walls and roofs. Their doors are the standard horizontal telescoping type that slide, overlap, and open up access to the entire hangar space when fully pushed to either side. The hangar attached to the northeast side of the Double M Aviation hangar is of similar design and construction, but it only about half as wide. The two hangars are largely open to each other inside, forming a single work space.

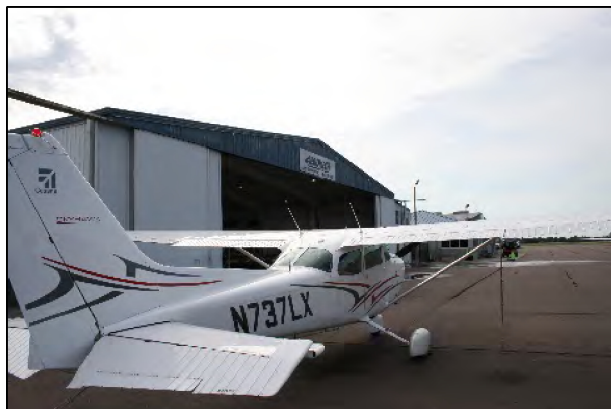
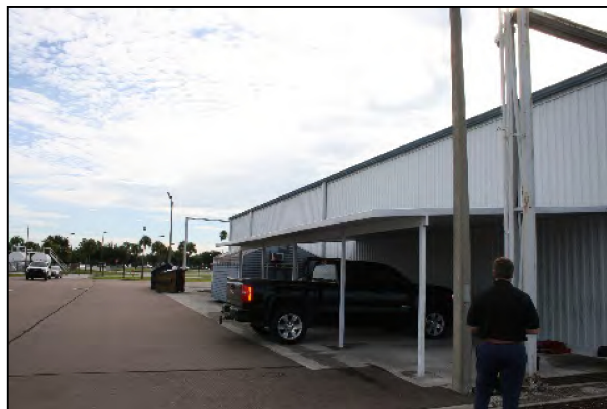
**Photo 5-96** (left): Aeromech Aviation maintenance hangar (Map ID #11c), southwest airside elevation; **Photo 5-97** (right): Aeromech Aviation maintenance hangar (Map ID #11c), northwest side elevation.

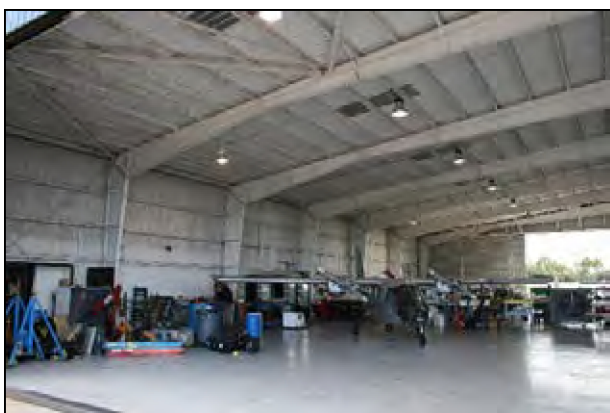
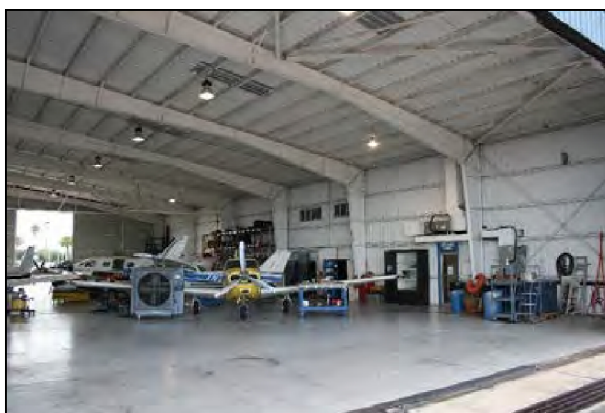
**Photo 5-98** (left): Aeromech Aviation maintenance hangar (Map ID #11c) interior view; **Photo 5-99** (right): Aeromech Aviation maintenance hangar (Map ID #11c) interior view.

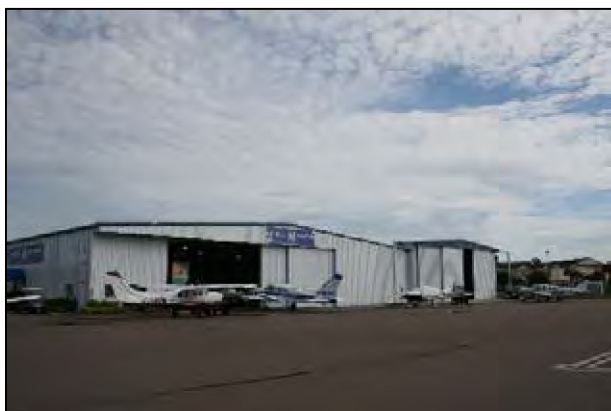
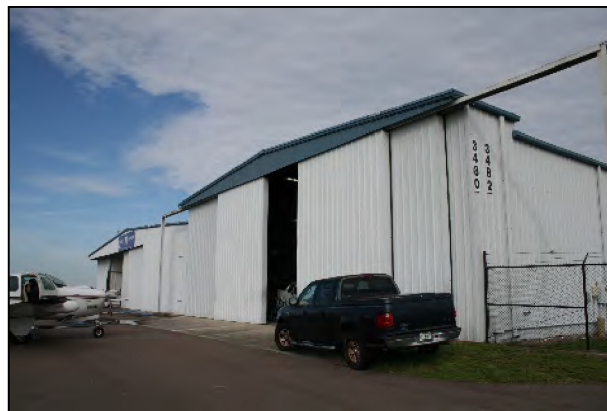
**Photo 5-100** (left): Double M Aviation maintenance hangars (Map ID #11d), southwest side and southeast airside elevations with first-built hangar at left; **Photo 5-101** (right): Double M Aviation maintenance hangars (Map ID #11d), southeast airside and northeast side elevations with second-built hangar at right.

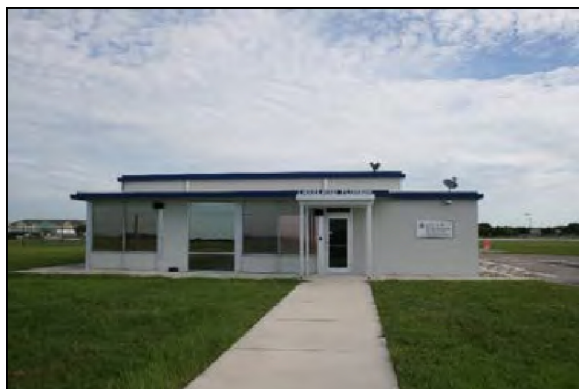
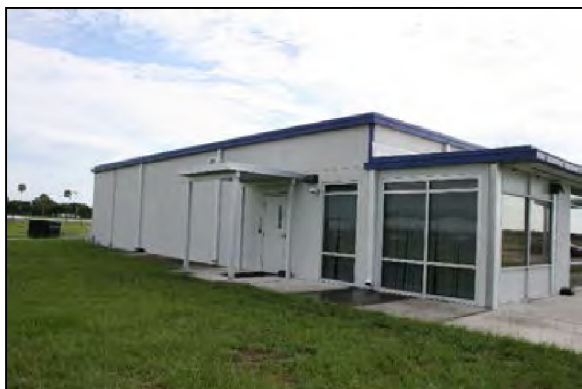
The remaining quarter of the former terminal now houses the airport's U.S. Customs and Border Protection (CPB) facility (**Photos 5-108 through 5-110**). The one-story building retains some of the walls of the terminal and perhaps one of the original three-part windows. A shorter one-story addition has been wrapped around its south and east elevations. This addition includes three-part windows similar to the original ones.

**Photo 5-108** (left): Current U.S. Customs and Border Protection building (Map ID #11e), south front elevation ; **Photo 5-109** (right): Current US Customs and Border Protection building (Map ID #11e), west side and south front elevations.

Due its dramatic alterations—not least the removal of one-quarter of its original structure—the former Lakeland Municipal Airport terminal, now home to the airport's CPB facility, is believed to have lost its integrity of design, materials, workmanship and, accordingly, feeling and association. It remains in an airport setting on its original location, but it appears to have clearly lost its overall integrity. Additionally, the building is not known to have any association with significant historic events or persons and does not appear to embody the distinctive characteristics of a type, period, or method of construction. It is accordingly recommended as not NR-eligible under Criteria A, B, or C. The former terminal is further recommended as not NR-eligible under Criterion D, for it is unlikely to yield important historical information not available from other sources.

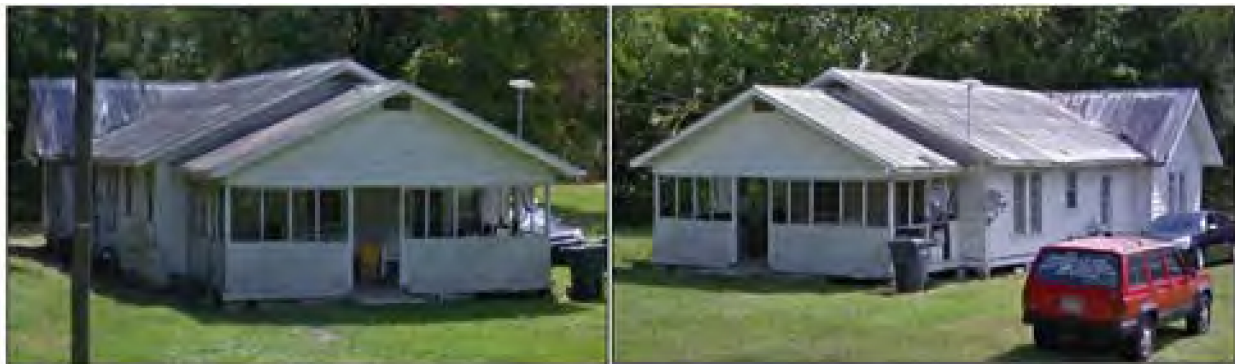
In 2011, according to Google Maps photos taken that year, the house had a frame, one-story, gable-front, central block (**Photos 5-7 through 5-12**). This was crossed at the front (west) by a partially enclosed gable-roofed porch and at the rear (east) by a perpendicular, gable-end, frame block. The house had double-hung sash windows, a seam-metal roof, and aluminum siding. Since 2011, the porch has been removed and replaced by an open porch; bays have been covered or shifted and windows and doors have been replaced; new artificial siding has been added; and a gable-front rather than gable-end roof has been placed atop the rear ell. The house continues to stand on concrete blocks. The house's many significant alterations suggest that after the 2011 photographs were taken, it was essentially stripped down to its studs and rebuilt, resulting in its current appearance. Bing Maps photographs from 2014 depict the house as it is at present, dating its alterations to between 2011 and 2014.

*Figure 1. Robberson House in 2011: left, north side and west front elevations; right, west front and south side elevations (source: <https://www.google.com/maps>).*

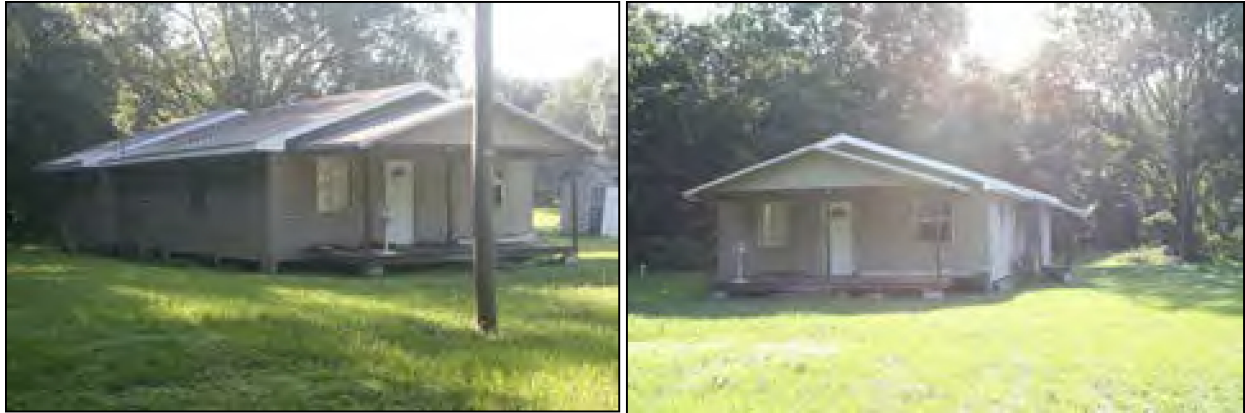
In 2011, according to Google Maps photos taken that year, the house had a frame, one-story, gable-front, central block (Figure 2 through Figure 4). This was crossed at the front (west) by a partially enclosed gable-roofed porch and at the rear (east) by a perpendicular, gable-end, frame block. The house had double-hung sash windows, a seam-metal roof, and aluminum siding. Since 2011 the porch has been removed and replaced by an open porch; bays have been covered or shifted and windows and doors have been replaced; new artificial siding has been added; and a gable-front rather than gable-end roof has been placed atop the rear ell. The house continues to stand on concrete blocks. The house's many significant alterations suggest that after the 2011 photographs were taken, it was essentially stripped down to its studs and rebuilt, resulting in its current appearance. Bing Maps photographs from 2014 depict the house as it is at present, dating its alterations to between 2011 and 2014.

*Figure 2. Robberson House in 2020: left, north side and west front elevations; right, west front and south side elevations.*

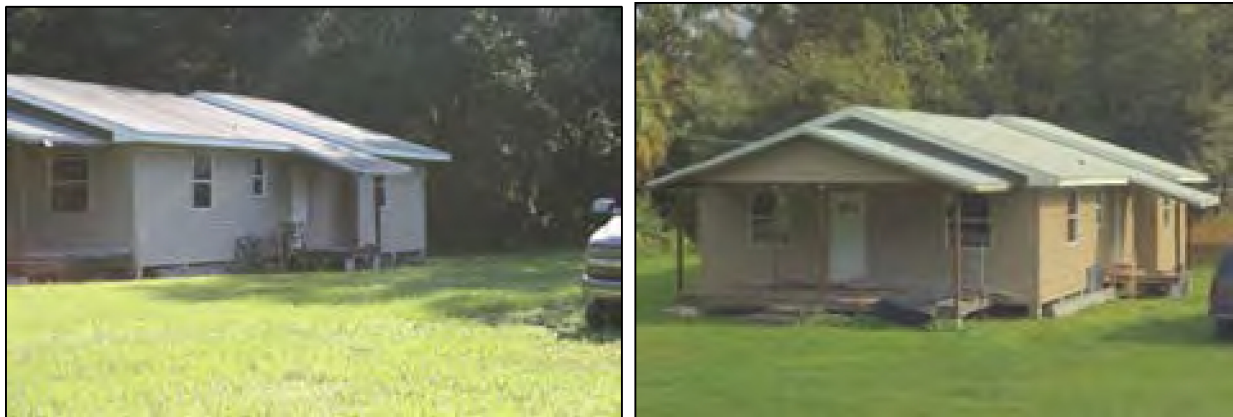
*Figure 3. Robberson House: left, west front and south side elevations in 2020; right, same elevations in 2014 (source: <https://www.bing.com/maps/>).*

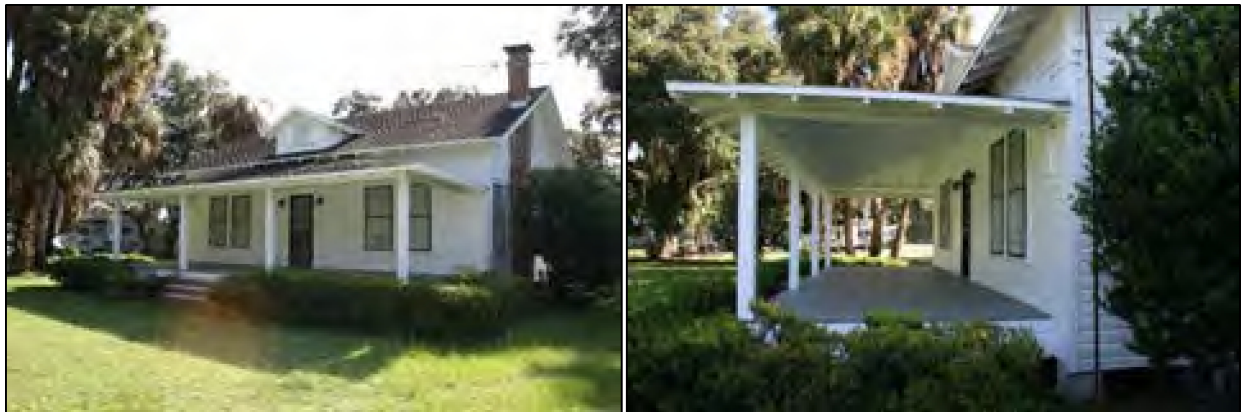
The Aaron E. and Maude Morgan House is recommended as eligible for NR listing under Criterion C for its architecture. It is a good intact representative of an early-twentieth-century Polk County farmhouse. It retains its original form, German siding, plain surrounds, front porch, and cornerboards, as well as its original Craftsman-style sash, doors, and overhanging eaves with exposed rafter tails. The only notable alterations appear to be the enclosure of a rear porch, which is clad in matching German siding, and the addition of a small room to the rear of the ell. Further, the house appears to stand on its original site. The Morgan House is therefore believed to retain its integrity of location, design, setting, materials, workmanship and, by extension, feeling and association.

*Figure 1. Aaron E. and Maude Morgan House: west front and south side elevations, 2020*

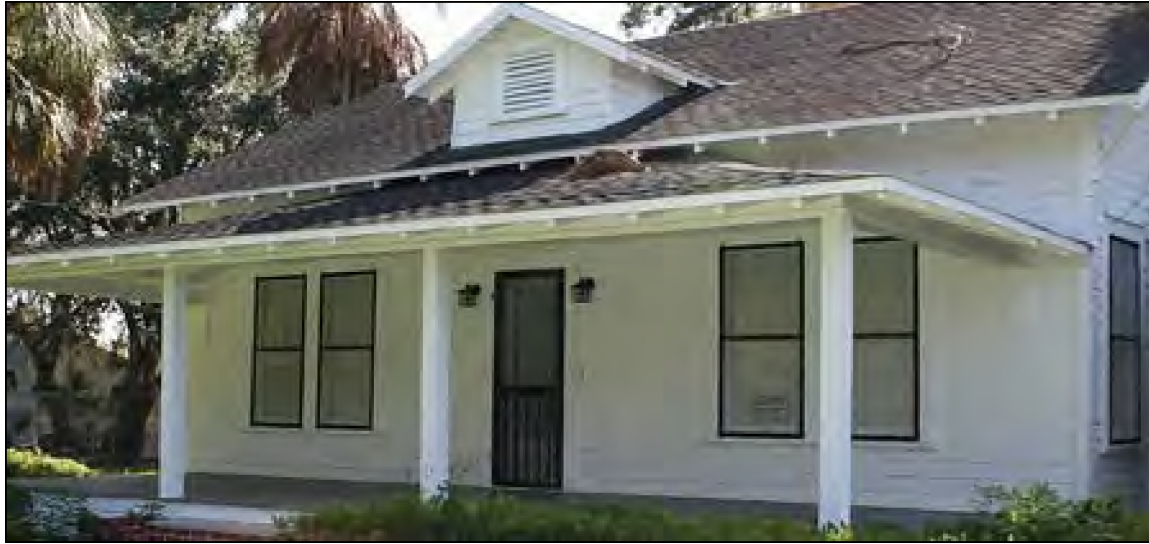
Figure 2. Aaron E. and Maude Morgan House: west front and south side elevations showing German siding and Craftsman-style windows, door, and exposed rafter tails, 2020.

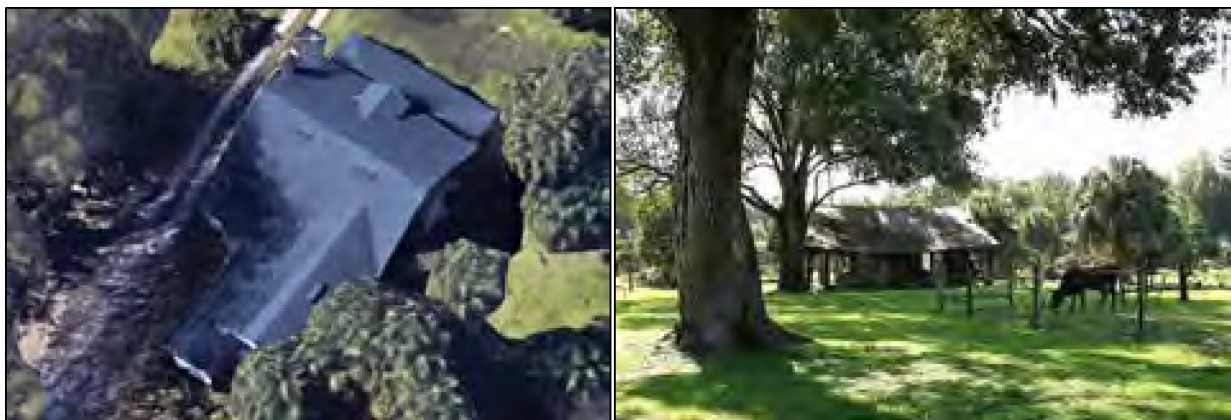
To the house’s rear (east), thick round poles support the gabled sheet-metal roof of an open pole barn that is less than 50 years old (Figure 4 through Figure 6). Shaded by the roof is an earlier building that appears to be largely built of slender, round, saddle-notched, unchinked logs. (Due to Covid concerns and no-trespassing signs, access to the property and its resources was limited.) Log buildings were erected in Polk and other northern and central Florida counties into the late nineteenth century (Florida Association of the American Institute of Architecture 2017: 4, 23, 108). The extant English Family Log Cabin, now located in Homeland Heritage Park, was moved to Homeland from elsewhere in Polk County. Constructed of round saddle-notched logs, it dates from about 1890 (Hacking, Forbes, and Jones 2006). Whether this building was erected in the late nineteenth century could not be determined.)

Figure 4. Aaron E. and Maude Morgan House: left, aerial depicting east rear and north side elevations, no date (source: <https://www.google.com/maps>); right, west front and south side elevations of barn to rear of house, 2020.

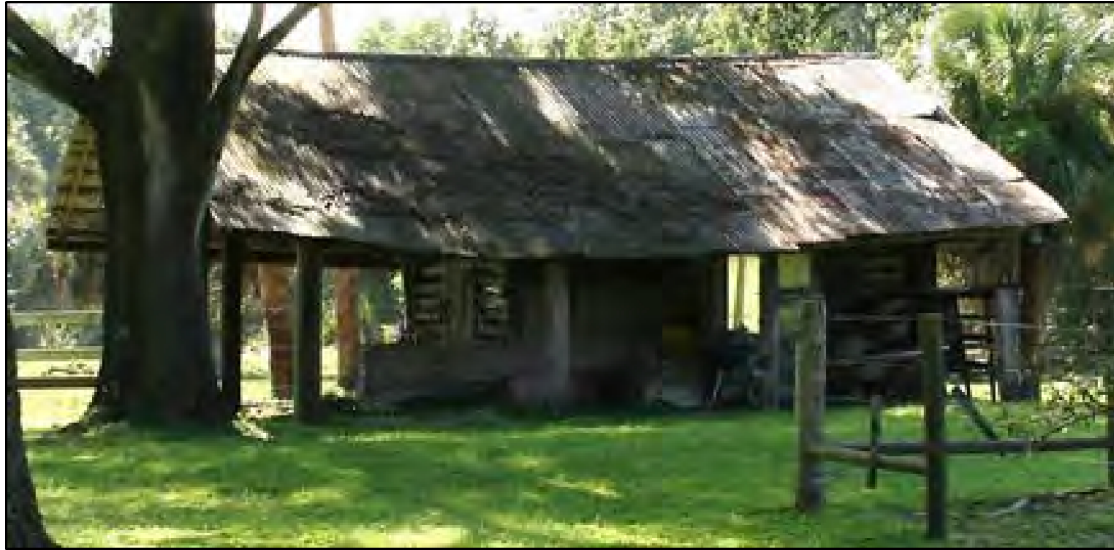
*Figure 5. Aaron E. and Maude Morgan House: west front and south side elevations of pole barn and log building within it, 2020.*

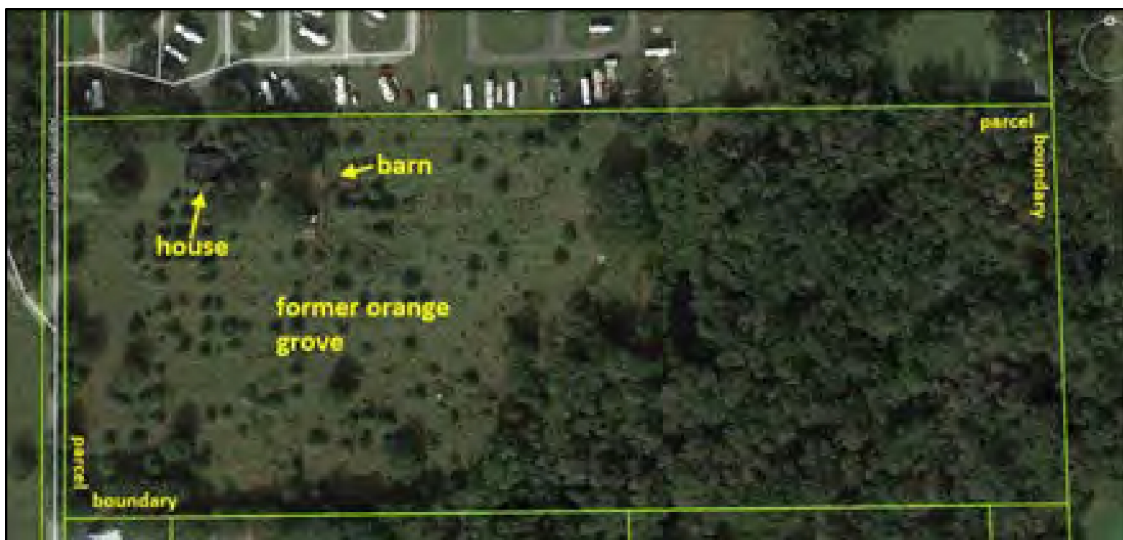
The Morgan House's NR boundaries are recommended as the boundaries of its approximately 16-acre parcel (Polk County parcel 232905000000042030) on its north, east, and south (Figure 7). On its west, where the parcel reaches toward Aaron Morgan Road, its boundary is recommended as ending on the east side of the county-maintained shallow ditch and road right-of-way. (It is not clear from tax maps whether the parcel already terminates there.) Contained within this boundary are the house and barn, both of which are contributing buildings, the former citrus grove, and woodland, all of which were historically associated with the property.

*Figure 7. Aaron E. and Maude Morgan House: recommended NR boundaries (Polk County parcel 23290500000042030).*

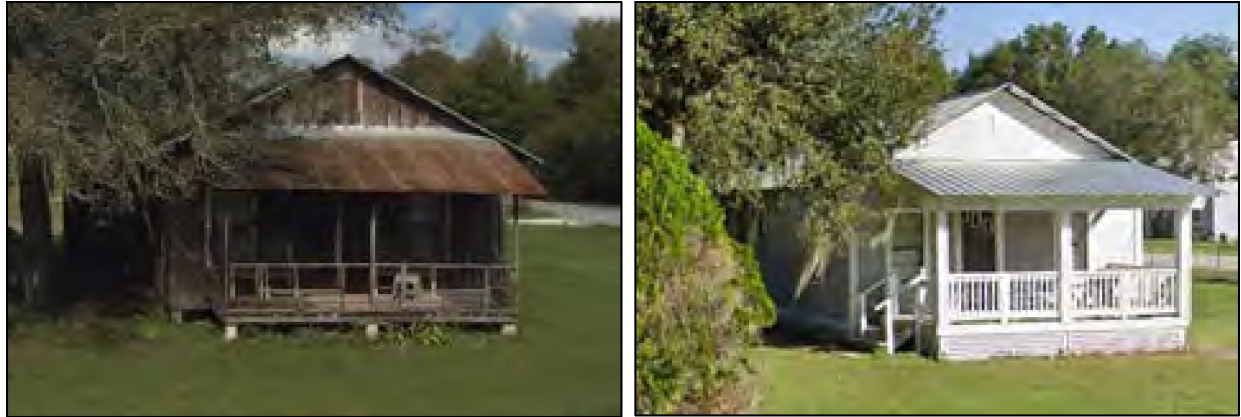
Photographs taken in 2011, before the house underwent a major renovation, depict a dwelling that may indeed have been built around 1920, the assigned tax date (Figure 1 through Figure 4). In 2011 the small, gable-front, frame house—about 16' across and 24' deep according to tax records—was sided in heavily weathered vertical boards without battens and topped by a metal roof. Its two-bay-wide south-facing front facade was shaded by a plainly finished porch covered by a metal shed porch. To its rear (north) extended an ell faced with T111-type siding that had a double-pitched shed roof. Tax records identify much of the ell as a formerly open porch. Between 2011 and 2019, the old front porch was replaced by one with square posts and a balustrade. The front door was also replaced. A new metal roof was set atop the house and it received new artificial siding. Its two-over-two, double-hung, sash windows were cleaned or replaced in kind; the plain window surrounds were cleaned and painted. The rear ell was also re-sided.

Figure 1. Morgan Family House 1: left, south front elevation, c2014 (source: <https://www.bing.com/maps/>); right, west side and south front elevations in 2019 (source: <https://www.google.com/maps>).

Due to its many post-2011 alterations, the house is believed to have lost its integrity of design, materials, workmanship and, accordingly, feeling and association. Its setting appears to be largely intact and it likely continues to stand on the location upon which it was built, but overall it has lost its integrity. Additionally, the house is not known to have any association with significant historic events or persons. It is therefore recommended as not eligible for NR listing under NR Criteria A or B. The house does not appear to embody the distinctive characteristics of a type, period, or method of construction and accordingly is recommended as not NR-eligible under Criterion C. Due to its loss of integrity and lack of significance, the house is recommended as not eligible for NR listing.

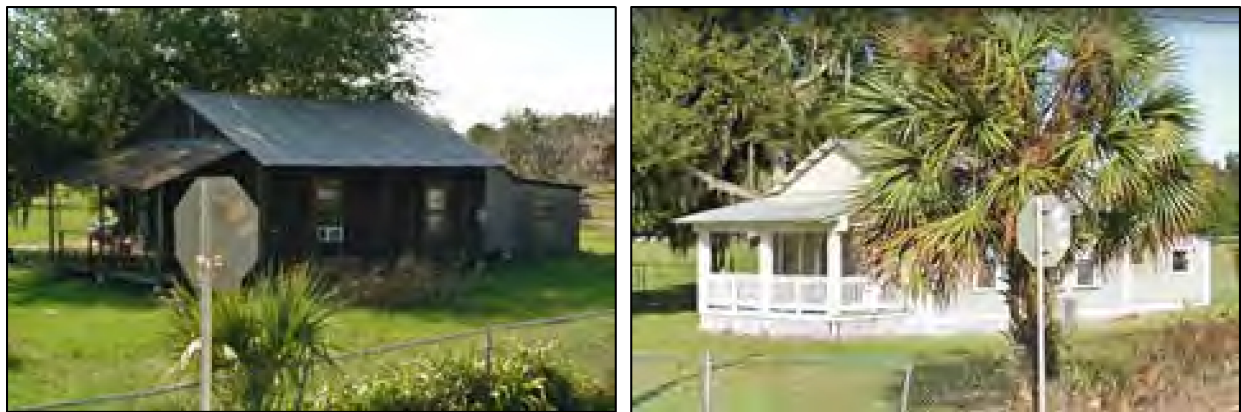
Figure 2. Morgan Family House 1: left, south front and east side elevations in 2011 and, at right, in 2019 (source of both: <https://www.google.com/maps>).

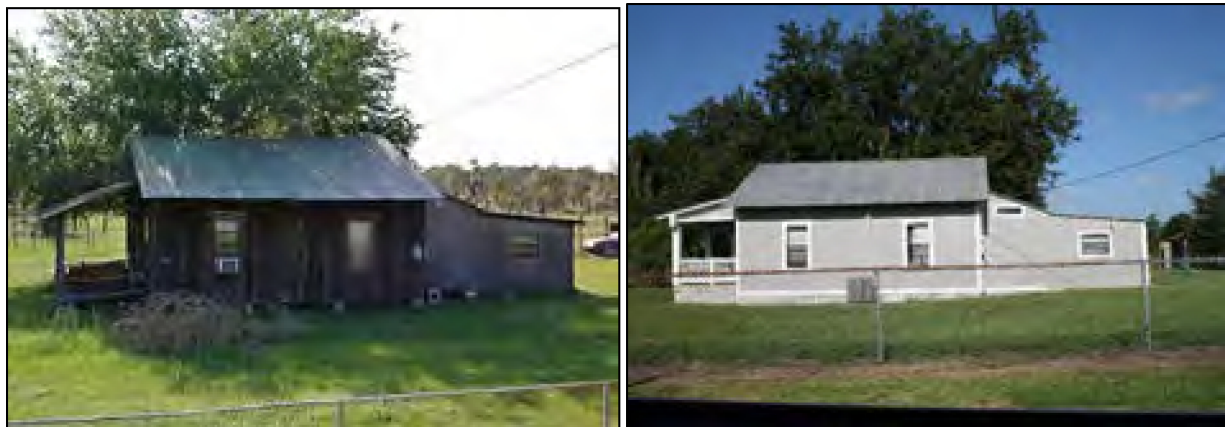
Figure 3. Morgan Family House 1: left, east side elevation in 2011 (source: <https://www.google.com/maps>) and, at right, in 2020.

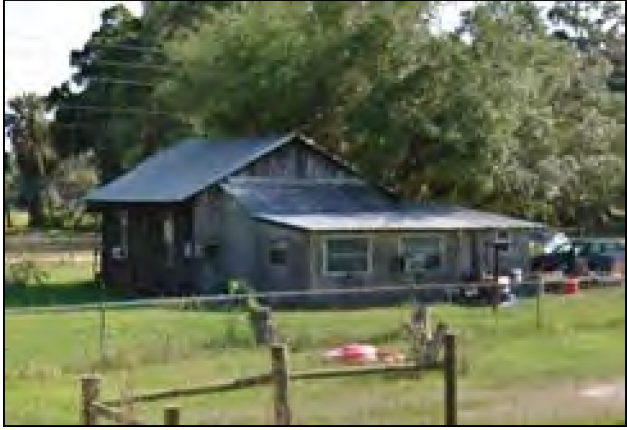
Figure 4. Morgan Family House 1: east side and north rear elevations, 2011 (source: <https://www.google.com/maps>).

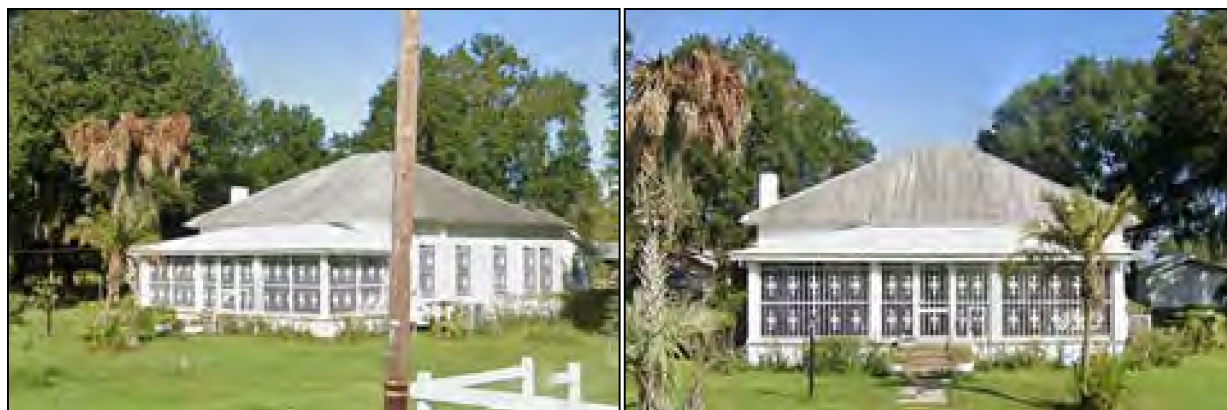
Tax records place the house's construction in 1935 (Figure 1 through Figure 6). Its dimensions and L-plan footprint are nearly identical (according to tax records) to those of the Aaron Morgan House to the east, which has a tax date of 1924. Both houses are one-story tall, of frame construction, German sided, and edged with cornerboards. This house lacks Craftsman-style details, though. It does not have exposed rafter tails at the roof of its main block or porch and its windows appear to be one-over-one. This suggests the house may well have been built in the 1930s. A seam-metal hipped roof tops the main block and the full-facade porch to its front (south). The porch has plain square posts and a heavy infill of modern decorative metal grillwork. The windows on the east and west side elevations are covered by the same grillwork. A narrow, exterior-end, brick chimney stack rises along the west side elevation of the main block, which is extended to the rear by a one-story gable-end ell. The L-shaped porch that extended along the rear of main block and ell has been largely enclosed.

Figure 1. Morgan Family House 2: left, south front and east side elevations and, right, south front elevation, 2019 (source of both: <https://www.google.com/maps>).

Morgan Family House 2 is not believed to retain the integrity necessary for NR eligibility. Its rural setting retains intact and it appears to stand upon the site where it was erected. However, the heavy intrusive grills that hide its porch and windows have negatively affected its integrity of integrity design, materials, and workmanship, and thereby of feeling and association. Further, the house is not known to have any association with significant historic events or persons and is therefore recommended as not eligible for NR listing under NR Criteria A or B. It also does not appear to embody the distinctive characteristics of a type, period, or method of construction and accordingly is recommended as not NR-eligible under Criterion C.

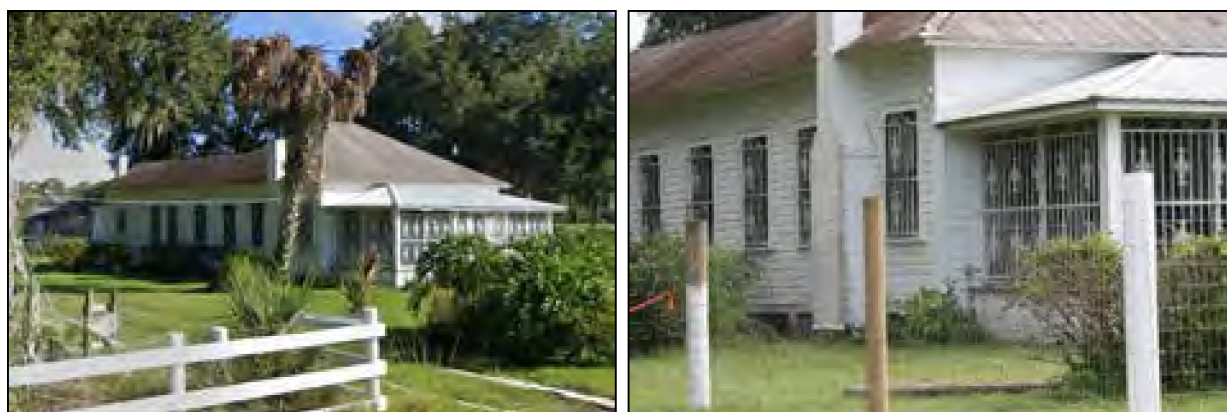
Figure 2. Morgan Family House 2: left, west side and south front elevations in 2019 (source: <https://www.google.com/maps>) and, right, same elevations in 2020.

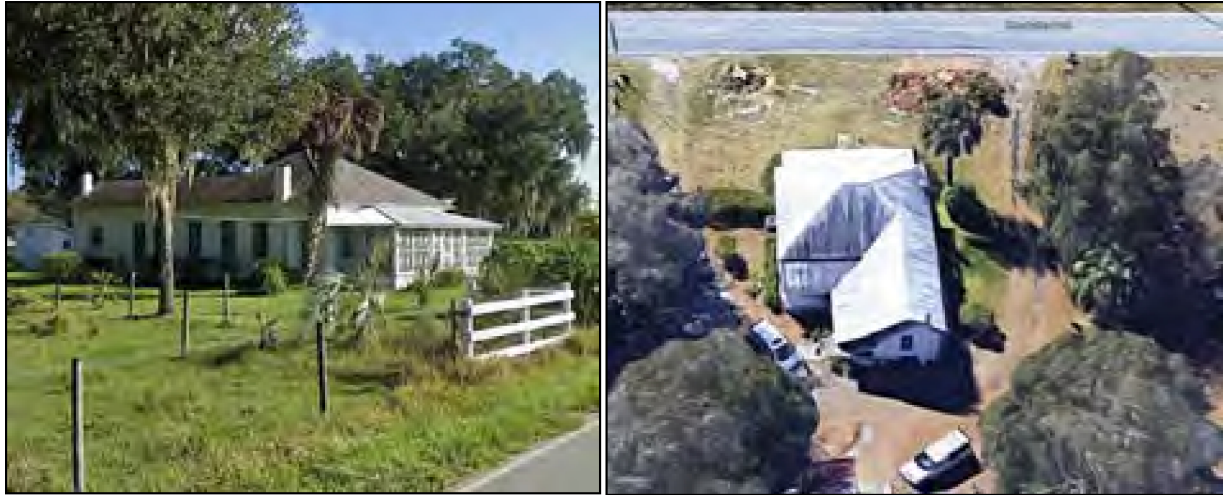
Figure 3. Morgan Family House 2: left, west side and south front elevations, 2019; right, aerial view of north rear elevation and roofs, 2018 (source of both: <https://www.google.com/maps>).

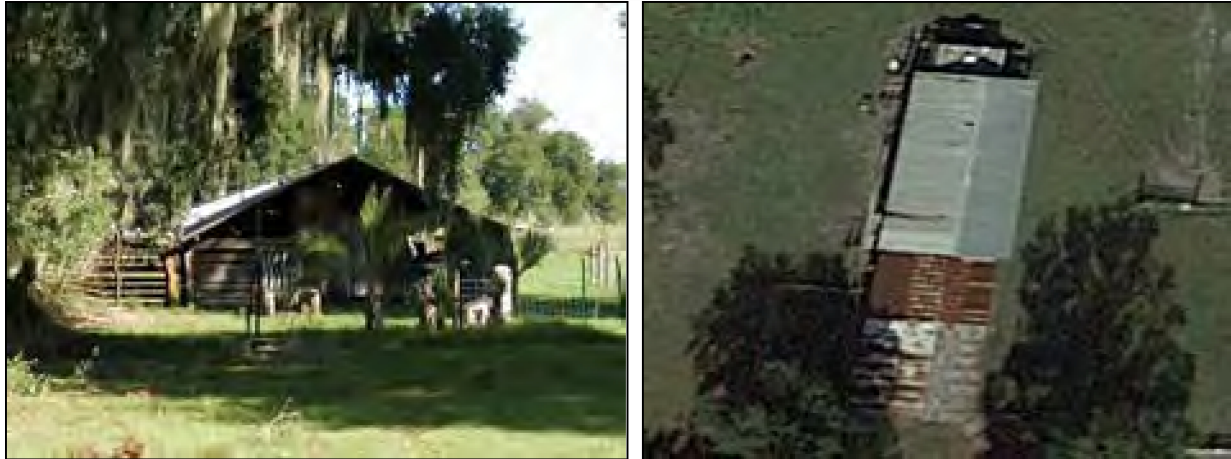
house's rear: a white shed-roofed shed and two taupe-colored gable-roofed sheds. The white shed may be more than 50 years old; the taupe sheds appear to have been built more recently. A long gable-roofed pole barn stands to the house's northwest. The varied pitches and conditions of its roof suggest it was built in three sections. Its first section rose at its south end, closest to the road. This may be the resource identified in tax records a "pole shed dirt [floor] erected in 1935. A second section added to its rear (north) may be the resource tax records identify as a "pole shed concrete [floor]," erected in 1960. A more substantial and longer third section of the barn was subsequently appended to barn's north end.

Figure 6. Morgan Family House 2: left, south front elevation of barn, 2019; right, aerial view of barn with south elevation at bottom, 2018 (source of both: <https://www.google.com/maps>).

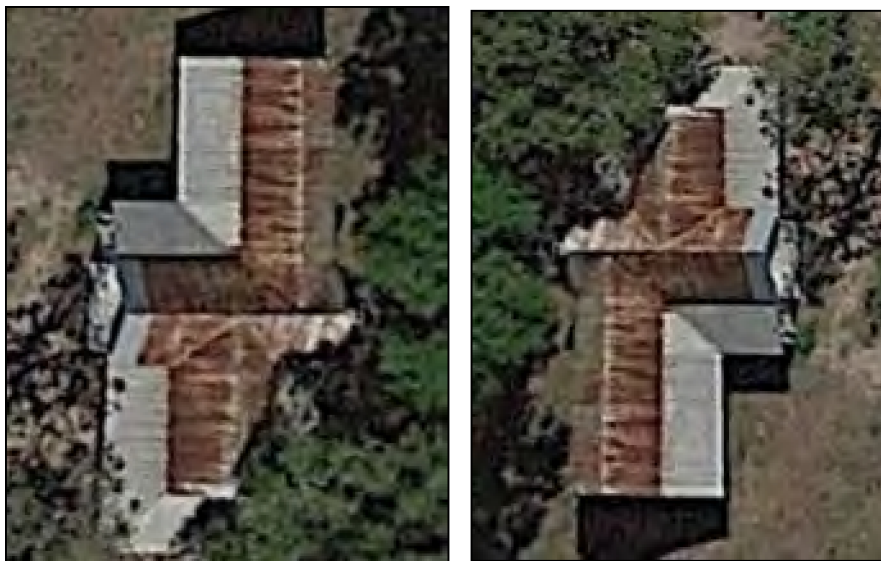
*Figure 1. English Family House: 2018 aerials with south at bottom of left image and north at bottom of right image; T-shaped roofs of main block and linearly extended ell are topped by rusted roofs; porches and west gable end of main block are apparent from shiny appearance of re-clad roofs.*
