# Final Environmental Assessment for Phase II Air Cargo Facility Development

Lakeland Linder International Airport  
Polk County, Florida

# **Phase II Air Cargo Facility Development at Lakeland Linder International Airport (LAL)**

## **Phase IB Cultural Resources Assessment Survey**

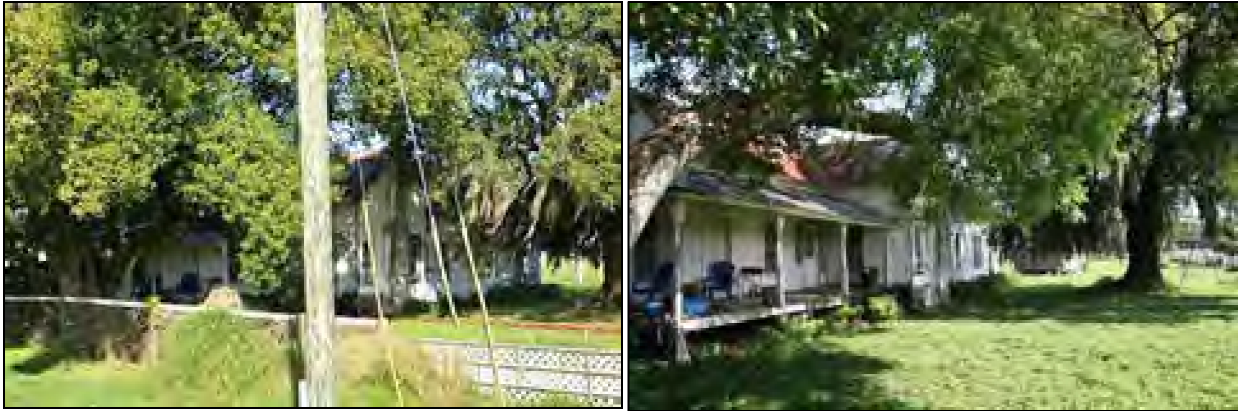
The English Family House is one-story tall and of frame construction (Figure 1 through Figure 6). Its main block has a T-shaped plan that is extended to the rear elevation by a one-story frame ell. The gable-front central part of the T-shaped block faces south toward Medulla Road. The legs of its T at its rear terminate in gables as well. The block retains original narrow cornerboards, German siding, and plain surrounds with slightly crosstetted lintels. The section facing the road is two bays wide; both of these bays hold original two-over-two, double-hung, sash windows. The rest of the house's window bays are finished in similar fashion. Entrances to the house are along either side of the projecting section. They are shaded and reached by a U-shaped porch that wraps around the front section. The porch retains turned posts and solid, floriated, jig-sawn brackets that appear to be original. The rear ell is original or early. An L-shaped porch that once crossed the rear of the main block and west side of the ell has been enclosed. Exterior-end brick chimney stacks rise along the rear gable of the ell and the east side gable of the main block.

Figure 2. English Family House: left, east side elevation in 2019 (source: <https://www.google.com/maps>); same elevation in 2020

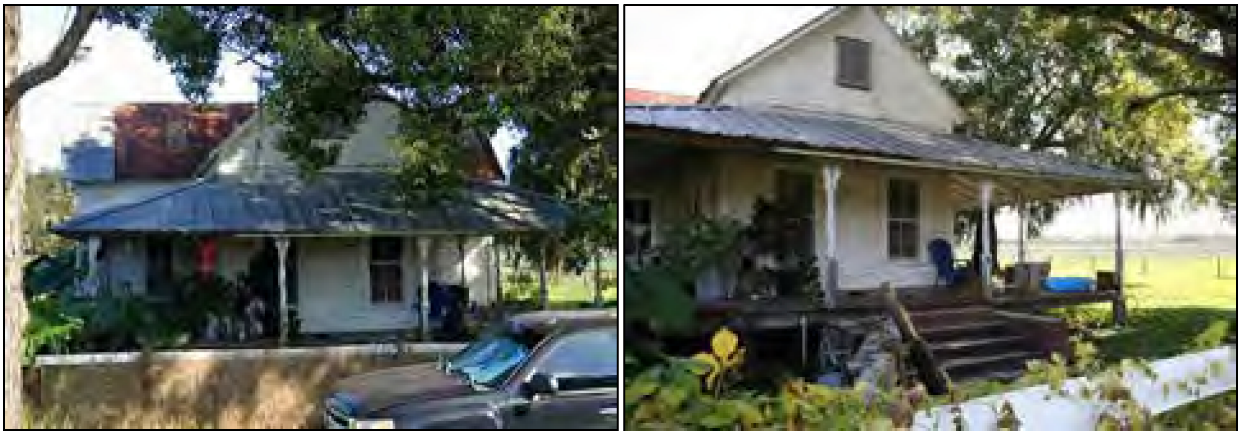
Figure 3. English Family House: left, south front and west side elevation in 2019 (source: <https://www.google.com/maps>); same elevations in 2020.

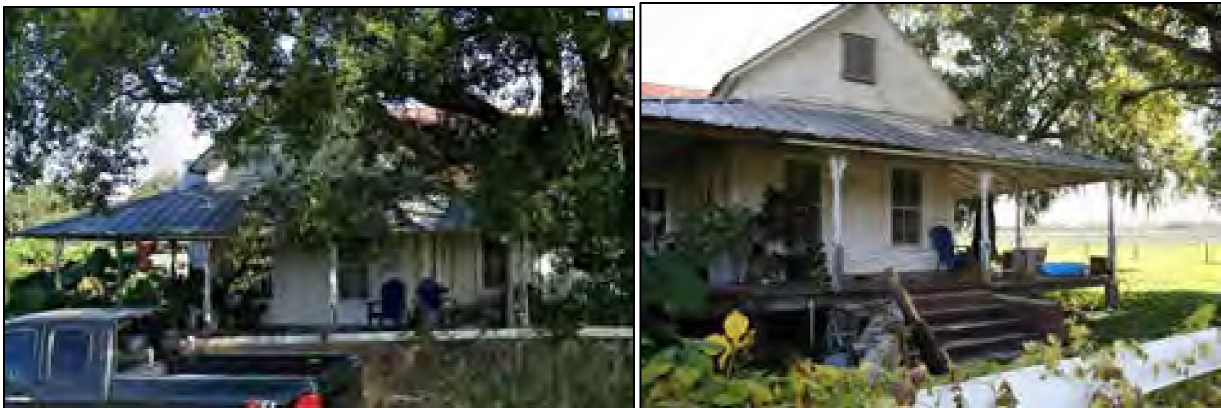
Figure 4. English Family House: left, south front elevation in 2019 (source: <https://www.google.com/maps>); right, same elevation in 2020.

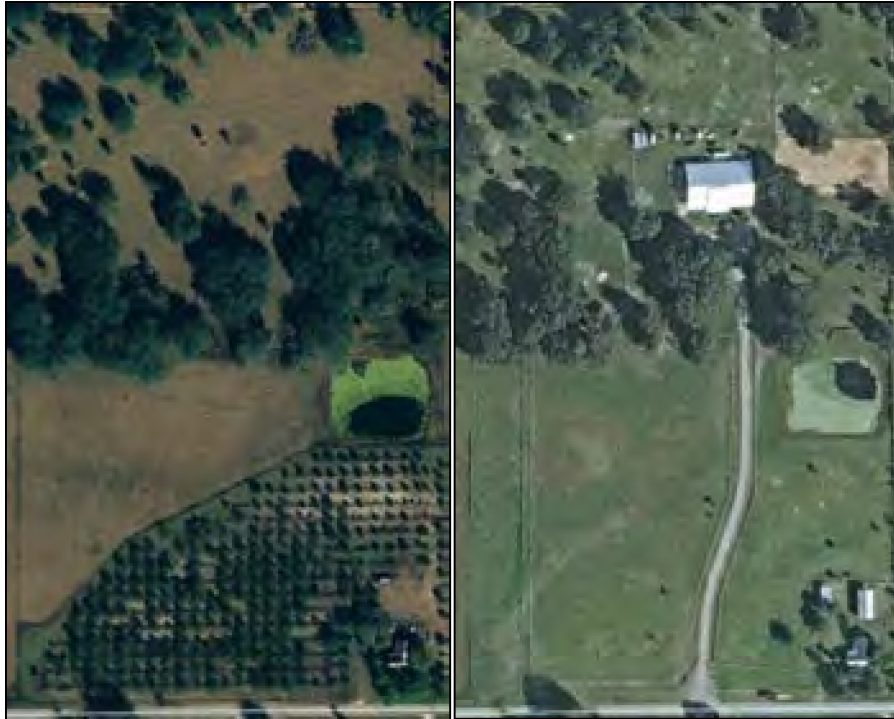
Figure 8. Left, parcel in December 2006 with house and outbuildings at lower right corner; right, parcel in November 2007 with citrus grove and early outbuildings removed and modern outbuildings and access road added (source of both: <https://www.google.com/maps>).

After the English family sold the parcel to the Morrells, they quickly converted the property into its current use as the English Oaks Equestrian Center (Figure 6 through Figure 9). (Its patrons include the Florida Southern University equestrian team, which Shannon Morrell coaches (*Lakeland Ledger* 2017).) In 2007 they removed the citrus grove that extended to the north and west of the house and filled the southeastern third of the parcel. They also removed early outbuildings near the house, built a frame and a metal pole barn to the house's north, and

added a large stable near the northern end of the property in 2013 accessed by a long new road. In 2017 the owners of the parcel abutting the east side of the English Family House parcel replaced a citrus grove with a solar farm, further altering the house's historic setting.

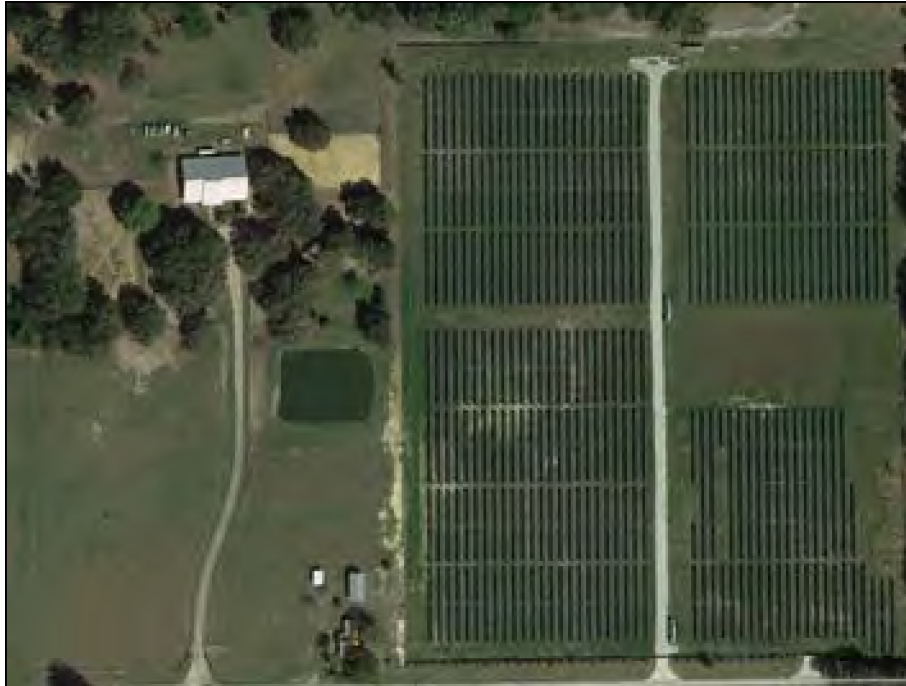
Figure 9. February 2017 aerial of English parcel at left (west) and solar farm on site of former citrus grove at right (source: <https://www.google.com/maps>).

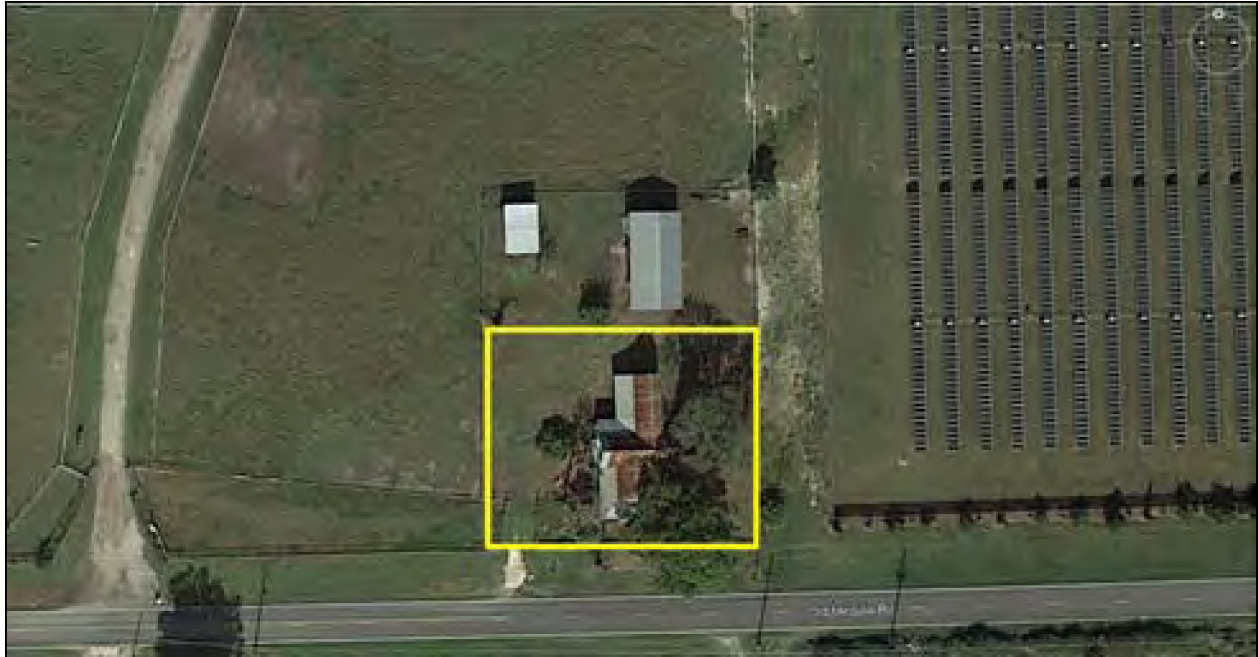
Figure 10. English Family House: proposed NR boundaries outlined in yellow.

The English Family House 2 is recommended as eligible for NR listing under Criterion C for its architecture. It remains a good intact representative of an early-twentieth-century Polk County farmhouse. It retains its original T-shaped form, German siding, crosstetted surrounds, two-over-two sash windows, cornerboards, and front porch with turned posts and decorative brackets. Its only notable alteration appear to be the enclosure of the rear porch. The house appears to stand on its original site and is therefore believed to retain its integrity of location, design, materials, workmanship and, by extension, feeling and association. The removal of outbuildings and construction of modern ones, along with the removal of its citrus grove and the one that abutted its parcel to the east, have negatively affected its setting. The proposed NR boundaries for the house are not recommended to encompass all of its approximately 20-acre historic parcel (Polk County parcel 232906000000024010), which is now a horse farm with modern outbuildings. Rather, they are recommended as the approximately ½-acre portion at the parcel's southeastern corner that includes the house and its associated trees and intact setting (Figure 10). The proposed boundaries extend south to a fence near the right-of-way of Medulla Road and east and west to fence lines. On the north they terminate 25 feet north of the ell, before the modern metal and frame pole barns are reached. Lacking any known association with historic events or persons, the house is not recommended as NR eligible under Criteria A or B.

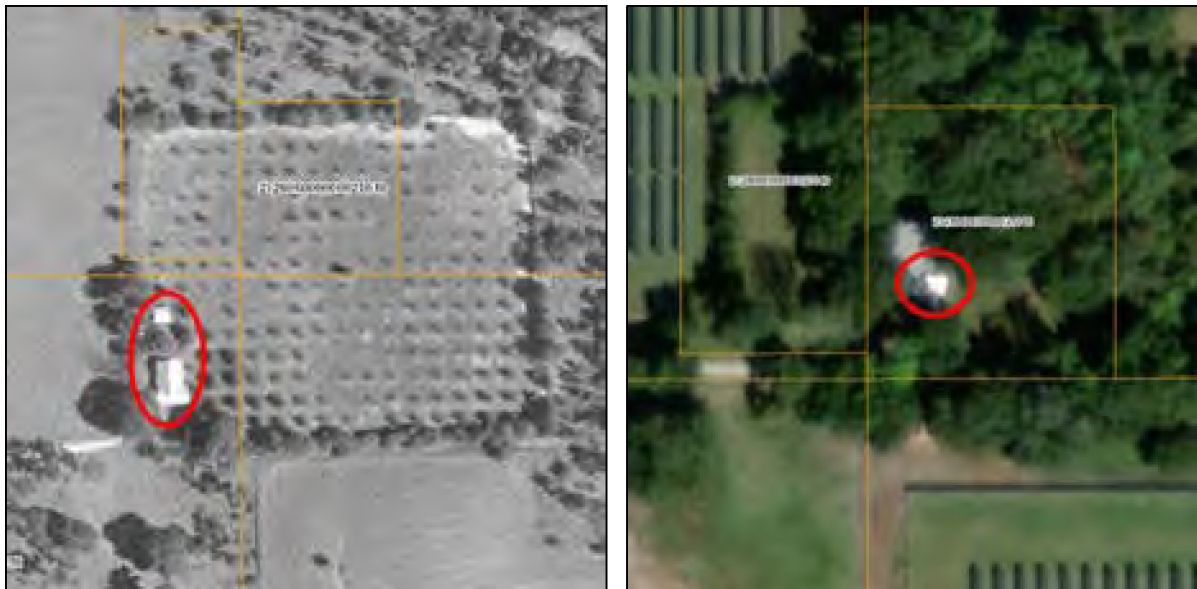
Figure 2. House at 4404 Hamilton Road: left, 1964 aerial with parcel mislocated to the northeast of house and, right, parcel in 2018 with former grove largely filled with trees and edged by solar farms (source of both: <http://gisapps.polk-county.net/gisviewer>).

The house at 4404 Hamilton Road is not known to have any association with significant historic events or persons. It is therefore recommended as not eligible for NR listing under NR Criteria A or B. From the available evidence, it does not appear to embody the distinctive characteristics of a type, period, or method of construction and accordingly is recommended as not NR-eligible under Criterion C. Additionally, its former citrus grove is now wooded and groves to its west and south hold modern solar farms. It is therefore believed to have lost its integrity of setting. Its basic form and c1934 construction date, coupled with available information and apparent abandonment and deterioration, suggest it has also lost its integrity of design, materials, workmanship and, thereby, feeling and association. Due to its loss of integrity and lack of significance, the house is recommended as not eligible for NR listing.

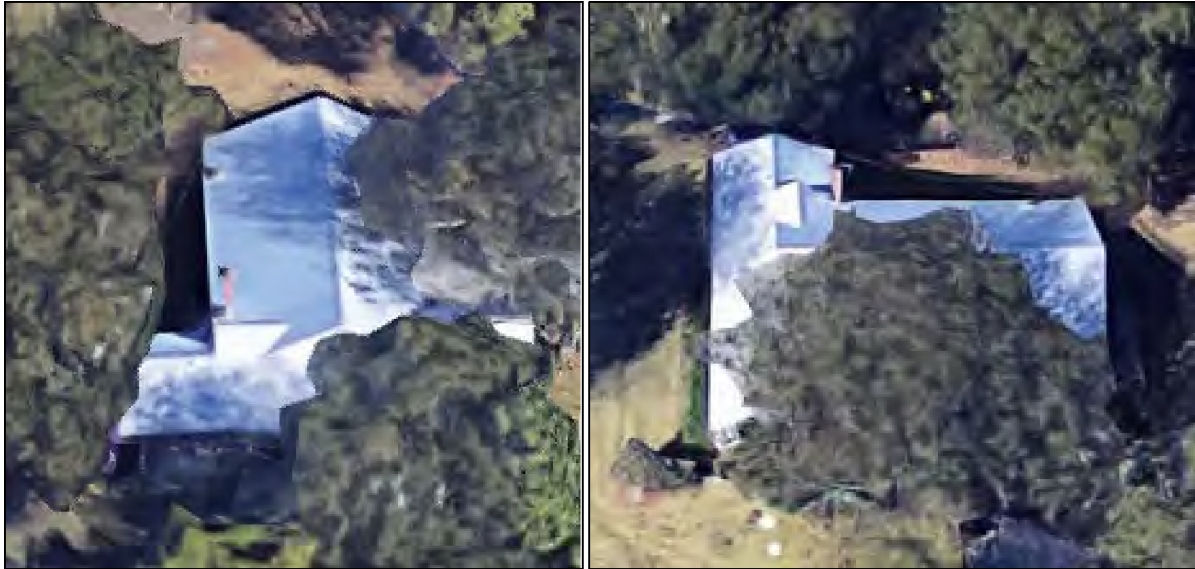
Figure 3. House at 4404 Hamilton Road: left, 2018 bird's-eye aerial view with south front of house at bottom and, right with south front of house at left (source of both: <https://www.google.com/maps>).

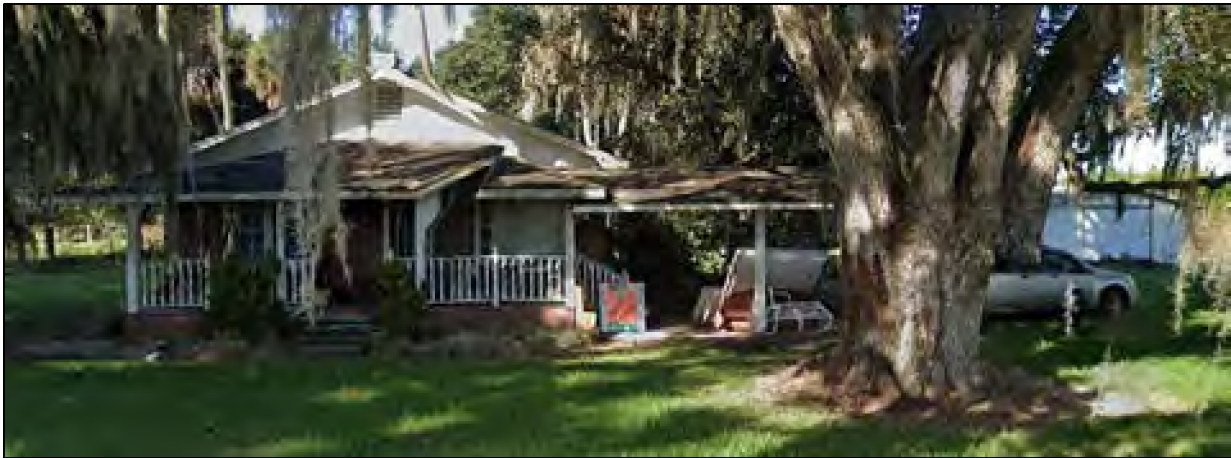
The house is built of frame with an overlay of brick veneer (Figure 1 through Figure 3). It is one-story tall and has a gable-front roof pierced by a central brick chimney stack. Three bays cross its front (east) elevation, a central door flanked by paired windows with clip-in muntins. Windows with clip-in muntins mark the side elevations as well. A full-facade porch crosses its front elevation. A carport extends to the porch's north. An artificial-sided gable-front shed stands to the carport's north. The house's veneer, porch, and windows suggest a construction date within the past 30 or 40 years. If it was built in 1920, it is so heavily altered that this is not discernable.

*Figure 1. House at 4333 Hamilton Road: east front elevation of house at left, carport at center, and modern shed at right in 2019 (source: <https://www.google.com/maps>).*

This house is not known to have any association with significant historic events or persons and therefore is recommended as not eligible for NR listing under NR Criteria A or B. It does not appear to embody the distinctive characteristics of a type, period, or method of construction and accordingly is recommended as not NR-eligible under Criterion C. If it is more than 50 years old, it has lost the integrity of design, materials, and workmanship—as well as setting, feeling, and association—that would express and represent that earlier period of construction. It is recommended as not eligible for NR listing under any of the Register's Criteria and Criteria Considerations.

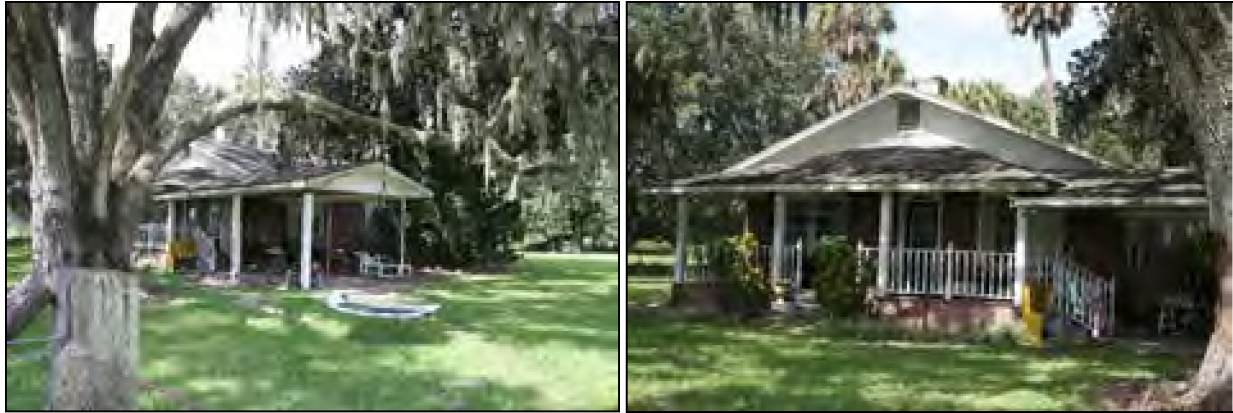
*Figure 2. House at 4333 Hamilton Road: south side and east front elevations, both 2020.*

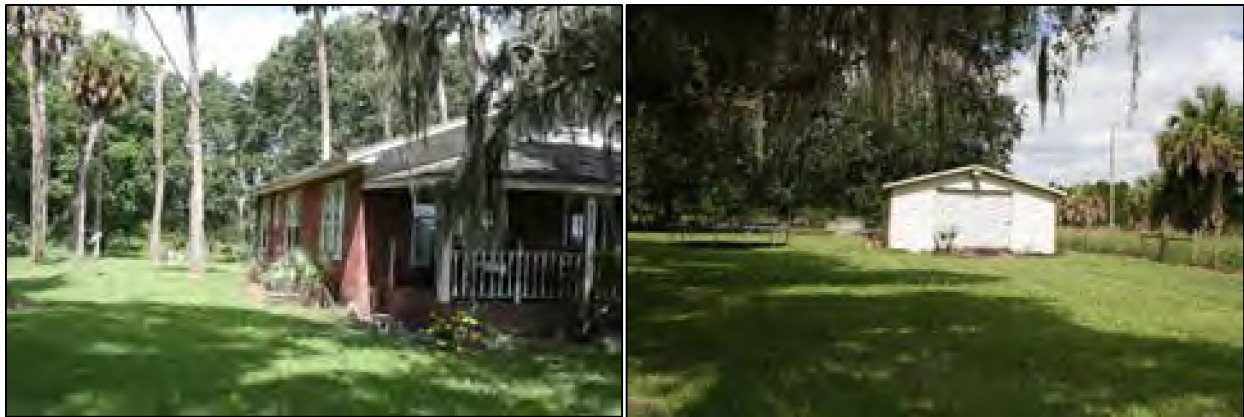
*Figure 3. House at 4333 Hamilton Road: left, north side and east front elevations; right, modern shed, both 2020.*

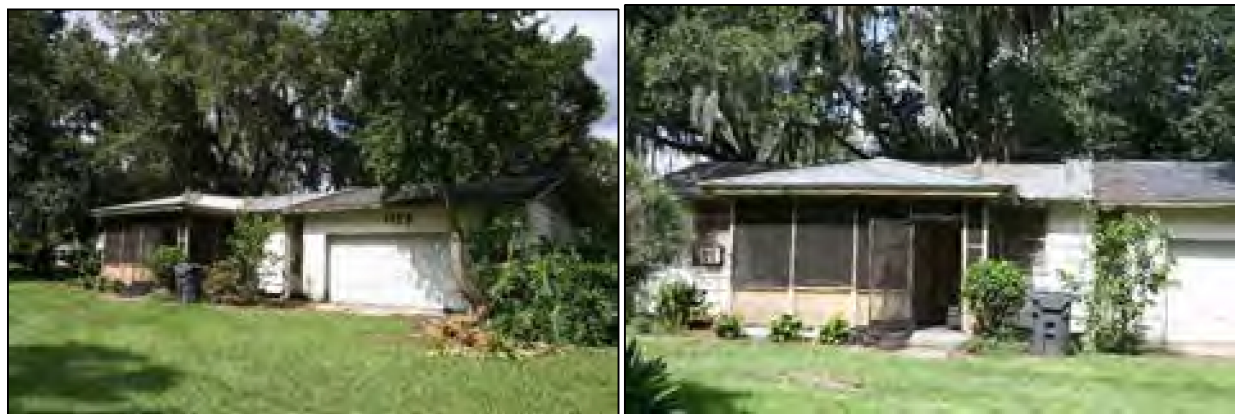
The house has two blocks that are nearly equal in size (Figure 1 through Figure 3). The gable-end block on the south is the principal one. Its east-facing front elevation is four bays wide. A door and a window are shaded by a hip-roofed screened front porch; a window is also placed to either side of the porch. These as the house's other windows are double-hung with two-horizontal-light-over-two-horizontal-light sash. The later-added north block holds a two-bay garage. Like the main block, it is topped by a gable-end roof and sided with asbestos shingles. It is flush with the main block at the front but extends a few feet farther back at the house's west-facing rear elevation. The window sash, their placement immediately under the eaves, the proportions of the main block, the asbestos shingles—all suggest a construction date within the past 50 years.

*Figure 1. Futch-Dawson House: left, east front and north side elevations; right, east front elevation.*

This house is not known to have any association with significant historic events or persons and therefore is recommended as not eligible for NR listing under NR Criteria A or B. It does not appear to embody the distinctive characteristics of a type, period, or method of construction and accordingly is recommended as not NR-eligible under Criterion C. If it is more than 50 years old, it has lost the integrity of design, materials, and workmanship—as well as setting, feeling, and association—that would express and represent that earlier period of construction. It is recommended as not eligible for NR listing under any of the Register's Criteria and Criteria Considerations.

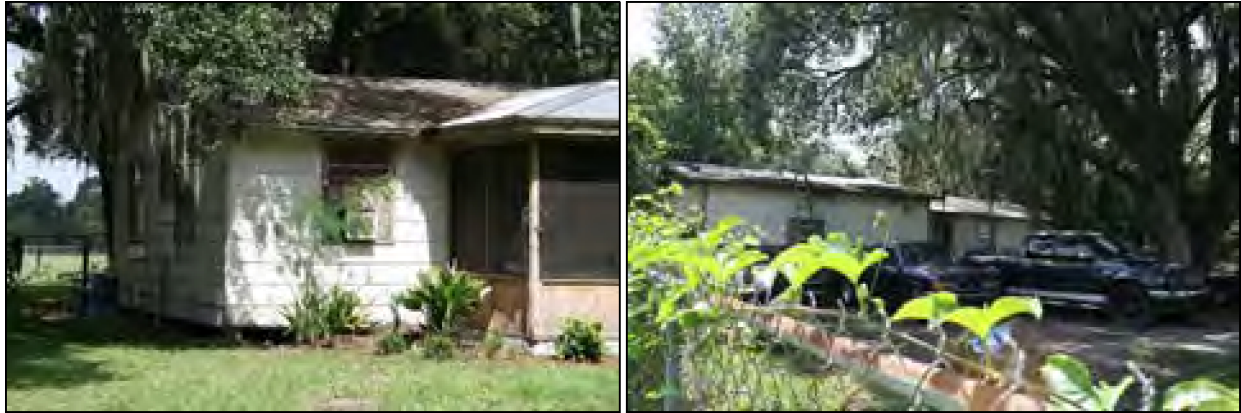
*Figure 2. Futch-Dawson House: left, south side and east front elevations; right, north side and west rear elevations.*

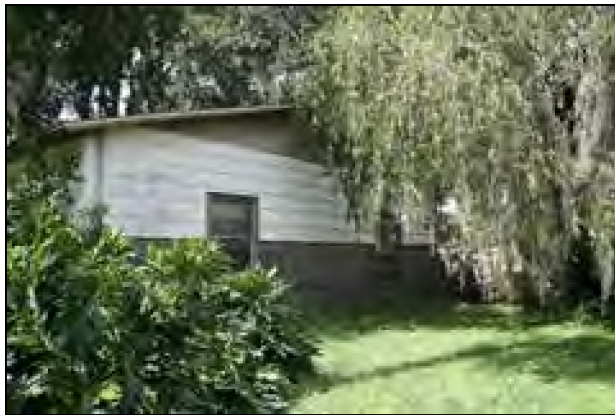
*Figure 3. Futch-Dawson House: east front and north side elevations.*

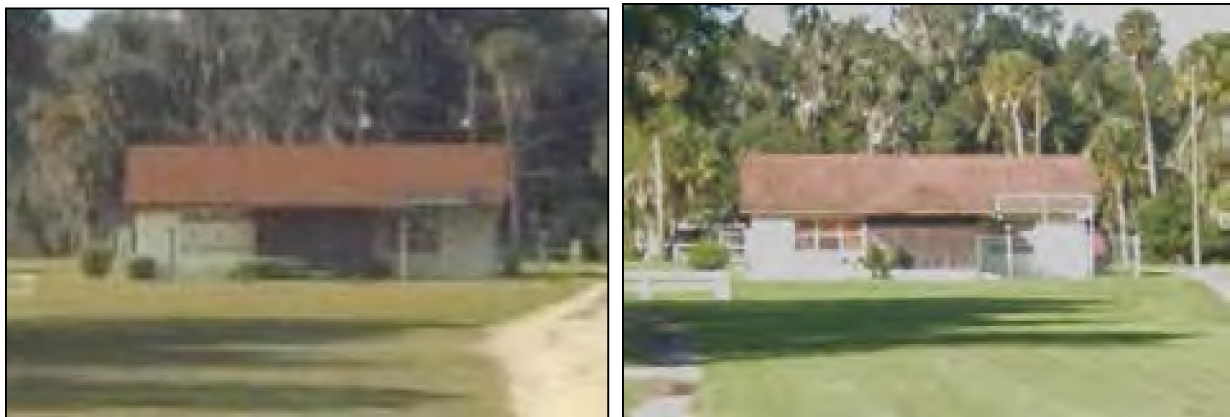
The house occupies a zig-zag-shaped parcel on the west side of Hamilton Road and is located down a lane about 300 yards from the road (Figure 1 through Figure 3). Its distance from the road and the shape of its parcel indicate that its 5.54-acre parcel was cut out of a larger agricultural tract. The house is almost square with a notch out of the back of the northwestern corner of its rear (west) elevation. One-story tall, it encompasses approximately 1,600 square feet. The house is of stuccoed masonry construction. Its gable-end roof is asphalt-shingled. At its front (east) elevation it has a tripled one-over-one window grouping at the left, an entry shaded by a screened hip-roofed porch at the center, and paired one-over-one windows at the right. The house's other windows are also one-over-one. A gabled roof extends to the house's rear. It is abutted by a fenced patio shaded by a modern metal-pole-supported roof. A modern outbuilding stands to the house's south. The window sash, the house's proportions and relatively large footprint, and its masonry construction suggest a construction date within the past 50 years.

*Figure 1. Dawson House: Left, east front elevation in 2014 (source: <https://www.bing.com/maps/>) and, right, same elevation in 2018 (source: <https://www.google.com/maps/>).*

This house is not known to have any association with significant historic events or persons and therefore is recommended as not eligible for NR listing under NR Criteria A or B. It does not appear to embody the distinctive characteristics of a type, period, or method of construction and accordingly is recommended as not NR-eligible under Criterion C. If it is more than 50 years old, it has lost the integrity of design, materials, and workmanship—as well as setting, feeling, and association—that would express and represent that earlier period of construction. It is recommended as not eligible for NR listing under any of the Register's Criteria and Criteria Considerations.

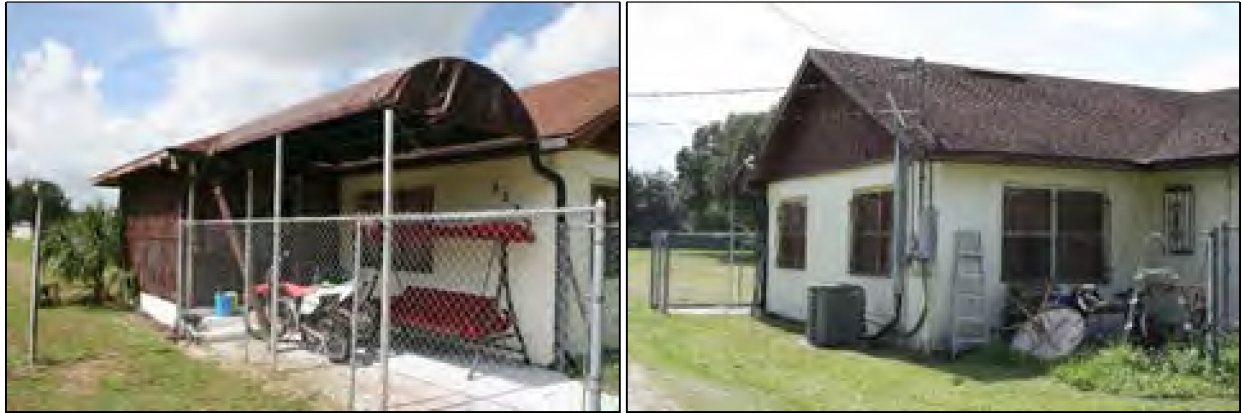
*Figure 2. Dawson House: left, east front and north side elevations; right, north side and west rear elevations.*

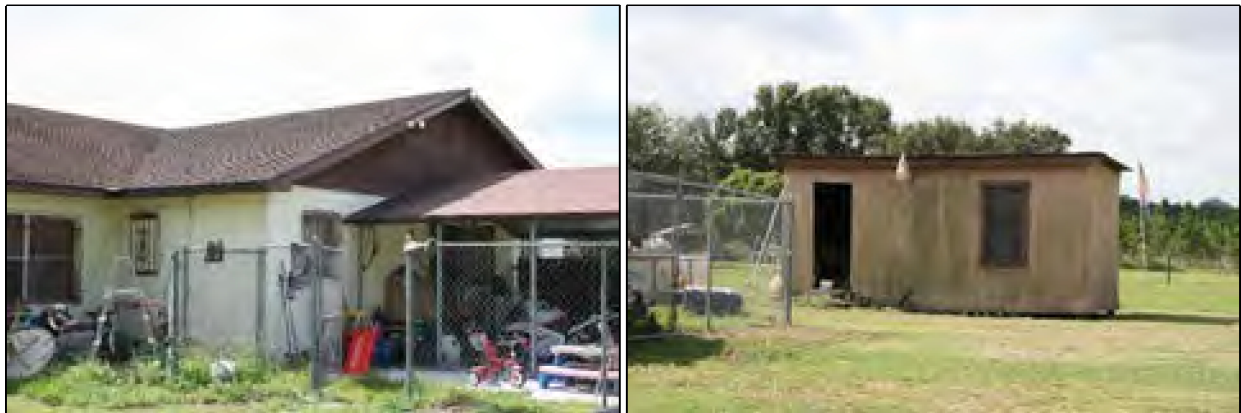
*Figure 3. Dawson House: left, west rear elevation; right, modern shed to house's south.*

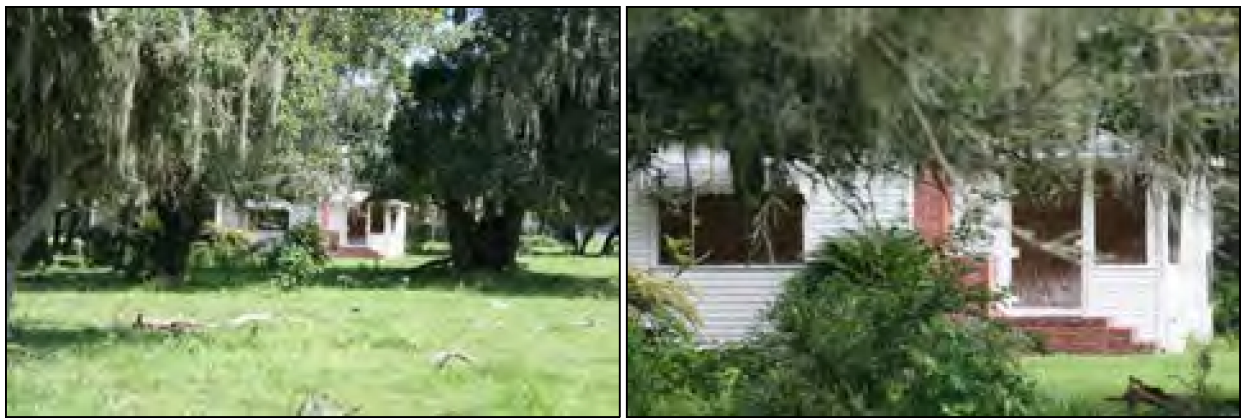
The house’s main block is one-story tall and two rooms deep (Figure 1 through Figure 4). It is built of frame and topped by an asphalt-shingled gable-roof. A one-bay gable-front porch supported by square posts extends over its central front (south-facing) entry. The windows to either side of the facade are shaded by later-added metal hoods. An exterior-end brick chimney rises from the block’s east gable. A hipped-roof wing wraps around much of the east side elevation of the house and part of the north rear elevation. The house has been vacant for a number of years and its windows are boarded over. It appears to be maintained, though, and its artificial siding is in good condition. When the house was artificially sided in recent years its original exposed rafter tails were boxed in. A frame two-car garage standing to the house’s north rear appears to have been its contemporary, likely dating from the 1930s. A largely collapsed frame barn is overgrown by trees farther to the north. Its construction date is not known.

Figure 2. Opal and Oliver Phillips House: left, south front elevation with porch post visible at left center; right, detail of south elevation, both 2020

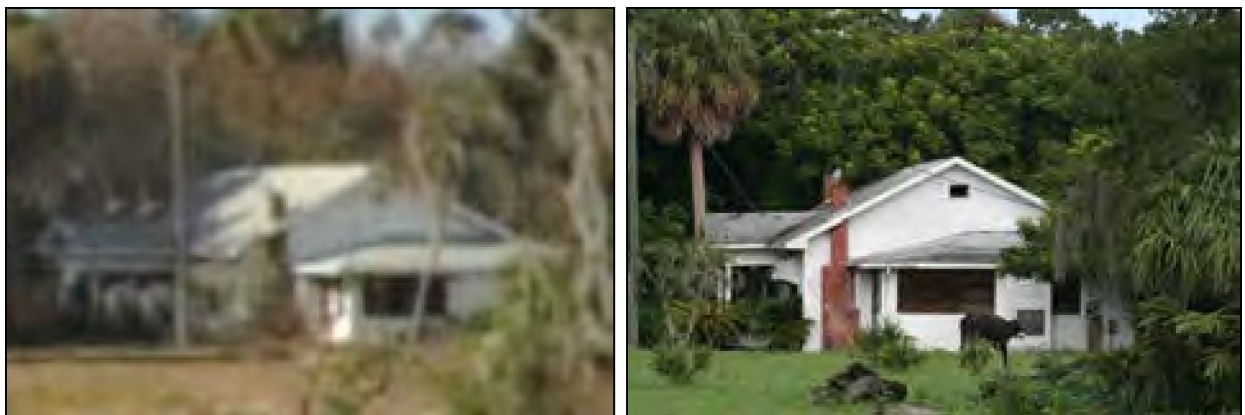
Figure 3. Opal and Oliver Phillips House: left, south front and east elevations with porch at left in 2014 (source: <https://www.bing.com/maps/>); right, same view in 2020.

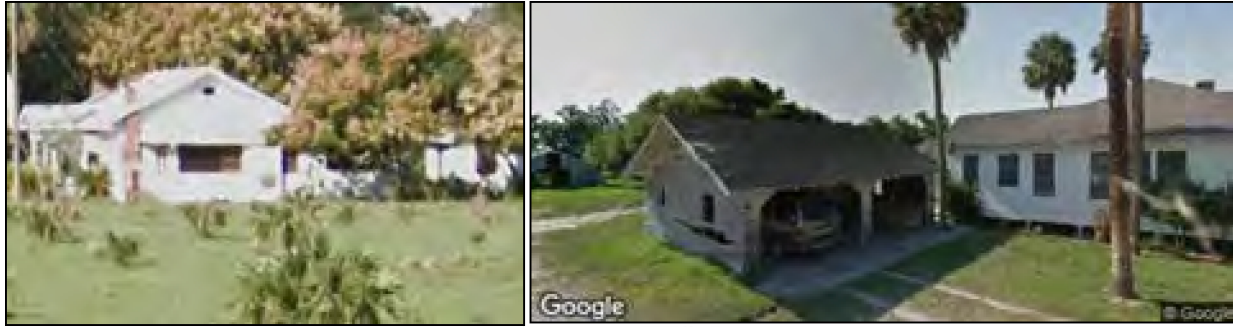
Figure 4. Opal and Oliver Phillips House: left, south front and east side elevations with garage at far right, 2019 (source: <https://www.google.com/maps>); right, north rear of house with garage at left center and now collapsed barn at far left, no date (source: Connected Investors website).

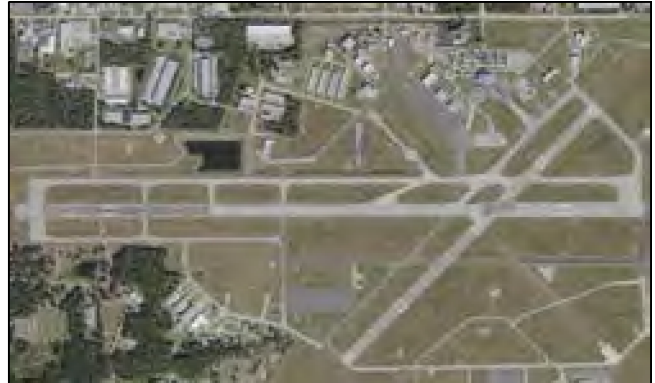
Only the ghost of the original runway pattern of the former Lakeland Army Air Base is visible at the current Lakeland Linder Airport (FMSF PO08466) (AECOM Resource 11a) (Figure 1). Since the late 1980s, it has been transformed by the construction of extensions and new runways and the sodding over of old runways and pads (*Tampa Tribune* 1967, 1968, 1997, 2000, and 2002). The runway and the airport grounds, therefore, are believed to have lost their integrity of design, setting, materials, workmanship and, thereby, feeling, and association. The airfield is accordingly not recommended as eligible for NR listing due to a loss of integrity. (The airfield does remain at its original location.)

Figure 1. Left, Lakeland Army Air Field (FMSF PO08466) (AECOM Resource #11a) with Drane Field Road at north top, 1953: (source: <https://web.archive.org/web/20120608222530/http://www.airfieldsdatabase.com/WW2/WW2%20R27b%20CO-HA.htm>; right, modern Google Maps aerial.

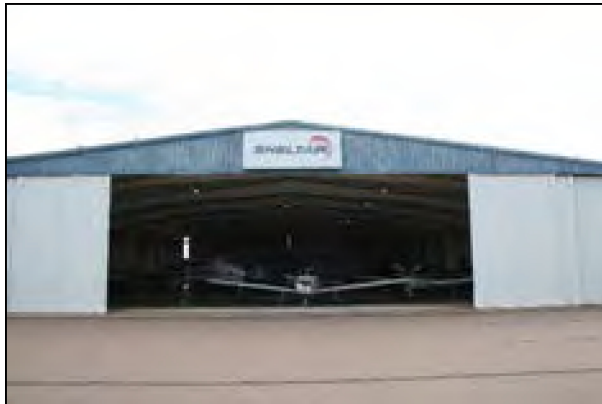
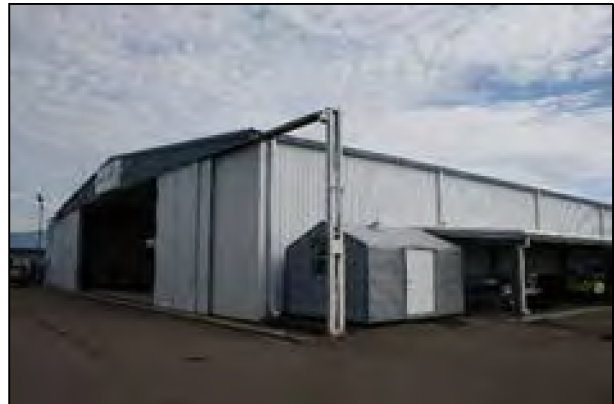
As noted at the historic context of the accompanying report, none of the airport's scores of WWII-era buildings survive. Tax records and historic aerials, however, indicate that four of the its standing resources were erected between about 1959 and 1971. Three of these are hangars standing on the southwest side of Airfield Drive West about 400' southeast of the modern airport terminal. Matching steel hangars erected c1960 (*Tampa Tribune* 1959a) now house the aircraft maintenance facilities of Shelterair Aviation (FMSF PO08462) (AECOM Resource 11b) (Figure 2 and Figure 3) and Aeromech Aviation (FMSF PO08463) (AECOM Resource 11c). These were joined by a nearly identical hangar to their northwest—now home to the maintenance facilities of Double M Aviation (FMSF PO08464) (AECOM Resource 11d)—between the taking of aerial photographs of the airport in 1964 and 1968. (The 1964 aerial appears to show ground preparation for the hangar.) A second building was added to this hangar by 1971. (A series of historic aerials of the airport and Polk County are available at the Polk County GIS Map Viewer site.) The three earliest hangars are essentially square, about 120' on each side. They are conventional hangar types with steel primary load-bearing trusses and framing and steel walls and roofs. Their doors are the standard horizontal telescoping type that slide, overlap, and open up access to the entire hangar space when fully pushed to either side. The hangar attached to the northeast side of the Double M Aviation hangar is of similar design and construction, but it only about half as wide. The two hangars are largely open to each other inside, forming a single work space.

Figure 2. Shelterair Aviation maintenance hangar (FMSF PO08462) (AECOM Resource #11b): left, southwest airside elevation; right, southwest airside and southeast elevations.

The maintenance hangars are believed to retain their integrity of location, design, setting, materials, workmanship and, thereby, feeling, and association. However, they are not believed to be significant for any association with significant events or individuals or to embody the distinctive characteristics of a type, period, or method of construction. They are conventional steel hangar types with standard telescoping doors (Luke and Howson 2002; Iungerich 2018; Weitze 1999). The hangars have no known associations with the Cold War or other military activities. They are therefore not believed to be significant under NR Criteria A, B, or C and are recommended as not eligible for NR listing.

Figure 9. Shelterair Aviation maintenance hangar (FMSF PO08462) (AECOM Resource #11b): left, southwest airside elevation; right, southwest airside and southeast elevations.

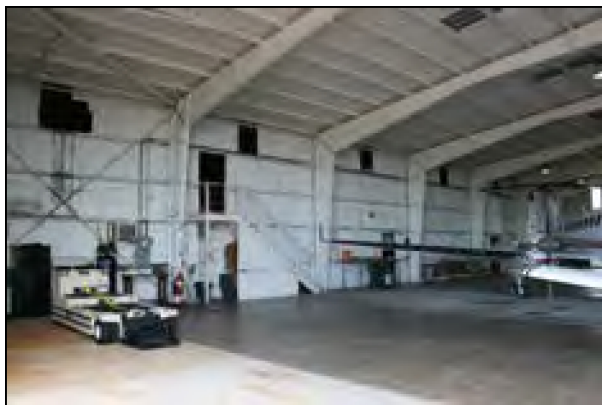
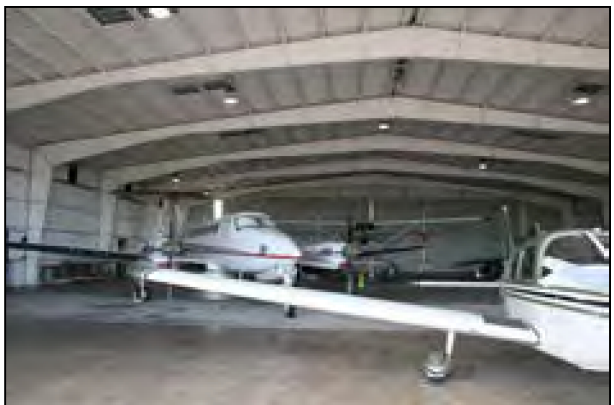
Figure 3. Shelterair Aviation maintenance hangar (FMSF PO08462) (AECOM Resource #11b): interior views.

Figure 10. Shelterair Aviation maintenance hangar (FMSF PO08462) (AECOM Resource #11b): interior views.

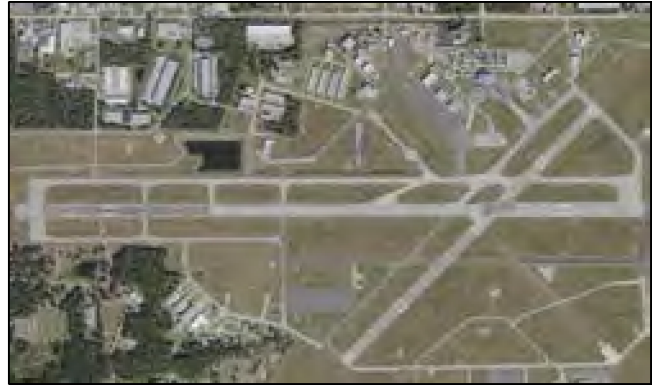
Only the ghost of the original runway pattern of the former Lakeland Army Air Base is visible at the current Lakeland Linder Airport (FMSF PO08466) (AECOM Resource 11a) (Figure 1). Since the late 1980s, it has been transformed by the construction of extensions and new runways and the sodding over of old runways and pads (*Tampa Tribune* 1967, 1968, 1997, 2000, and 2002). The runway and the airport grounds, therefore, are believed to have lost their integrity of design, setting, materials, workmanship and, thereby, feeling, and association. The airfield is accordingly not recommended as eligible for NR listing due to a loss of integrity. (The airfield does remain at its original location.)

Figure 1. Left, Lakeland Army Air Field (FMSF PO08466) (AECOM Resource #11a) with Drane Field Road at north top, 1953: (source: <https://web.archive.org/web/20120608222530/http://www.airfieldsdatabase.com/WW2/WW2%20R27b%20CO-HA.htm>; right, modern Google Maps aerial.

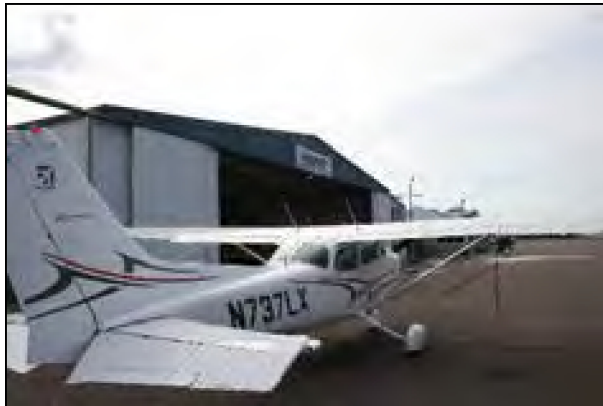
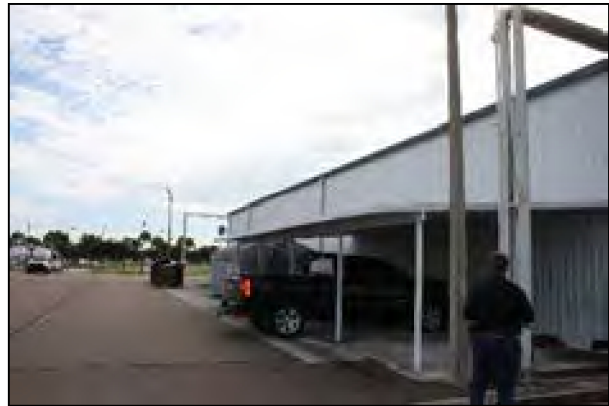
As noted at the historic context of the accompanying report, none of the airport's scores of WWII-era buildings survive. Tax records and historic aerials, however, indicate that four of the its standing resources were erected between about 1959 and 1971. Three of these are hangars standing on the southwest side of Airfield Drive West about 400' southeast of the modern airport terminal. Matching steel hangars erected c1960 (*Tampa Tribune* 1959a) now house the aircraft maintenance facilities of Shelterair Aviation (FMSF PO08462) (AECOM Resource 11b and Aeromech Aviation (FMSF PO08463) (AECOM Resource 11c) (Figure 2 through Figure 3). These were joined by a nearly identical hangar to their northwest—now home to the maintenance facilities of Double M Aviation (FMSF PO08464) (AECOM Resource 11d)—between the taking of aerial photographs of the airport in 1964 and 1968. (The 1964 aerial appears to show ground preparation for the hangar.) A second building was added to this hangar by 1971. (A series of historic aerials of the airport and Polk County are available at the Polk County GIS Map Viewer site.) The three earliest hangars are essentially square, about 120' on each side. They are conventional hangar types with steel primary load-bearing trusses and framing and steel walls and roofs. Their doors are the standard horizontal telescoping type that slide, overlap, and open up access to the entire hangar space when fully pushed to either side. The hangar attached to the northeast side of the Double M Aviation hangar is of similar design and construction, but it only about half as wide. The two hangars are largely open to each other inside, forming a single work space.

Figure 2. Aeromech Aviation maintenance hangar (AECOM Resource #11c): left, southwest airside elevation; right, northwest side elevation.

The maintenance hangars are believed to retain their integrity of location, design, setting, materials, workmanship and, thereby, feeling, and association. However, they are not believed to be significant for any association with significant events or individuals or to embody the distinctive characteristics of a type, period, or method of construction. They are conventional steel hangar types with standard telescoping doors (Luke and Howson 2002; Iungerich 2018; Weitze 1999). The hangars have no known associations with the Cold War or other military activities. They are therefore not believed to be significant under NR Criteria A, B, or C and are recommended as not eligible for NR listing.

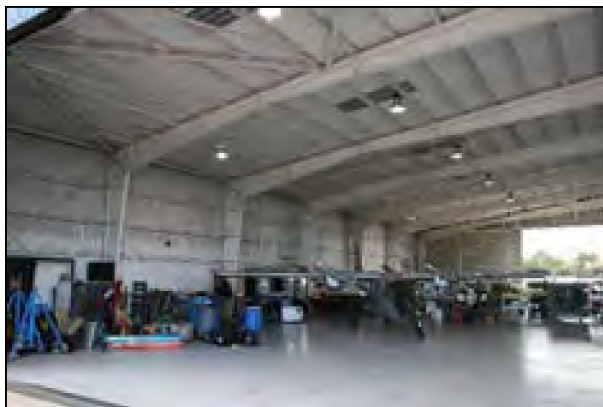
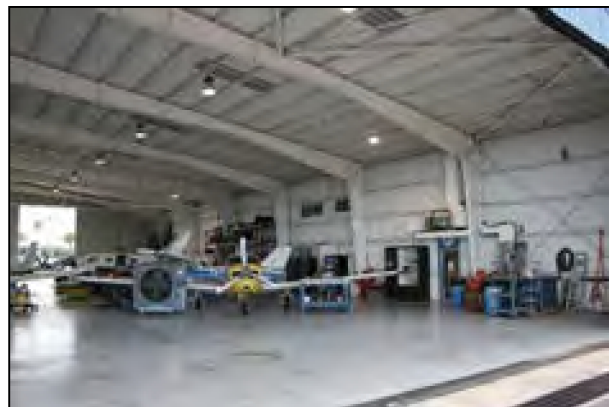
Figure 3. Aeromech Aviation maintenance hangar (AECOM Resource #11c): interior views.

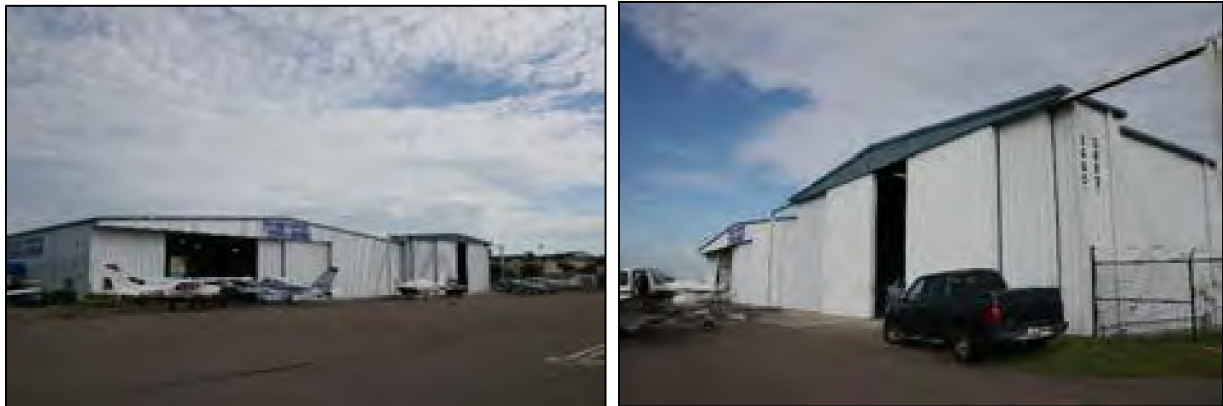
As noted at the historic context of the accompanying report, none of the airport's scores of WWII-era buildings survive. Tax records and historic aerials, however, indicate that four of the its standing resources were erected between about 1959 and 1971. Three of these are hangars standing on the southwest side of Airfield Drive West about 400' southeast of the modern airport terminal. Matching steel hangars erected c1960 (*Tampa Tribune* 1959a) now house the aircraft maintenance facilities of Shelterair Aviation (FMSF PO08462) (AECOM Resource 11b) and Aeromech Aviation (FMSF PO08463) (AECOM Resource 11c). These were joined by a nearly identical hangar to their northwest—now home to the maintenance facilities of Double M Aviation (FMSF PO08464) (AECOM Resource 11d)—between the taking of aerial photographs of the airport in 1964 and 1968 (Figure 2 through Figure 3). (The 1964 aerial appears to show ground preparation for the hangar.) A second building was added to this hangar by 1971. (A series of historic aerials of the airport and Polk County are available at the Polk County GIS Map Viewer site.) The three earliest hangars are essentially square, about 120' on each side. They are conventional hangar types with steel primary load-bearing trusses and framing and steel walls and roofs. Their doors are the standard horizontal telescoping type that slide, overlap, and open up access to the entire hangar space when fully pushed to either side. The hangar attached to the northeast side of the Double M Aviation hangar is of similar design and construction, but it only about half as wide. The two hangars are largely open to each other inside, forming a single work space.

Figure 2. Double M Aviation maintenance hangars (AECOM Resource #11d): left, southwest side and southeast airside elevations with first-built hangar at left; right, southeast airside and northeast side elevations with second-built hangar at right.

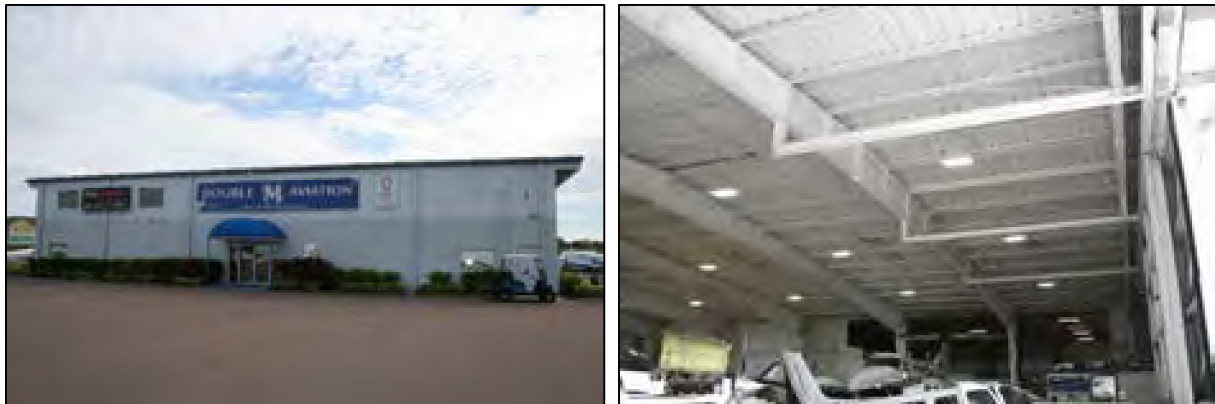
Figure 3. Double M Aviation maintenance hangars (AECOM Resource #11d): left, southwest side elevation of first-built hangar; right, interior view looking from first-built hangar into darker second-built hangar space.

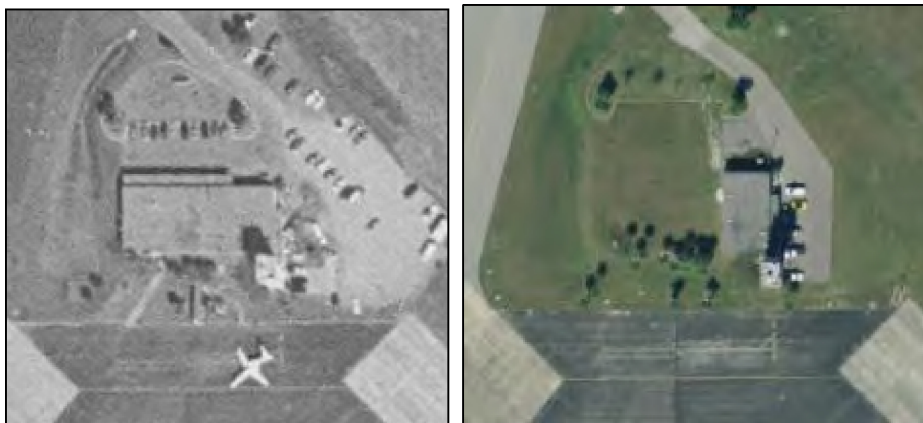
Figure 2. Left, aerial views of former Lakeland Municipal Airport terminal (FMSF PO08465) (AECOM Resource #11e) in 2002 and, right, in 2005 (source of both: Polk County GIS Map Viewer site)

A portion of one additional building that is more than 50 years old survives at the airport (Figure 2 through Figure 5). In December 1959 the airport was completing construction of its first purpose-built terminal. A basic Modernist building, the Lakeland Municipal Airport terminal was a one-story-tall rectangle of masonry construction topped by a flat roof. Exposed posts separated it into seven bays across its front. Three had three-part glass windows and paired doors that extended most of the way toward the roof; four were windowless. A flat-roofed portico supported by steel posts crossed the glassed bays. In the late 1980s or early 1990s, a control tower was built off the terminal's southeastern corner. Between 2002 and 2005, the western three-quarters of the building were lopped off, leaving only its eastern quarter. In the mid-2010s the control tower was removed as well.

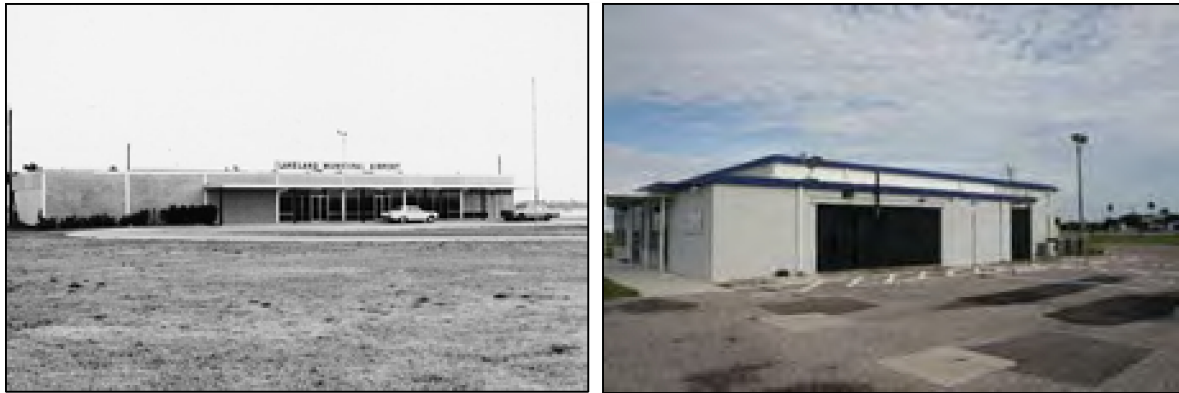
Figure 3. Left, Lakeland Municipal Airport terminal building (FMSF PO08465) (AECOM #11e), 1967 (source: <https://cdm15809.contentdm.oclc.org/digital/collection/p15809coll7/id/66/rec/1>); right, current US Customs and Border Protection building (same number), south front and east side elevation.
