# Final Environmental Assessment for Phase II Air Cargo Facility Development

Lakeland Linder International Airport  
Polk County, Florida

# **Phase II Air Cargo Facility Development at Lakeland Linder International Airport (LAL)**

## **Phase IB Cultural Resources Assessment Survey**

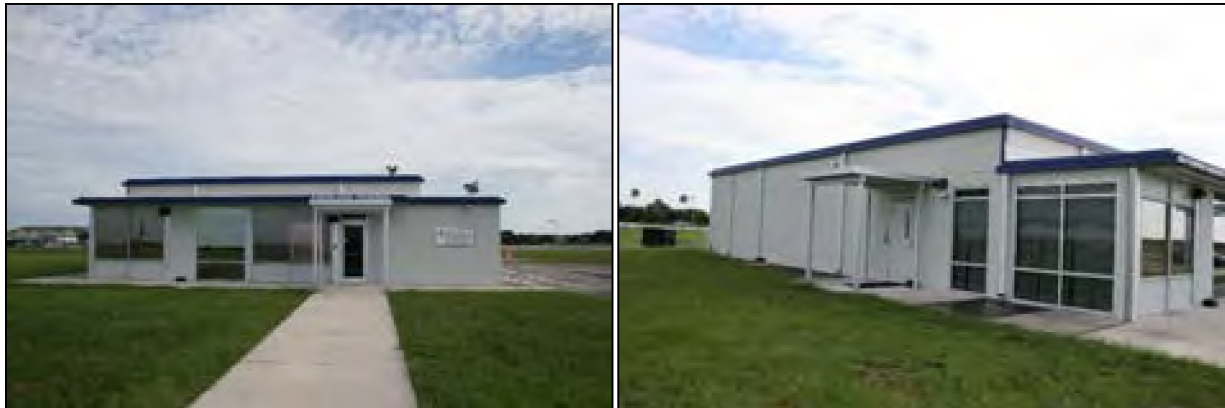
Figure 4. Left, current US Customs and Border Protection building (FMSF PO08465) (AECOM #11e), south front elevation and, right, west side and south front elevations.

A portion of one additional building that is more than 50 years old survives at the airport (Figure 2 through Figure 5). In December 1959 the airport was completing construction of its first purpose-built terminal. A basic Modernist building, the Lakeland Municipal Airport terminal was a one-story-tall rectangle of masonry construction topped by a flat roof. Exposed posts separated it into seven bays across its front. Three had three-part glass windows and paired doors that extended most of the way toward the roof; four were windowless. A flat-roofed portico supported by steel posts crossed the glassed bays. In the late 1980s or early 1990s, a control tower was built off the terminal's southeastern corner. Between 2002 and 2005, the western three-quarters of the building were lopped off, leaving only its eastern quarter. In the mid-2010s the control tower was removed as well.

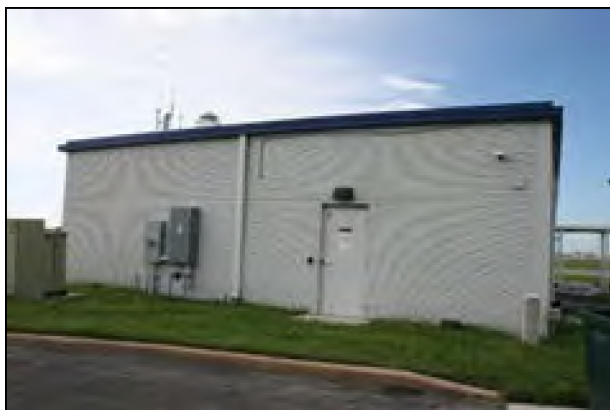
Figure 5. Left, current US Customs and Border Protection building (FMSF PO08465) (AECOM #11e), north rear elevation.

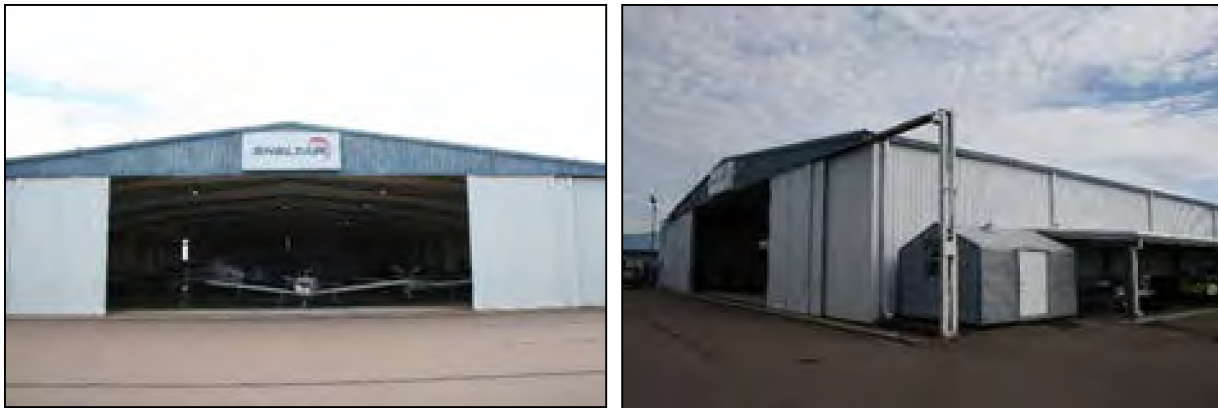
Figure 9. Shelterair Aviation maintenance hangar (FMSF PO08462) (AECOM Resource #11b): left, southwest airside elevation; right, southwest airside and southeast elevations.

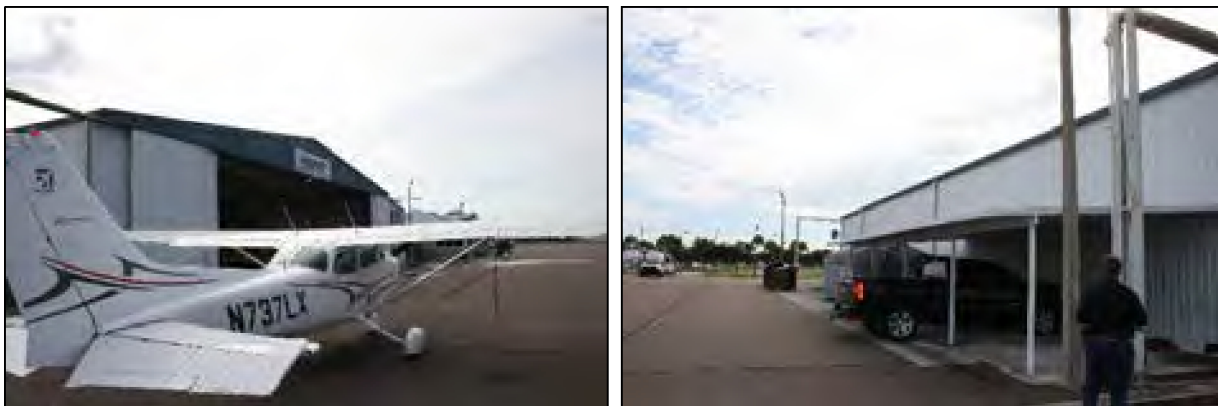
Figure 11. Aeromech Aviation maintenance hangar (FMSF PO08463) (AECOM Resource #11c): left, southwest airside elevation; right, northwest side elevation.

As noted at the historic context of this report, none of the airport's scores of WWII-era buildings survive. Tax records and historic aerals, however, indicate that four of the its standing resources were erected between about 1959 and 1971. Three of these are hangars standing on the southwest side of Airfield Drive West about 400' southeast of the modern airport terminal. Matching steel hangars erected c1960 (*Tampa Tribune* 1959a) now house the aircraft maintenance facilities of Shelterair Aviation (FMSF PO08462) (AECOM resource 11b) (Figure 9 and Figure 10) and Aeromech Aviation (FMSF PO08463) (AECOM resource 11c) (Figure 11 Figure 12). These were joined by a nearly identical hangar (Figure 13 and Figure 14) to their northwest—now home to the maintenance facilities of Double M Aviation (FMSF PO08464) (AECOM resource 11d)—between the taking of aerial photographs of the airport in 1964 and 1968. (The 1964 aerial appears to show ground preparation for the hangar.) A second building was added to this hangar by 1971. (A series of historic aerals of the airport and Polk County are available at the Polk County GIS Map Viewer site.) The three earliest hangars are essentially square, about 120' on each side. They are conventional hangar types with steel primary load-bearing trusses and framing and steel walls and roofs. Their doors are the standard horizontal telescoping type that slide, overlap, and open up access to the entire hangar space when fully pushed to either side. The hangar attached to the northeast side of the Double M Aviation hangar is of similar design and construction, but it only about half as wide. The two hangars are largely open to each other inside, forming a single work space.

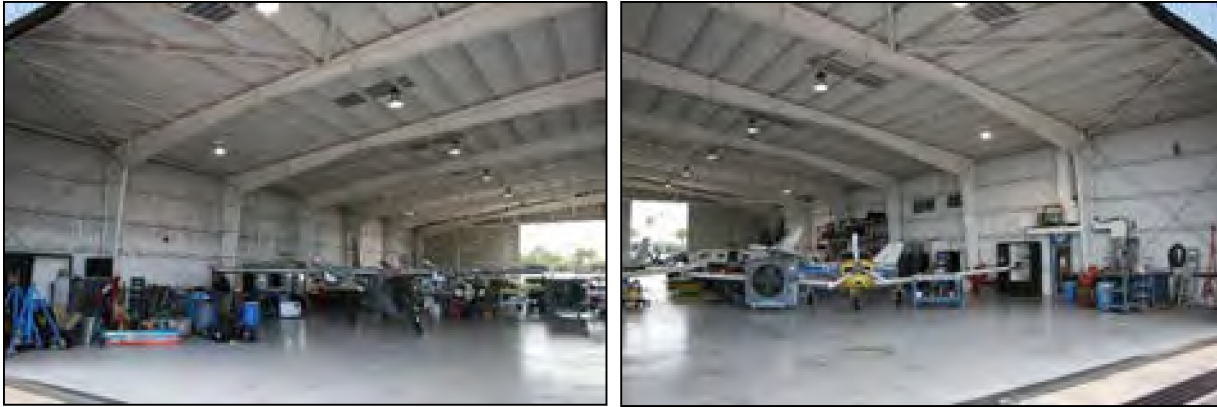
*Figure 12. Aeromech Aviation maintenance hangar (FMSF PO08463) (AECOM Resource #11c): interior views.*

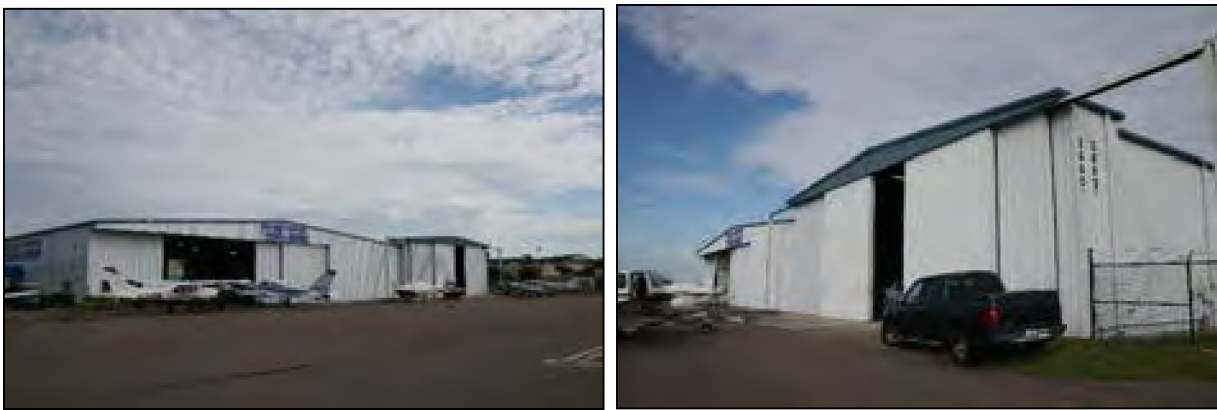
*Figure 13. Double M Aviation maintenance hangars (FMSF PO08464) (AECOM Resource #11d): left, southwest side and southeast airside elevations with first-built hangar at left; right, southeast airside and northeast side elevations with second-built hangar at right.*

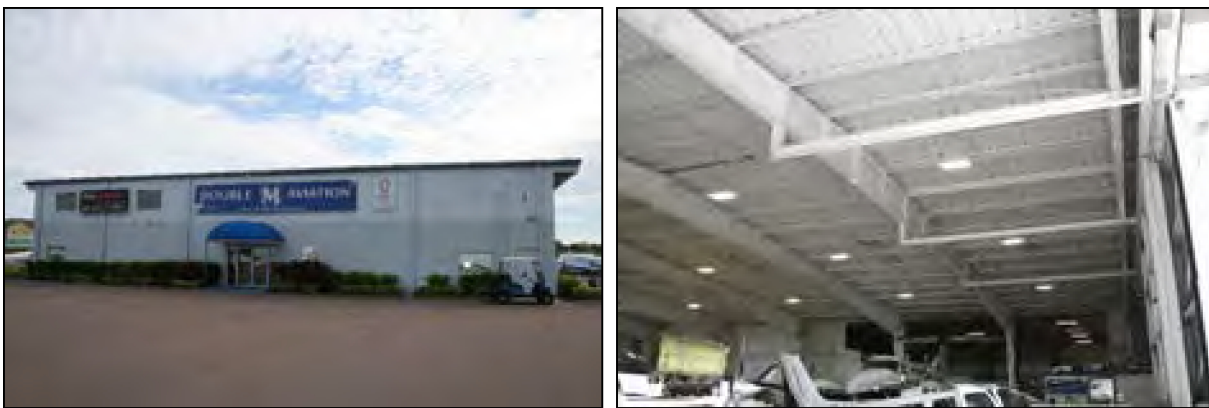
*Figure 14. Double M Aviation maintenance hangars (FMSF PO08464) (AECOM Resource #11d): left, southwest side elevation of first-built hangar; right, interior view looking from first-built hangar into darker second-built hangar space.*

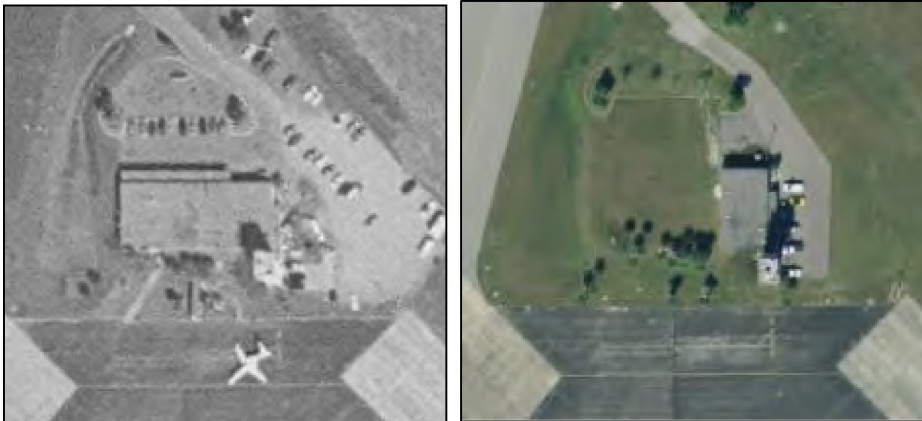
Figure 15. Left, aerial views of former Lakeland Municipal Airport terminal (FMSF PO08465) (AECOM #11e) in 2002 and, right, in 2005 (source of both: Polk County GIS Map Viewer site)

A portion of one additional building that is more than 50 years old survives at the airport (Figure 15 and Figure 16). In December 1959 the airport was completing construction of its first purpose-built terminal (FMSF PO08465) (AECOM Resource #11e). A basic Modernist building, the Lakeland Municipal Airport terminal was a one-story-tall rectangle of masonry construction topped by a flat roof. Exposed posts separated it into seven bays across its front. Three had three-part glass windows and paired doors that extended most of the way toward the roof; four were windowless. A flat-roofed portico supported by

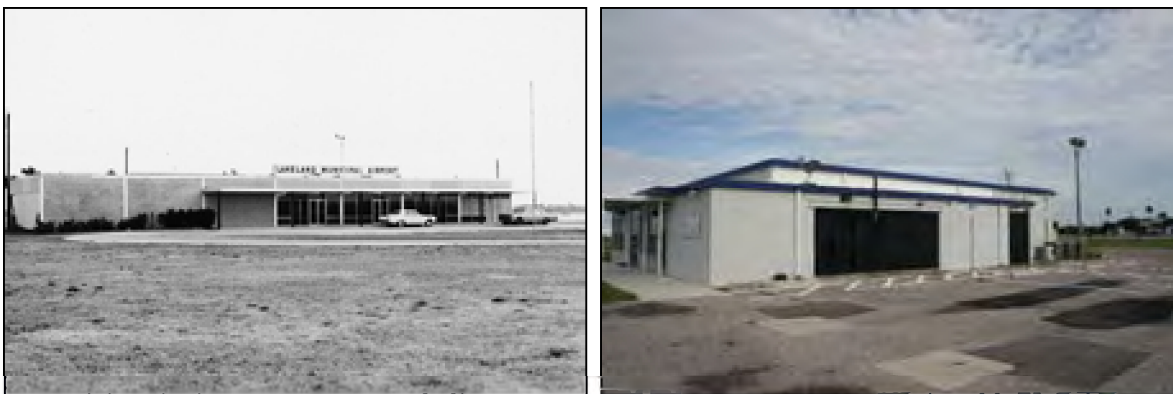
Figure 16. Left, Lakeland Municipal Airport terminal building (FMSF PO08465) (AECOM #11e), 1967 (source: <https://cdm15809.contentdm.oclc.org/digital/collection/p15809coll7/id/66/rec/1>); right, current US Customs and Border Protection building (same number), south front and east side elevation.

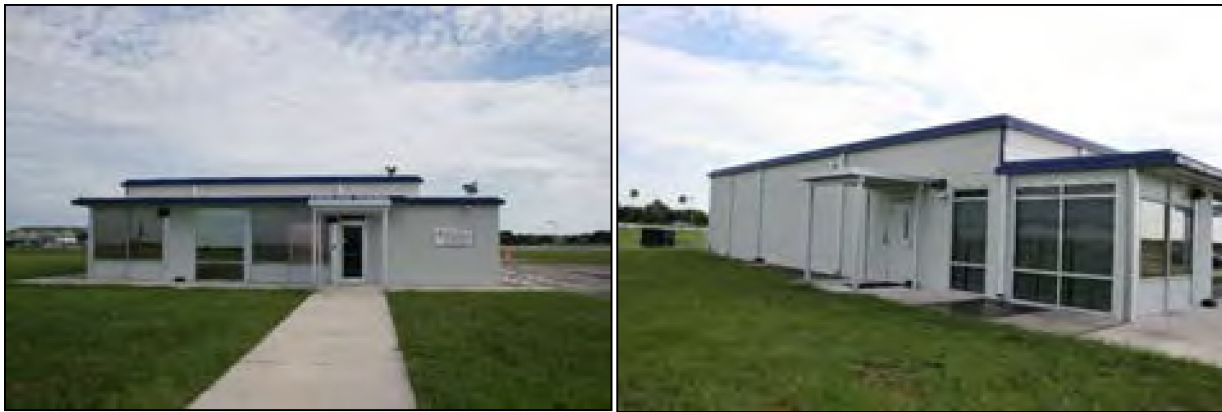
*Figure 17. Left, current US Customs and Border Protection building (FMSF PO08465) (AECOM #11e), south front elevation and, right, west side and south front elevations.*

The remaining quarter of the former terminal now houses the airport's US Customs and Border Protection (CPB) facility (Figure 17 and Figure 18). The one-story building retains some of the walls of the terminal and perhaps one of the original three-part windows. A shorter one-story addition has been wrapped around its south and east elevations. This addition includes three-part windows similar to the original ones.

Due its dramatic alterations—not least the removal of one-quarter of its original structure—the former Lakeland Municipal Airport terminal, now home to the airport's CPB facility, is believed to have lost its integrity of design, materials, workmanship and, accordingly, feeling and association. It remains in an airport setting on its original location, but it appears to have clearly lost its overall integrity. Additionally, the building is not known to have any association with significant historic events or persons and does not appear to embody the distinctive characteristics of a type, period, or method of construction. It is accordingly recommended as not NR-eligible under Criteria A, B, or C.

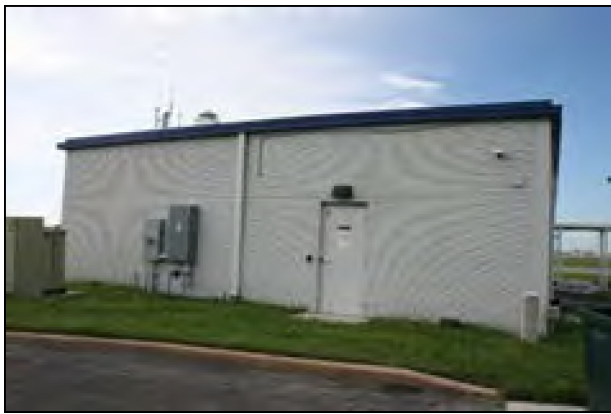
*Figure 18. Left, current US Customs and Border Protection building (FMSF PO08465) (AECOM #11e), north rear elevation.*
